Research article

Geological and geophysical assessment of groundwater contamination at the Roundhill landfill site, Berlin, Eastern Cape, South Africa

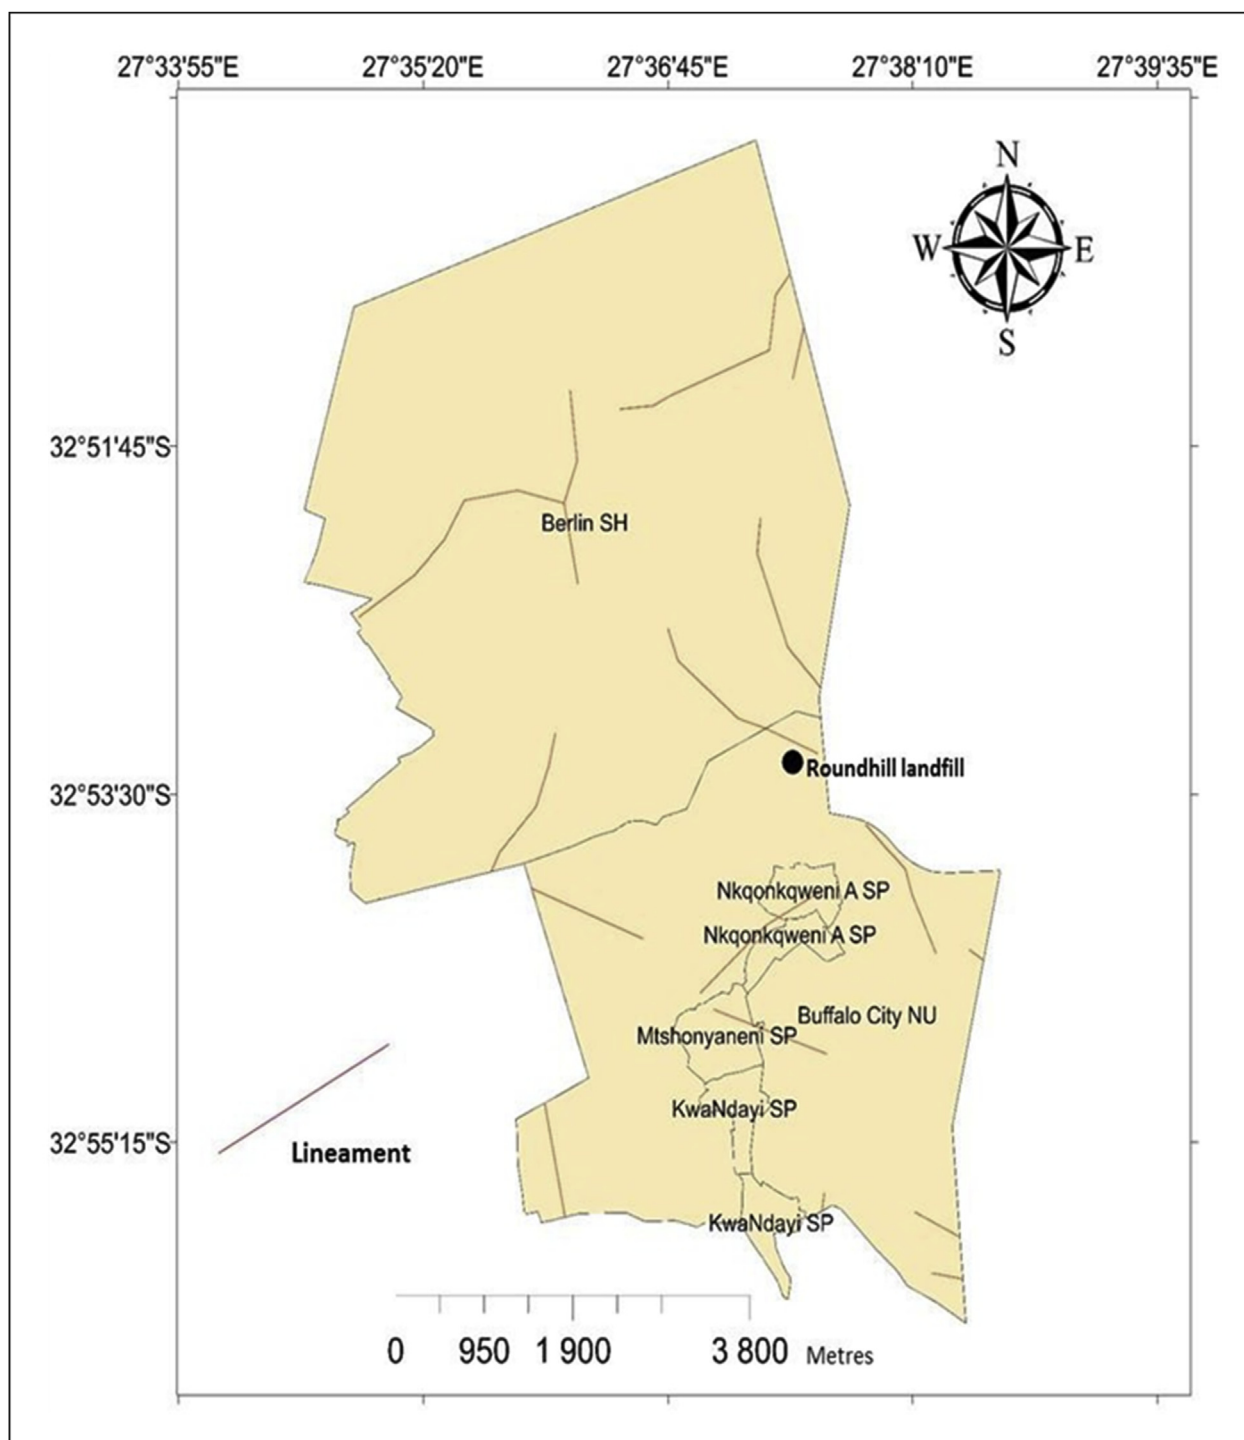
Figure 3. Local geological settings at the Roundhill landfill site.

The local geology of the Roundhill landfill site shows the predominance of the Daggaboersnek Member of the Balfour Formation in the Beaufort Group, comprising of a top layer of silty sandstone which is underlain by a clay layer (Baiyegunhi and Gwavava, 2016; Katemaunzanga and Gunter, 2009). A layer of weathered basement (sandstone) is below the clayey layer and it sits atop fresh bedrock of dolerite. The sandstone formation having poorly sorted framework with low permeability hosts the aquiferous zone. The presence of geological structures controls the occurrence of groundwater and its vulnerability to contamination. The identification of lineament structures and fractured zones can be used to determine the direction of groundwater flow (Salama et al., 1993; Baiyegunhi et al., 2019). The lineament map of the area showed SE- NW trending lineament, coinciding with the direction of groundwater flow about 200 m from the back of the landfill site (Figure 3). This indicates that the area around the landfill may have groundwater potential. This fact is corroborated by the dense vegetation, natural and artificial surface water sources found in the vicinity of the landfill. The average depth to the groundwater level as observed from the boreholes is about 50 m. The orientation of the lineament northwards in the direction of the Nahoon River located about 10 km away from the landfill poses a potential danger not only to the groundwater below but may serve as an excellent pathway for the drainage of possible leakages from the landfill.

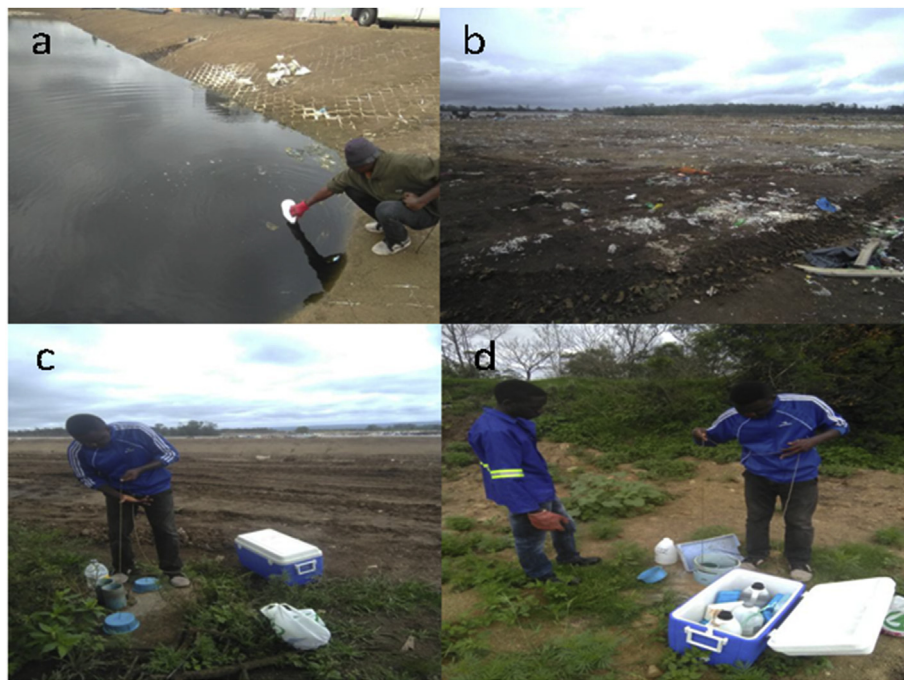
Figure 4. a. Leachate pond at the site, b. Surface composition of the landfill, c. Borehole (BH2) at the edge of the landfill, d. Dry borehole (BH3) at the back of the landfill.

The Berlin landfill, also known as the Roundhill landfill is strategically located on a watershed which occurred between the Nahoon and the Buffalo rivers. It is surrounded by small water bodies in form of artificial and natural dams. The drainage pattern in the area is northwards, towards the Nahoon River. The landfill site has well-constructed waste cells which are typically flat thus accounting for the gentle topography within the landfill area. The location of active cropland in the vicinity of the landfill site suggest a good groundwater potential in the area. Three groundwater monitoring boreholes (BH1–BH3) and a leachate pond were identified on the site (Figure 2). Two of the three boreholes had groundwater and the third borehole had no water. This is

probably due to the shallow depth of the borehole and the dominance of dolerite exposures in the vicinity of the borehole (BH3).

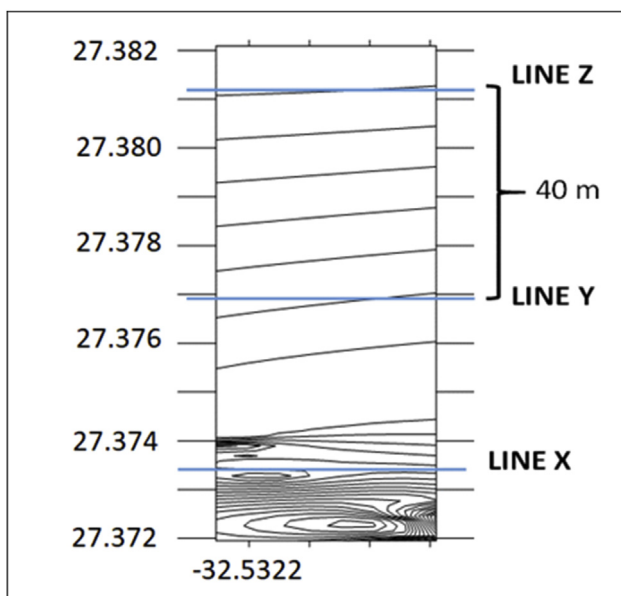
Figure 5. Geophysical data acquisition map of the Roundhill landfill.

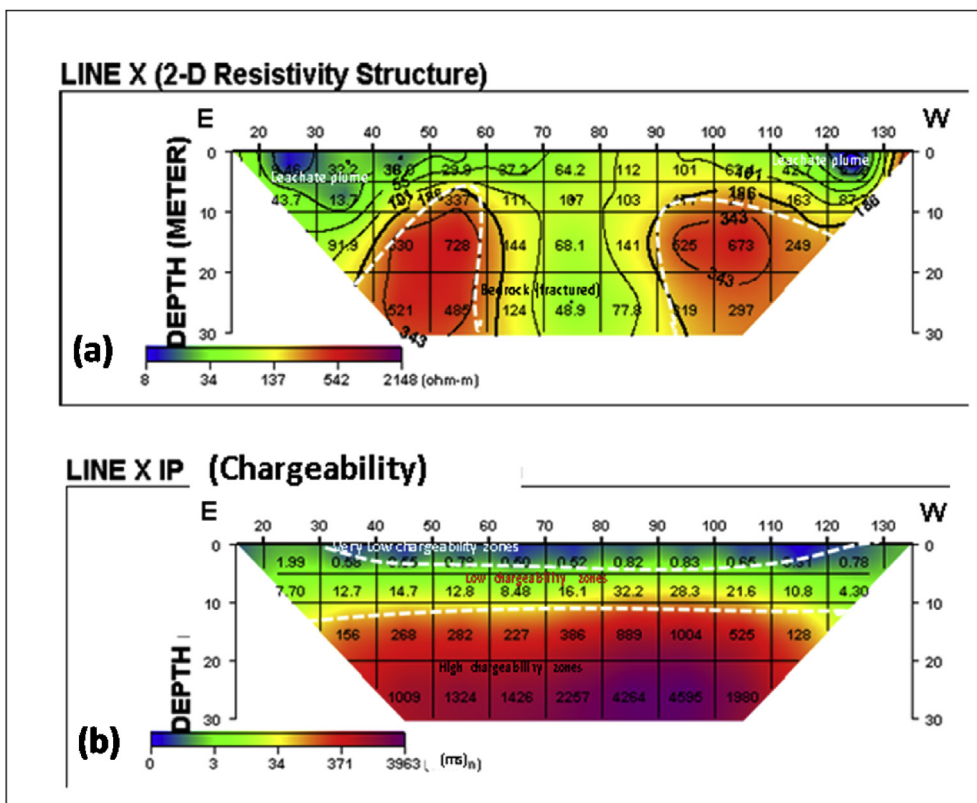
Figure 6. a. Dipole-dipole resistivity pseudosection along line X, b. Induced polarization section along line X.

The pseudosections generated from the electrical resistivity and time – domain induced polarization measurements using the double-dipole array across three traverse lines are shown in Figures 6, 7, and 8.

depth to the bedrock of about 20 m. Contaminant leachate plume were observed on Line X, revealing contamination to a depth of about 10 m through the top layers (Figure 6). A fractured bedrock which could serve as excellent pathways for the migration of contaminants into the groundwater below was also observed on line X (Figure 6). Chargeability values ranges from very low at the top surface (1.25 ms) to high values (1286 ms) at the bedrock across the pseudosections (Figure 7). Generally, across the sections, areas with low time domain chargeability values correspond to low resistivity on the sections ($<112 \Omega\text{-m}$; Figures 6 and 7). This is interpreted to be percolating leachate plume in the unsaturated zone. The effectiveness of reducing ambiguities in interpretation through the combined electrical resistivity and induced polarization method was demonstrated on line Z (Figure 8), where anomalies on the IP sections (between 60 -100 m) were not detected on the resistivity pseudosections. This suggests the dense non aqueous nature of the contaminants on the IP section and low clay content in the top layer. The fractured plane of the bedrock is more obvious on line Z (Figure 8). The weathered to fresh basement zones were characterized by high resistivity and chargeability zones across the sections. This suggests that the basement layers lithology pose low risk to groundwater contamination.

contamination by leachate to a depth of about 10 m across three profiles and a depth to the bedrock of about 20 m. Anomalous zones of low resistivity correspond to low chargeability values, indicating percolating leachate plume in the unsaturated zone. A general observation across the pseudosections revealed that while the layer lithologies and stratigraphy poses low risk to groundwater contamination, the presence of structural controls such as fractures in the bedrock may be favourably disposed to the percolation of contaminants into the groundwater below over time.

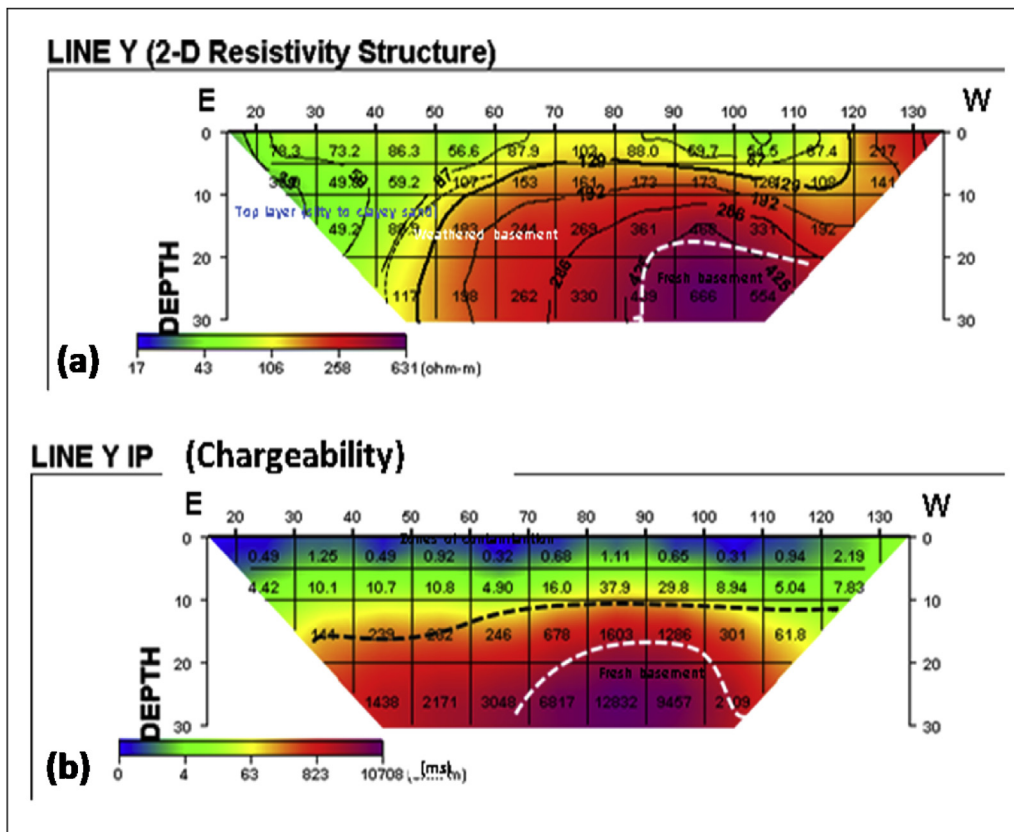
Figure 7. a. Dipole-dipole resistivity pseudosection along line Y, b. Induced polarization section along line Y.

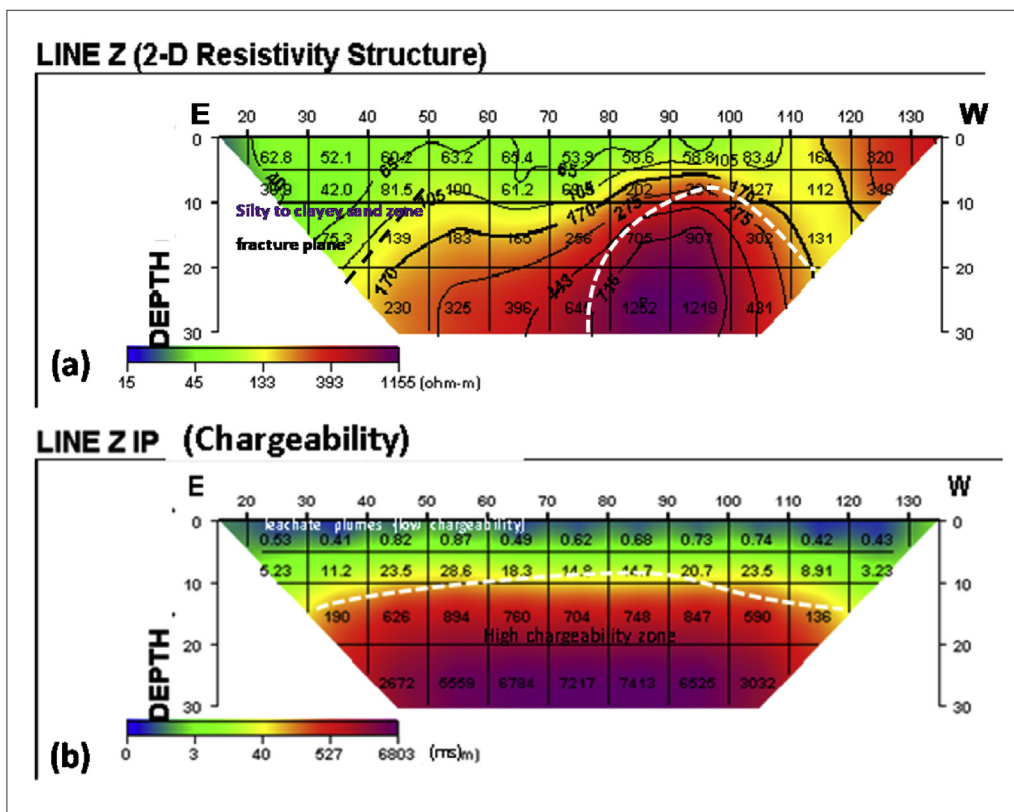
Figure 8. a. Dipole-dipole resistivity pseudosection along line Z, b. Induced polarization section along line Z.
