Corrosion Damage to Joints of Lattice Towers Designed from Weathering Steels

Abstract: The article dealt with the load-bearing capacity and durability of power line lattice towers designed from weathering steel. Attention was paid in particular to the bolted lap joints. The article evaluates the static and corrosion performance of bolted lap joints in long-term operating towers, and also presents and evaluates design measures that can be applied in the design of new lattice towers, or in the reconstruction of already operating structures. Power line lattice towers are the most extensive realization of weathering steel in the Czech Republic. On the basis of the inspections carried out to evaluate the working life of the transmission towers in operation, it can be stated that a sufficiently protective layer of corrosion products generally developed on the bearing elements of the transmission towers. However, the development of crevice corrosion at the bolted joints of the leg members is a significant problem. In this paper, the corrosion damage of bolted joints was evaluated considering two basic aspects: (1) the influence of crevice corrosion on the bearing capacity of the bolted j

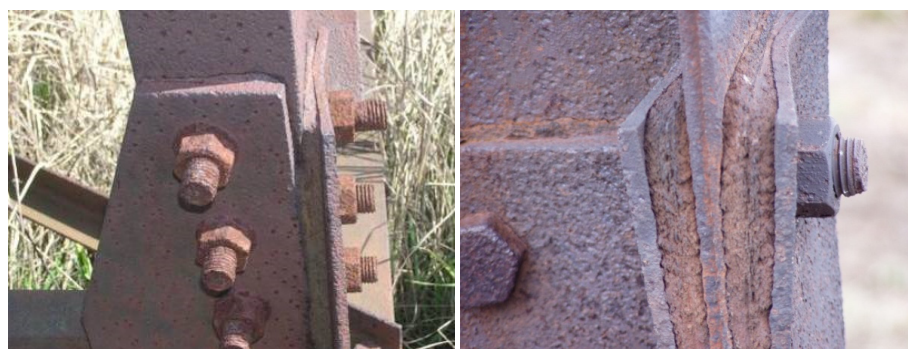
In the case of the bolted joint of the leg members, crevice corrosion [21,22] occurs in the crevice, between the splices and the angles to be connected [23], as illustrated in Figure 1. The time of surface wetting is prolonged in the crevice, impurities accumulate, and aeration and concentration differences are created, all of which favour the development of the corrosion process. The conditions necessary for the formation of a protective patina do not occur in the crevice. The accumulated corrosion products deform the splices in the connection.

Figure 1. Crevice corrosion in the bolted joint of the leg member.

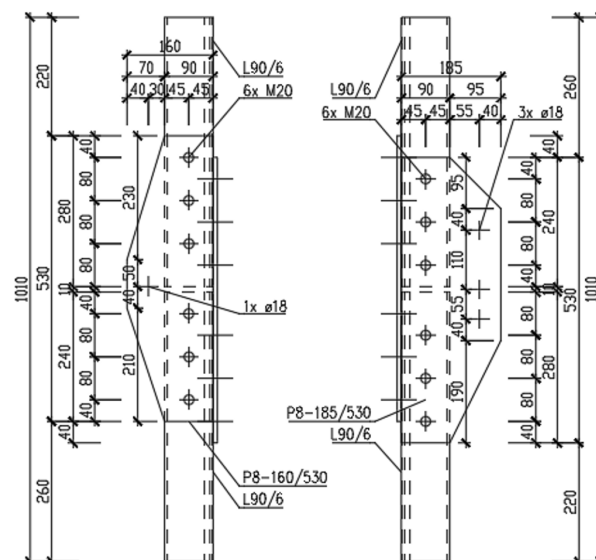
Figure 2. Detail of the A-type joint.

For the destructive tensile test of the joints, two pieces of the A-type joint, and six pieces of the K-type joint, were prepared. In all cases, L90/6 equal-leg angles were connected using P8 splices. The splices were connected to the profiles with 2×6 M20 bolts, of the class 5.6. The geometry of the test specimens is presented in Figures 2–4.

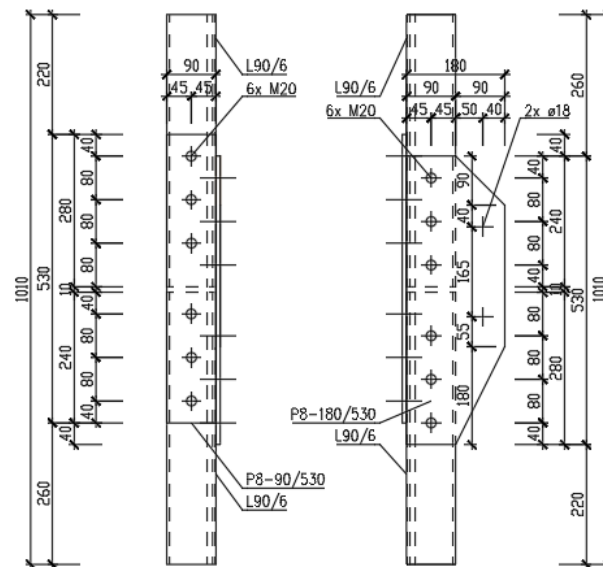
Figure 3. Detail of the K-type joint.

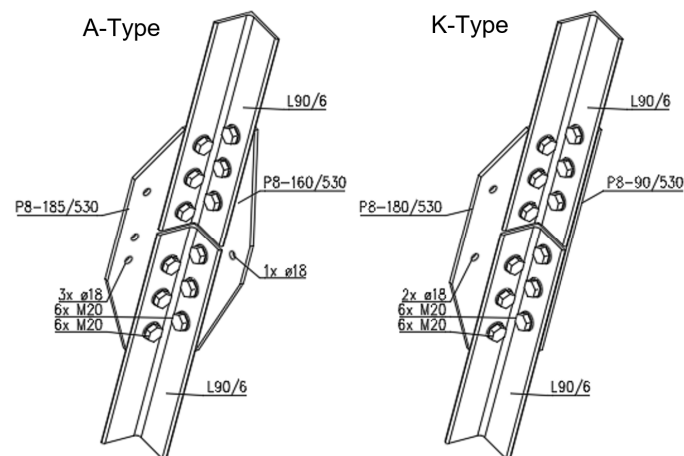
Figure 4. Details of the joint: an isometric view of the joints.

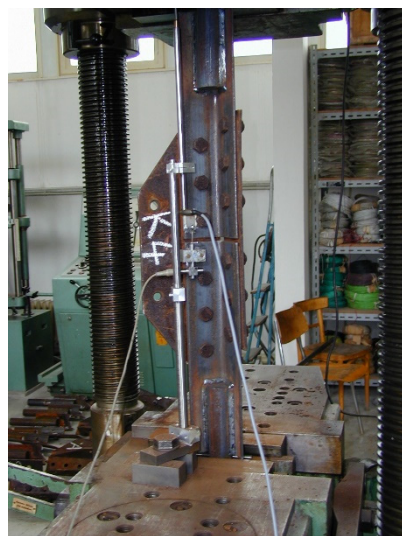
Figure 5. Test piece arrangement in the tensile testing machine.

During the tensile testing of the bolted joints, the relation between the tensile force F (kN) and the total deformation u (mm) of the test specimens was registered. At the same time, the gap opening (i.e., the change in the longitudinal distance between the ends of the connected angles) between the connected members was also measured. The uniform length of the test specimens between fixed ends is $L_0 = 1010$ mm, see Figure 5. The tensile testing was carried out until the specimen failed. Verification of the bearing capacity of the joint was performed using analytical relationships, in accordance with the valid European standards EN 1993-1-1 [24] and EN 1993-1-8 [25]. Numerical analysis was also carried out on the selected joint using ANSYS software. The joint was modelled using 3D solid elements and assuming the application of deformation load. The material properties of the steel and bolts were introduced using the Ramberg–Osgood stress–strain curve [38].

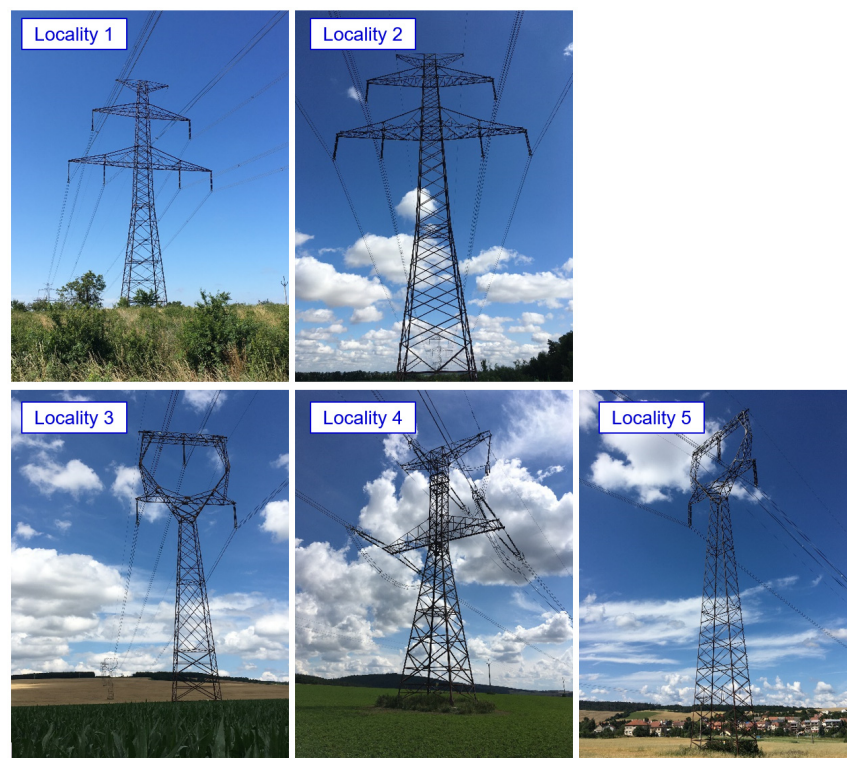
The transmission towers are located in an agricultural area (corrosivity category C2). The structural design of the transmission towers can be seen from the photographs presented in Figure 6.

Figure 6. The structural design of the evaluated transmission towers (Locality 1: Tasovice; Locality 2: Dyjákovičky; Locality 3: Ivančice; Locality 4: Rosice; Locality 5: Veverské Knínice).

For all lattice towers situated at sites locality 1 to locality 5, as presented in Figure 6, the development of corrosion products in the crevice between the angle and the splices is identified. The bolted joints rehabilitation had not yet been performed on the transmission tower placed at locality 5. In the area of the bolted joint of the leg member, a typical development of corrosion products in the crevice between the splices and the leg member is observed, associated with the development of permanent plastic deformation of the splices, as illustrated in Figure 16. The thickness of corrosion products in the crevice reaches up to 10 mm.

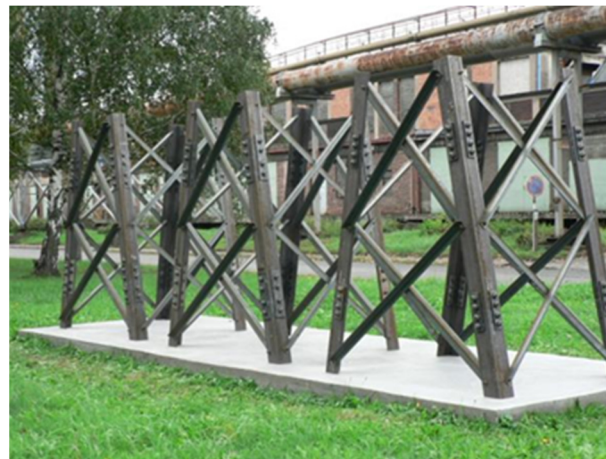
Figure 7. View of the experimental towers' assembly at the time of installation.

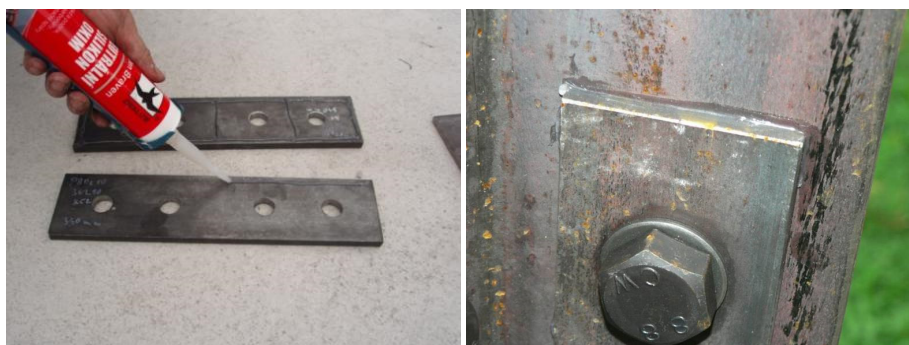
Figure 8. Application of silicone sealant ((left) application of sealant to the splices; (right) sealant smoothed around the perimeter of the splice).

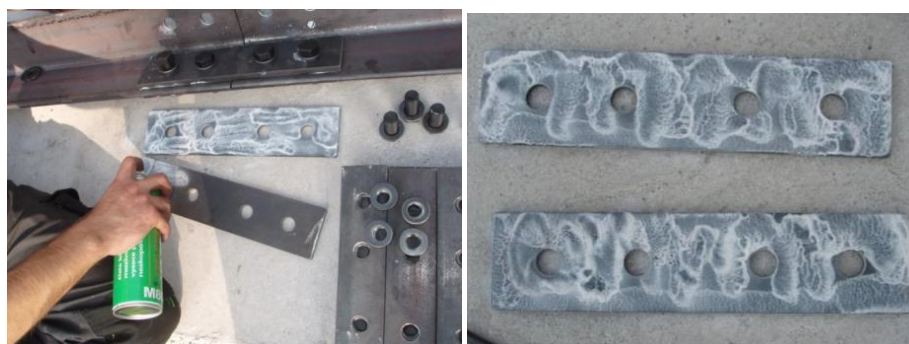
Figure 9. Application of Teflon Vaseline to the splices.

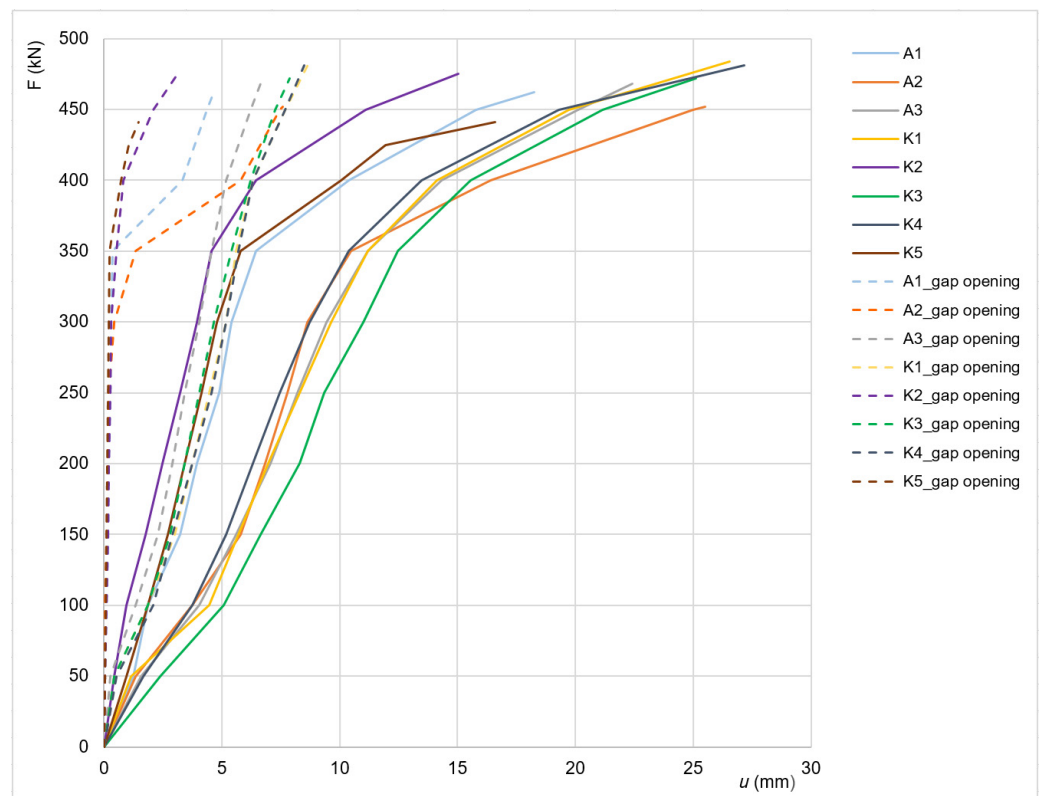
Figure 10. Tensile test results: the solid line shows the dependence of the tensile force F (kN) and the total deformation u (mm); the dashed line shows the dependence between the tensile force F (kN) and the gap opening between the connected angles.

The loading tests are carried out until the failure of the test specimens, which occurs either by rupture of the angle of leg member, or by shear of the bolts. Summary results for both 'A' and 'K' test specimens are shown in Table 9. The ultimate load at failure of the test specimen is in the interval 441 to 484 kN, the average value being 466.9 kN. The load at the beginning of the plastic deformation of the test specimen in all cases is close to 350 kN (visible reduction of the axial stiffness of the specimens, as shown Figure 10). Significant

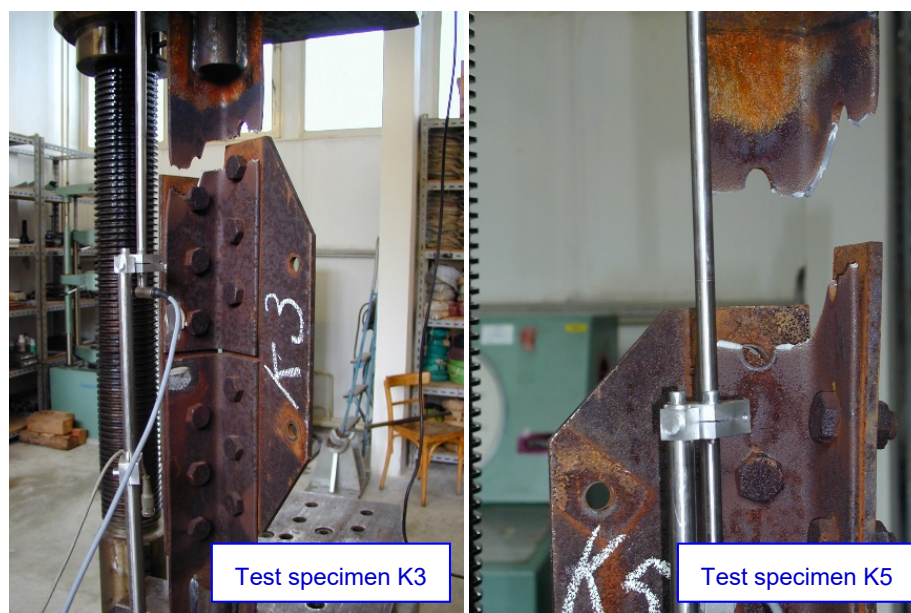
Figure 11. Failure of the test specimens by rupture of the angles (test specimens K3 and K5).

differences are observed in the deformation values of the individual test specimens. In the opinion of the authors of the paper, these differences are mainly due to the different values of slip in the individual joints, and probably also the different levels of friction in the joints. The failure of the test specimen occurs by rupture of net cross-sectional area at holes for fasteners, as illustrated Figure 11. In one case, there is a shear failure of the bolts.

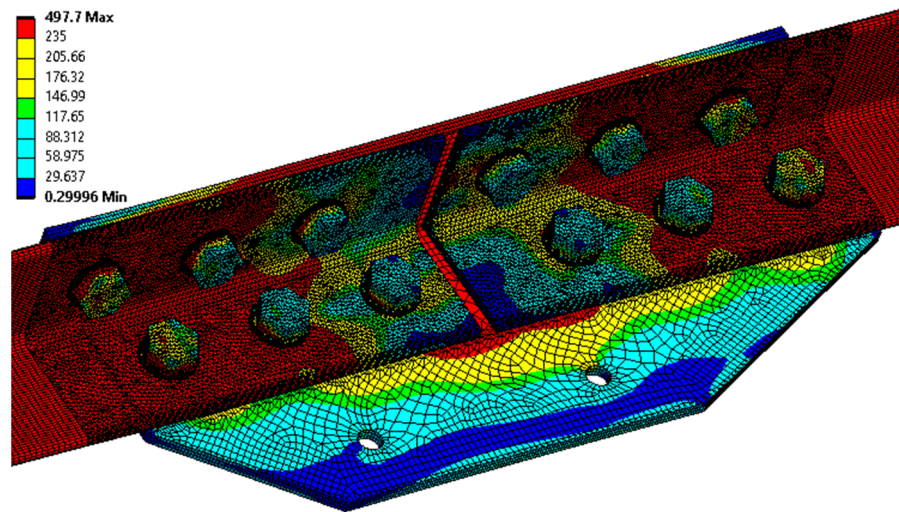
Figure 12. The von Mises equivalent stress (MPa) in the K-type joint (model without the effect of the crevice corrosion).

For the K-type joint modelled without the effect of joint corrosion, the maximum von Mises equivalent stress of 497.7 MPa is obtained by numerical analysis. Figures 12 and 13 demonstrate the distribution of the von Mises equivalent stress, and the von Mises equivalent strain, and, therefore, the assumed location of the real failure is confirmed by destructive tests. The reaction force of the model is 474.0 kN, and the average value measured during destructive testing is 466.9 kN.

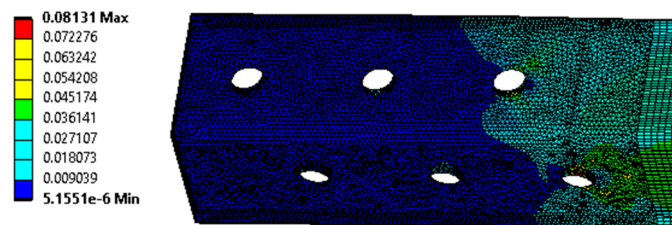
Figure 13. The von Mises equivalent strain in the selected part of the K-type joint (model without the effect of the crevice corrosion).

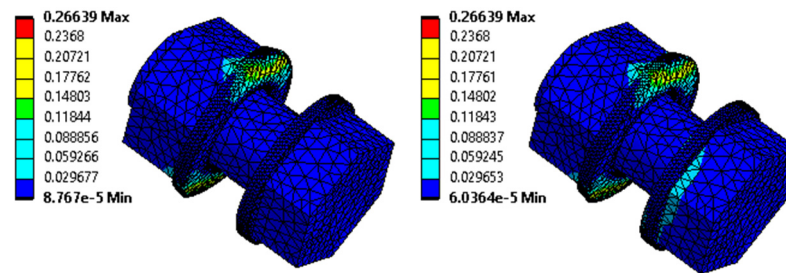
Figure 15. The von Mises equivalent strain in the K2 joint bolts (model considering the effect of the crevice corrosion); left: results corresponding to the application of deformations from crevice corrosion; right: results after subsequent loading with the prescribed displacement.

For a K-type joint modelled considering the effect of crevice corrosion, the von Mises equivalent stress of 499.9 MPa is obtained by numerical analysis. The consideration of the effect of crevice corrosion is based on a specific case of deformation of the splice of the K2 tested joint, where the measured maximum size of the crevice with corrosion products is equal to 10 mm. The model prescribes a 10 mm deformation of the vertical lines of the splices away from the L profile. The total elongation of the assembly is set, according to the K2 failure test, to 15 mm. The reaction force of the model is 486.7 kN, and the real measured force in the destructive test with bolt failure is 475 kN. Figures 14 and 15 below show, on the left, the results corresponding to the application of deformations from the crevice corrosion, and on the right, the results after the application of the subsequent load by the prescribed displacement.

These results show that the bolts are significantly stressed from the beginning of the development of corrosion products in the crevice. With subsequent static tensile loading, the stresses in the bolts increase further. The numerical analysis is in good agreement with the results of the analytical calculation presented in Section 3.1.2.

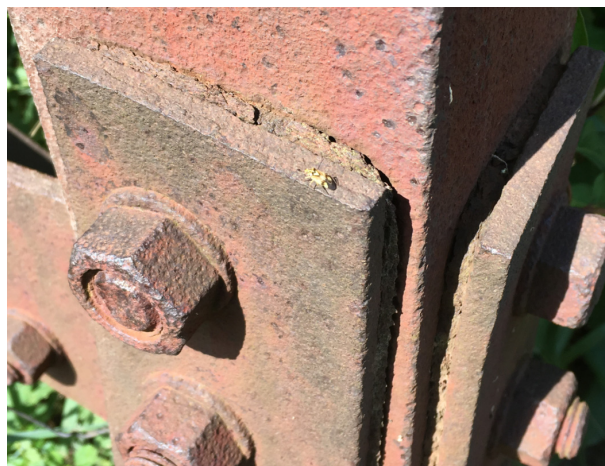
Figure 16. Crevice corrosion at the bolted joint of leg members (Locality 5).

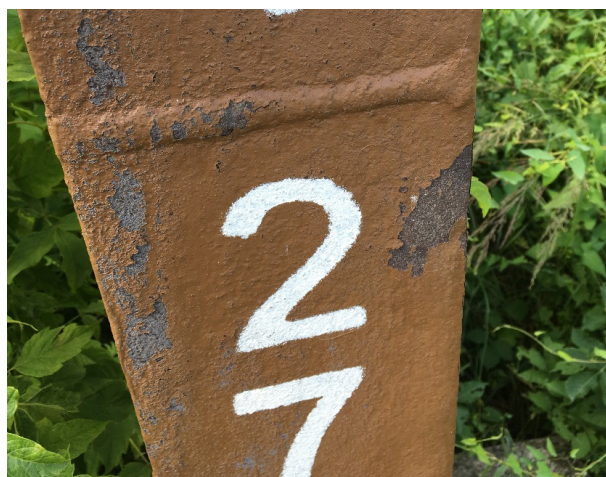
Figure 17. Failure of a paint system applied to a poorly prepared surface (the original protective layer of corrosion products remains under the peeling paint).

For the other transmission towers located at sites locality 1 to locality 4, the rehabilitation of the bolted joints was already carried out. The rehabilitation of the transmission towers was undertaken approximately 10 years ago. The repair of the transmission towers is carried out by workers wearing full body harnesses, and who are authorised to work at heights. In these difficult working conditions, it is very complicated to comply flawlessly with all the requirements recommended for the rehabilitation of the bolted joints of the leg members. For the transmission towers evaluated, failures of the additionally applied coating system are more frequently identified, especially on surfaces that the primer was applied to without prior proper surface cleaning (refer to Figure 17). However, from the point of view of the long-term reliable functioning of the structure, these failures of the coating system do not represent a significant problem, as the original protective layer of corrosion products remain under the peeling coating.

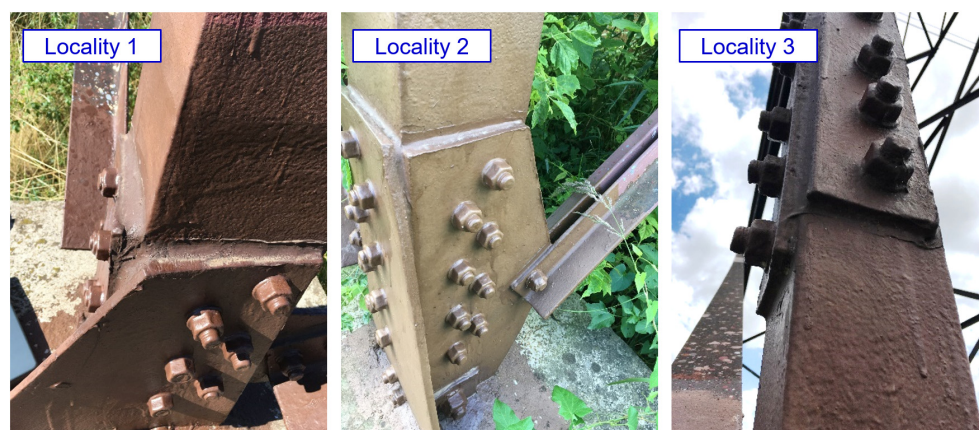
Figure 18. Functional crevice protection with sealant (selected examples).

The protection of the crevice by the sealant is still functional, and no significant failures are identified on the transmission towers evaluated (see Figure 18). Thus, the bolted joint of the leg members is protected from further development of crevice corrosion, even after about 10 years following the application of the sealant.

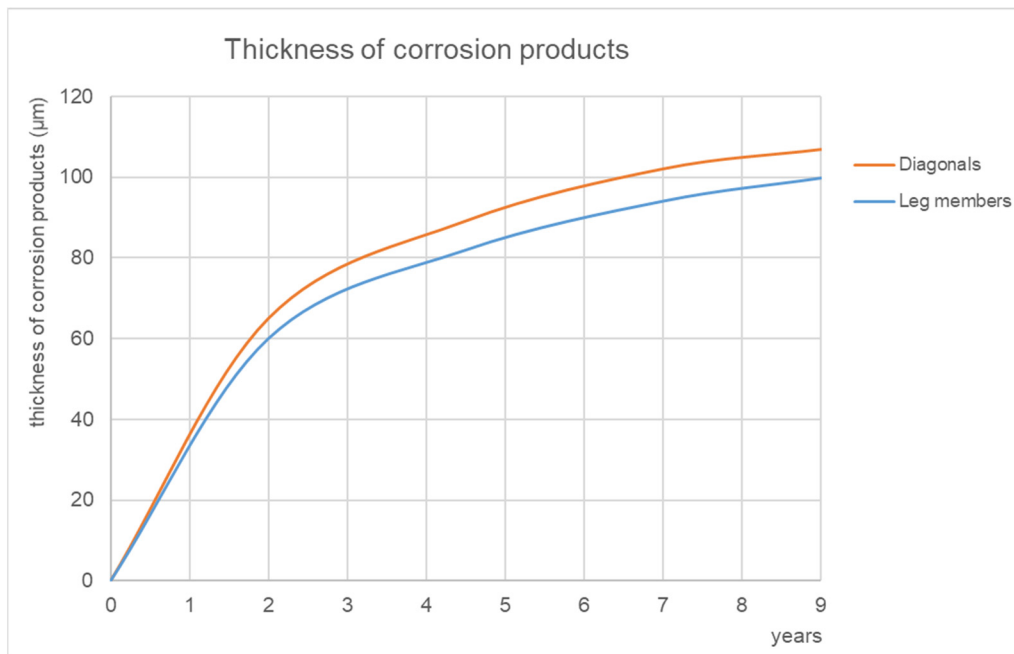
Figure 19. Experimental towers: development of thickness of corrosion products over time.

The development of corrosion products on leg members and diagonals is monitored at regular intervals. The increase in the average corrosion thicknesses is noted in Figure 19. It is expected that the average thickness of the corrosion products will continue to increase gradually in the coming years (for the long-standing transmission towers in operation, an average thickness of corrosion product of 161 μm is found, see Chapter 3.2.1). During the manufacture of the towers, the surface of the steel elements is deliberately left as rolled, including the mill scales. The thin surface mill scale has mostly fallen off after 9 years of exposure. The rolled thicker scales still remain on some surfaces, but their surface is gradually diminishing.

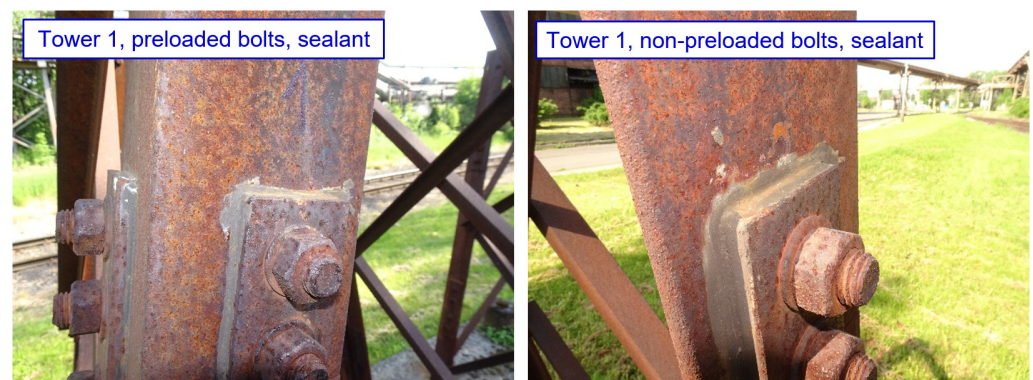
Figure 20. Tower 1: Selected examples of joints (functional sealant along the edge of the splice).

No phenomena related to the formation of crevice corrosion are observed in tower 1, which is designed with 10 mm thick splices, and with minimum bolt spacing and end/edge distances. No deterioration of the sealant is observed in the connections protected by sealant, as shown in Figure 20. For the other connection types, no mechanical damage to the splices is observed so far, although a lighter strip of corrosion products is visible on the top edge of the connection. No differences are observed between joints with preloaded and non-preloaded bolts.

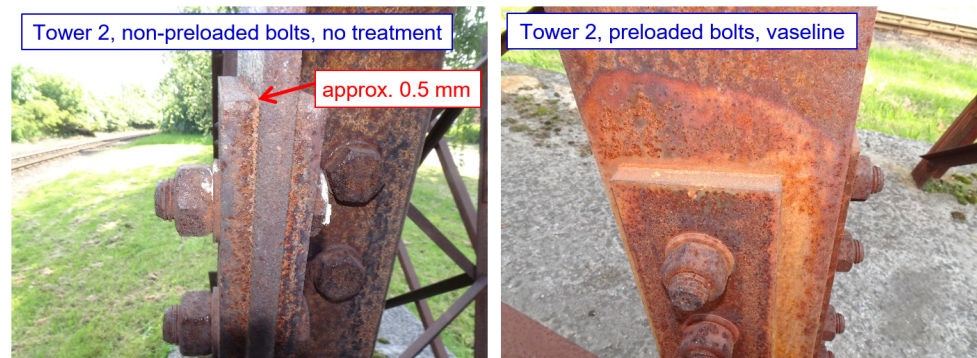
Figure 21. Tower 2: Selected examples of joints ((left): initial development of corrosion products in the crevice; (right): visual influence of the development of corrosion products in the area around the joints protected with Vaseline).

For tower 2, which is designed with 10 mm thick splices, and with normal bolt spacings and end/edge distances, phenomena related to the formation of corrosion products in the crevice between the bolt and the leg member are already observable. For bolted joints without treatment, the initial development of corrosion products in the crevice are observed (the thickness of the corrosion products at the top edge of the splice is still very small: up to about 0.5 mm, as demonstrated in Figure 21). For the other connections, the development of crevice corrosion is not yet identified, although a lighter strip of corrosion products is visible at the top edge, especially for the joints with coatings. All joints protected with sealant are functional. No significant differences between preloaded and non-preloaded bolts are observed. There is a visual influence on the development of corrosion products

around the joints protected with Vaseline (this is only a visual failure, with a slowing of the development of corrosion products).

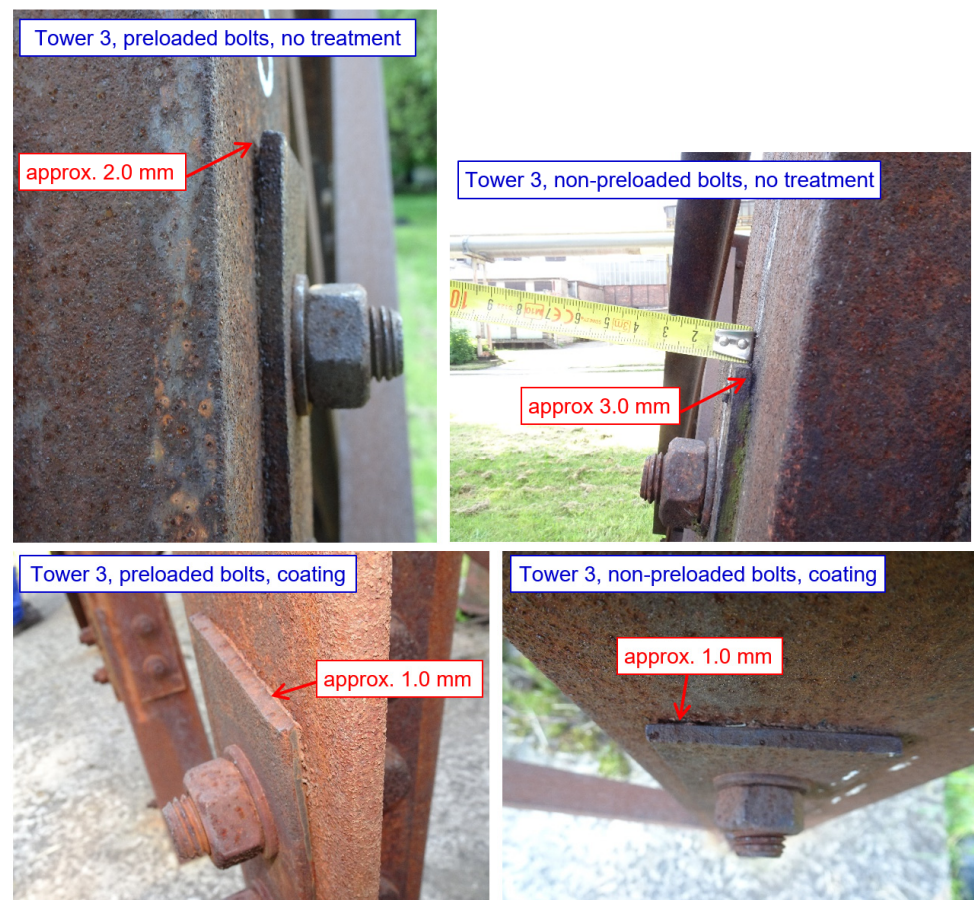
Figure 22. Tower 3: Selected examples of joints (the development of corrosion products in the crevice of joints without treatment, and in joints with coating on the inner surface of the splices).

In tower 3, which is designed with 5 mm thick splices, and with normal bolt spacings and end/edge distances, development of crevice corrosion occurs at some bolted joints, as illustrated in Figure 22. For untreated bolted joints, corrosion products with a thickness of up to 3 mm are found at the top edge of the splice (the thickness of corrosion products is slightly less for preloaded bolted joints, approx. 2 mm).

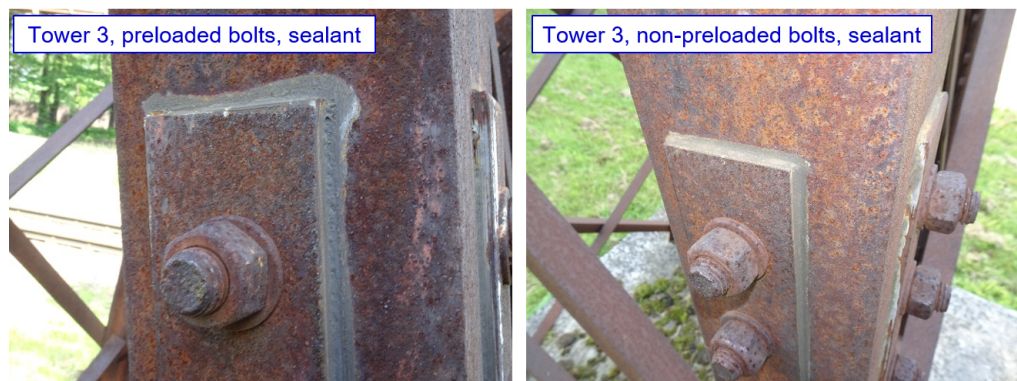
Figure 23. Tower 3: Selected examples of joints (functional sealant along the edge of the splice).

Corrosion products with a thickness of 1 mm are also found on joints (both non-preloaded and preloaded bolted joints) protected by coating system. The joints protected with sealant are functional, as indicated in Figure 23.

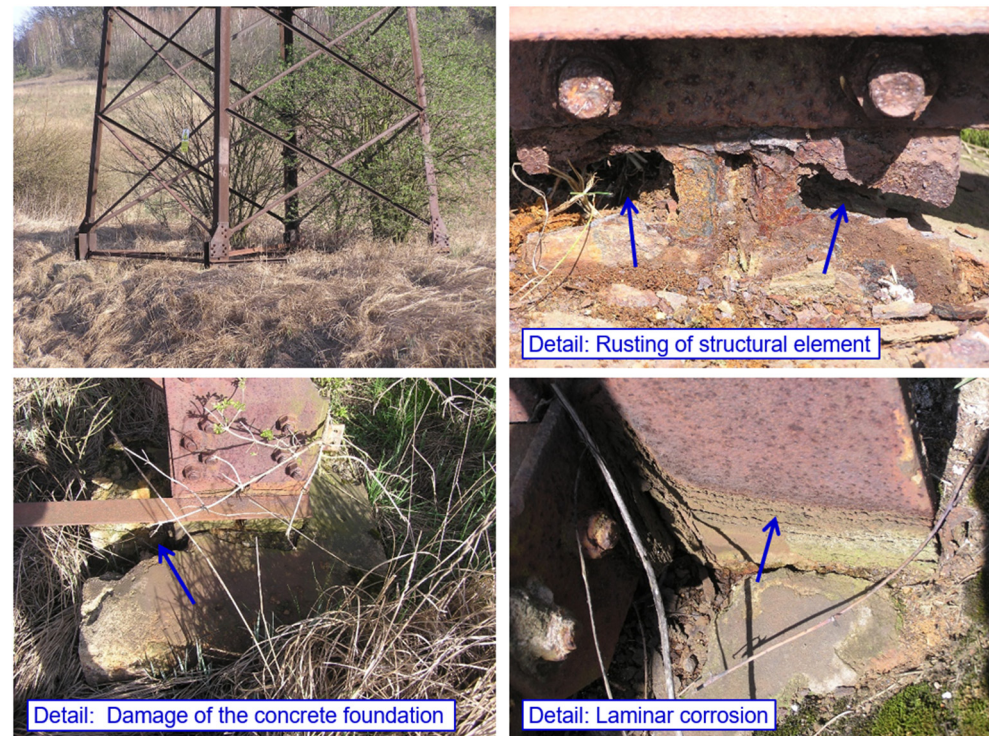
Figure 24. Selected examples of corrosion damage in the anchorage area of transmission towers.
