Case Report

Nexplanon removal from intramuscular implantation in biceps: case report[☆]

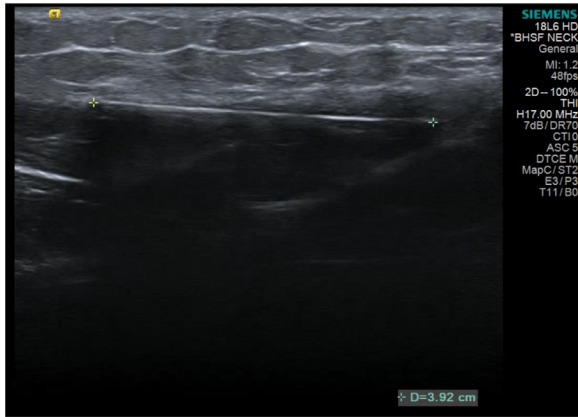
Fig. 1 – The Nexplanon implant can be seen as a linear echogenic shadowing structure measuring approximately 4 cm in length in close proximity to the bicep's fascia.

device on ultrasound and fluoroscopy in the hopes of helping other surgeons in a similar situation to recognize the device on those imaging modalities.

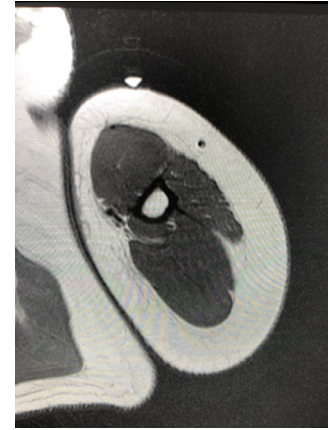
Fig. 2 – Pre-operative MRI, axial plane, of the upper arm. The implant was unable to be discriminated from other anatomic landmarks.

In this specific case, the device could not be palpated because it had been placed or migrated into a subfascial location. We were able to locate the Nexplanon device on fluoroscopy and ultrasound. Interestingly, the preoperative MRI did not localize the device due to the close proximity to the fascia of the biceps. We have provided images of the appearance of the

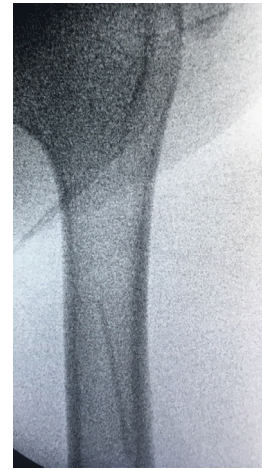
Fig. 3 – Pre-operative fluoroscopy image localizing the device. The Nexplanon can be seen parallel to the humerus in the lower part of the image.

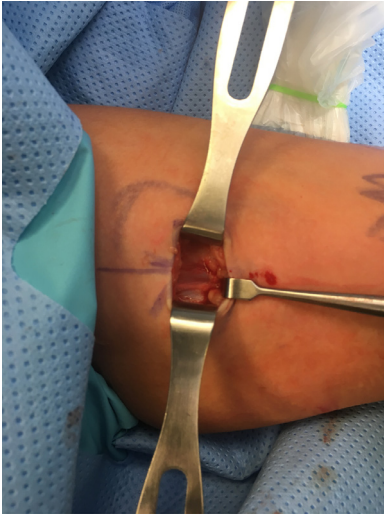
Fig. 4 – Intraoperative photograph showing device below the bicep's fascia.

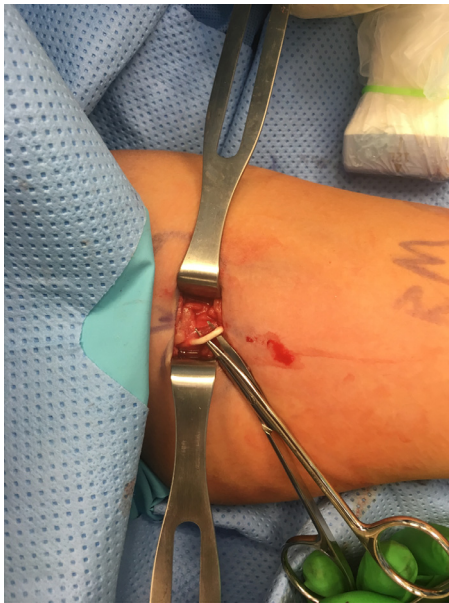
Fig. 5 – Intraoperative photograph of the device after splitting the fascia and pulling the device out of the wound.

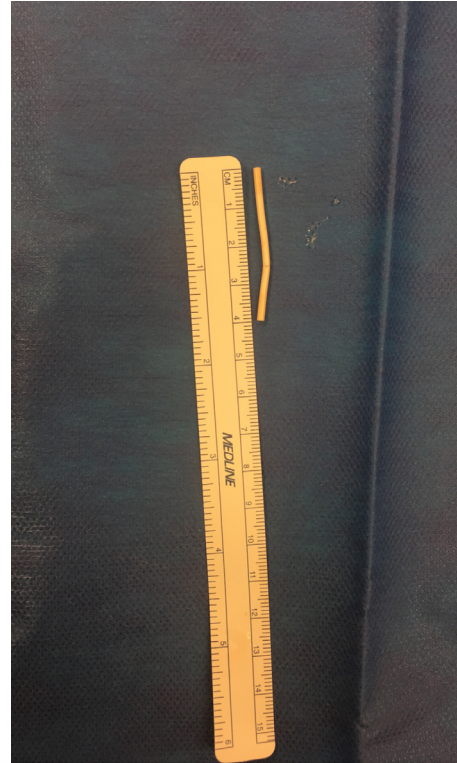
Fig. 6 – Clinical photograph of the device that was removed. A photograph of the explanted Nexplanon.

A 21-year-old female with a history of a Nexplanon implant in her left arm for 3 years, presented to our office for implant removal. She was referred by her obstetrician because they were unable to localize the device in the subcutaneous tissue. During the visit, the device was localized by ultrasound in the upper arm (Fig. 1). However, the preoperative ultrasound was unable to provide sufficient details to determine the exact location of the device in relation to other anatomic landmarks. Upon communication with the implant device company, we determined that it could be localized via fluoroscopy, ultrasound, and MRI. We found that the device could be visualized by 2 out of 3 methods. In our patient, the implant was not identified on preoperative MRI, in all sequences used, irrespective of the imaging plane (Fig. 2). The patient was scheduled for surgery under local anesthesia with sedation due to the deep nature of the device. Fluoroscopy and ultrasound guidance were used intraoperatively to localize the device (Fig. 3). An incision site was marked using fluoroscopy and ultrasound. An incision was made over the device. Blunt dissection was performed to the level of the fascia (Fig. 4). The fascia was divided, and the device was found to be directly below the fascia of the biceps brachii muscle (Fig. 5). The device was removed (Fig. 6). Final fluoroscopy images demonstrated complete removal of the implant (Fig. 7).

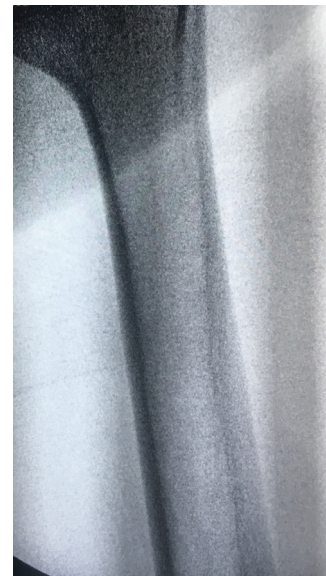
Fig. 7 – Post-operative fluoroscopy image demonstrating complete removal of the device.
