## Snapping Phenomenon after Revisional Total Knee Arthroplasty

The cases of revision total knee arthroplasty (TKA) are increasing. In this report, snapping phenomenon after final implantation of revision TKA has been presented. Snapping was caused by adhered iliotibial band (ITB) impinging against the lateral part of femoral component. Fractional lengthening the ITB by puncture resolved the snapping phenomenon. Surgeons should be aware of the presence of such a case which should be identified during operation to avoid secondary operations.

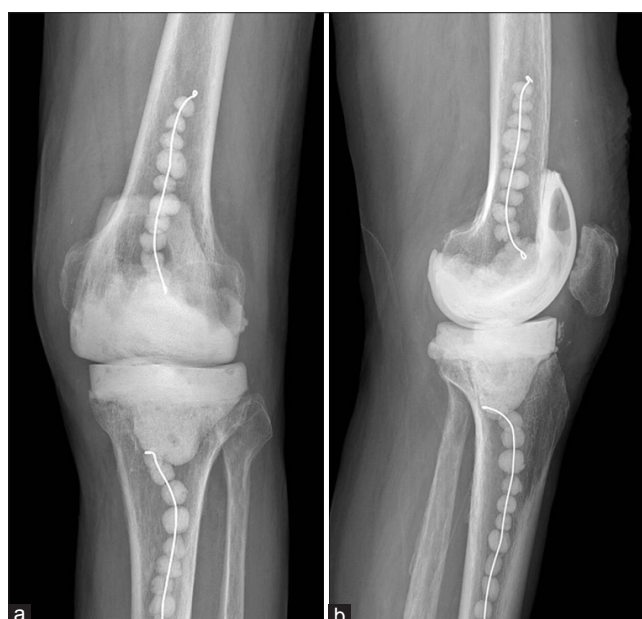
**Figure 2:** (a) Anteroposterior (b) lateral view of knee joint showing articulating spacer with cement beads

Two-stage procedure including articulated antibiotic-impregnated cement spacer was planned [Figure 2]. Thorough debridement and irrigation were performed. The patient was maintained on an antibiotic regimen (Vancomycin 500mg IV bid) as recommended by the infectious disease consultants for 6 weeks. The eradication of infection was suggested by the return of inflammatory markers to normal. There was no patella subluxation or dislocation.
