# Stent removal using novel balloon catheter after rupture of stent for EUS-guided pancreatic duct drainage

2<sup>nd</sup> Department of Internal Medicine, Osaka Medical College, Osaka, Japan

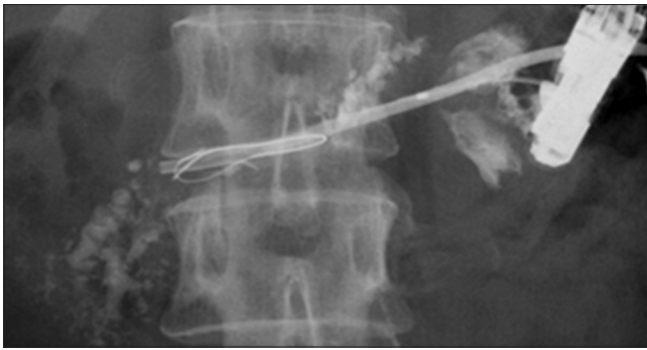
**Figure 1.** The guidewire is inserted into the pancreatic duct through the fistula

proximal end. A pigtail is present at the proximal end, and the distal end is tapered.<sup>[5]</sup> After this procedure, pancreatic pseudocyst was completely resolved. After 1 month, ERCP was attempted because of stent occlusion. First, the guidewire was inserted into the fistula [Figure 1], and the stent removal was attempted using grasping forceps. However, stent rupture occurred [Figures 2 and 3].

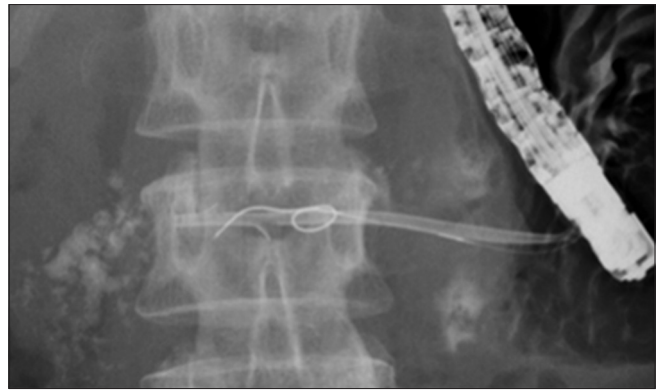
**Figure 2.** Stent rupture is occurred

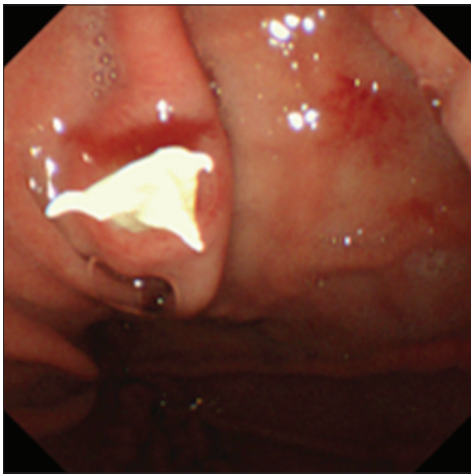
**Figure 3.** Complete rupture is seen in endoscopic view

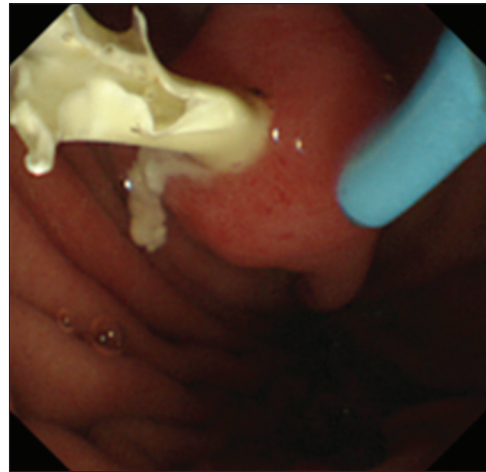
**Figure 4.** Endoscopic retrograde cholangiopancreatography catheter is inserted into the ruptured stent

Because any devices such as the guidewire or balloon catheter could not be inserted into the fistula, the guidewire was inserted into the ruptured stent [Figures 4 and 5]. Next, fine gauge balloon catheter (4 mm, REN biliary dilation catheter; KANEKA, Osaka, Japan,) was inserted into the ruptured stent [Figure 6]. The tip of this balloon catheter is only 3 Fr and tapered. In addition, this balloon catheter is coaxial with the guidewire, therefore, can be easily inserted within the plastic stent. Finally, we successfully removed the ruptured stent, and new plastic stent could be placed. The stent, which was used in this case, has double side hole in the proximal end, therefore, this site may be easily ruptured compared with conventional stent. It may be important to grasp the more distal end from this site.

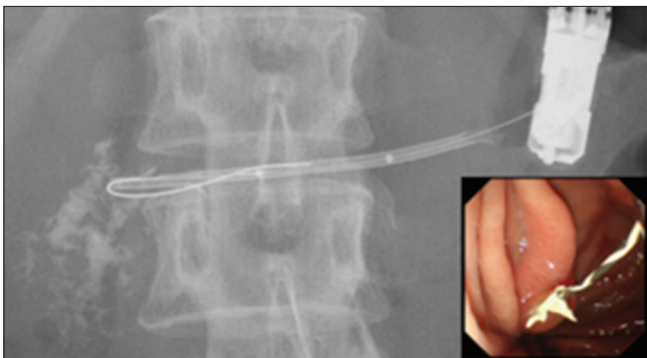
**Figure 5.** The guidewire is inserted into the ruptured stent, and balloon catheter is also inserted into the ruptured stent

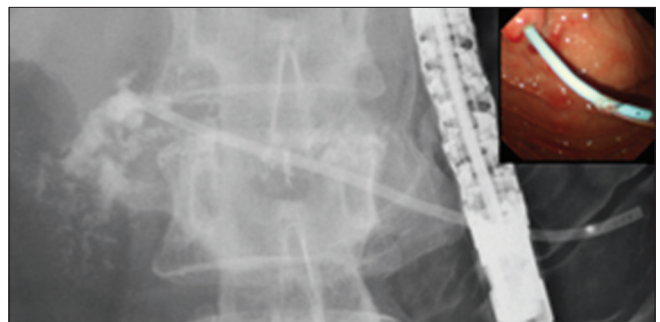
**Figure 6.** Stent removal is successfully performed, and the new plastic stent is also placed
