# Peri-Implant Fracture Following Prior Fixation of Femoral Neck Fracture Using the Femoral Neck System: A Case Report

**Case Report:** We present a case of an intertrochanteric PIF in the setting of a non-displaced femoral neck fracture treated with the DePuy Synthes Femoral Neck System (FNS).

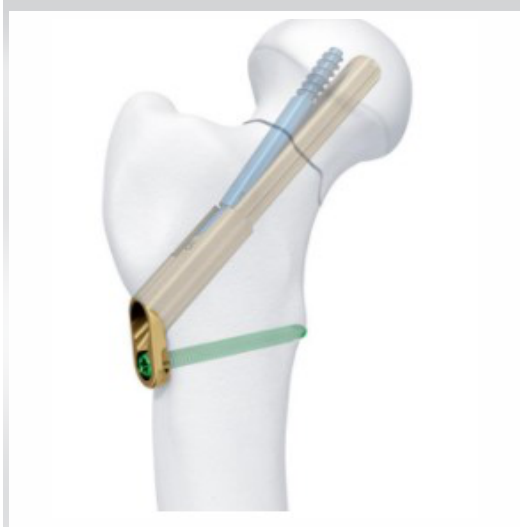
**Figure 1:** A 3-dimensionally constructed example of the Femoral Neck System (DePuy Synthes, West Chester, PA).

Newer implant designs for femoral neck fractures have attempted to combine the benefits of minimally invasive cannulated screw fixation with the rigid angular stability seen with dynamic hip screws (DHS) [1]. The femoral neck system (FNS) (Fig. 1) is one such design (DePuy Synthes, West Chester, Pennsylvania, USA). Fixation of femoral neck fractures is associated with a higher incidence of complications than any other fracture [2]. Complications following the fixation of non-displaced femoral neck fractures include non-union, avascular necrosis, implant cutout, varus collapse, and subtrochanteric peri-implant fracture (PIF) [3]. Subtrochanteric PIFs associated with cannulated screw fixation and DHS constructs lead to additional reoperation risks, particularly in the immunocompromised and

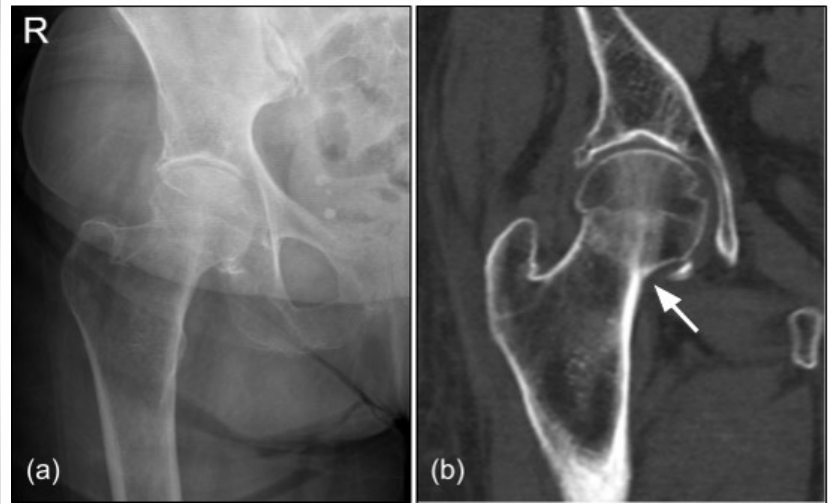
**Figure 2:** (a) Initial injury AP radiographs of the right hip (b) Computed tomography of the right proximal femur noting sclerosis of femoral neck (white arrow) concerning for femoral neck fracture.

radiographs (Fig. 2a) and a CT scan (Fig. 2b). An MRI was unable to be obtained secondary to the patient's history of retained metal shrapnel. Therefore, a three-phase bone scan was obtained which demonstrated increased uptake in the subcapital femoral neck region (Fig. 3). The patient underwent fracture fixation using the FNS 130-degree one-hole plate with an 85 mm barrel and a locking antirotation screw (Fig. 4). She tolerated surgery successfully without immediate post-operative complications. She was allowed to fully weight bear immediately after surgery. Her perioperative stay was otherwise uneventful, and she was discharged on post-operative day six to an inpatient rehabilitation center. Secondary to the fragility fracture, the patient was referred to her primary care physician for evaluation and management of osteoporosis. The patient was seen in the orthopedic trauma clinic at 2 weeks postoperatively for suture removal.

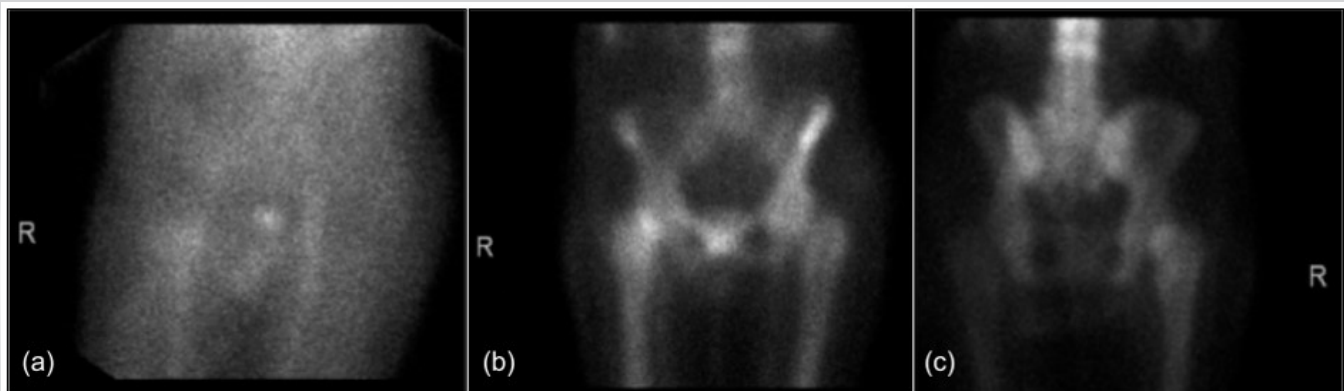
**Figure 3:** (a) Threephase bone scan noting increased vascularity on blood pool image in the region of the femoral neck, with increased radiotracer uptake on delayed anterior (b) and posterior (c) images.

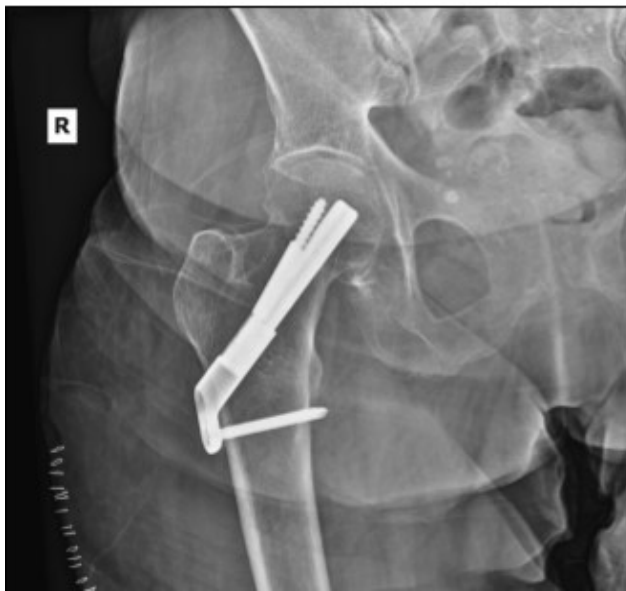
**Figure 4:** Post-operative radiographs demonstrating fixation of a non-displaced femoral neck fracture utilizing the femoral neck system.

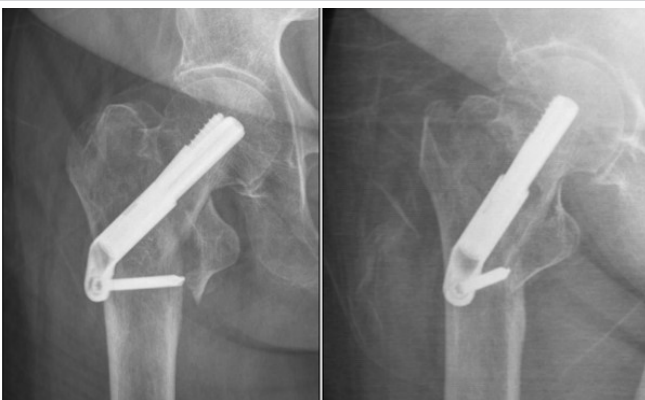
emergency department following a second ground-level fall from standing at home. Radiographs and advanced imaging in the emergency department demonstrated a new four-part, peri-implant intertrochanteric fracture about the pre-existing FNS (Figs. 5 and 6). All instrumentation appeared intact without evidence of screw penetration, varus collapse, or other mode of construct failure outside of the PIF. Recommendations were made to the patient and her family regarding the removal of the instrumentation with cephalomedullary nail fixation versus possible hip hemiarthroplasty. The patient elected to proceed with revision surgical fixation versus possible hemiarthroplasty and was medically optimized before returning to the operating room.

**Figure 5:** Radiographic images demonstrating a displaced, peri-implant intertrochanteric femur fracture with an intact femoral neck system fixation device.

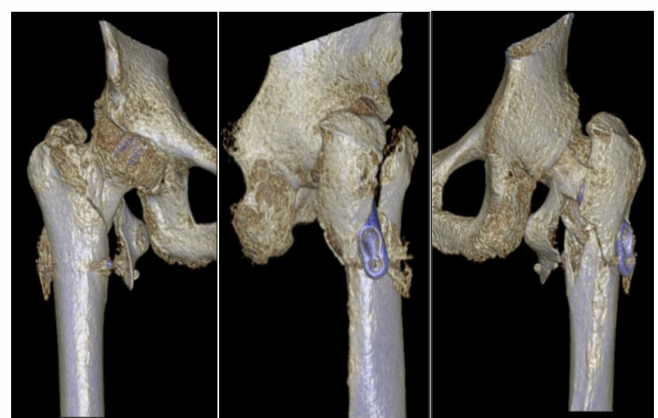
**Figure 6:** 3D CT reconstruction imaging of 4-part peri-implant intertrochanteric hip fracture about the pre-existing femoral neck system.

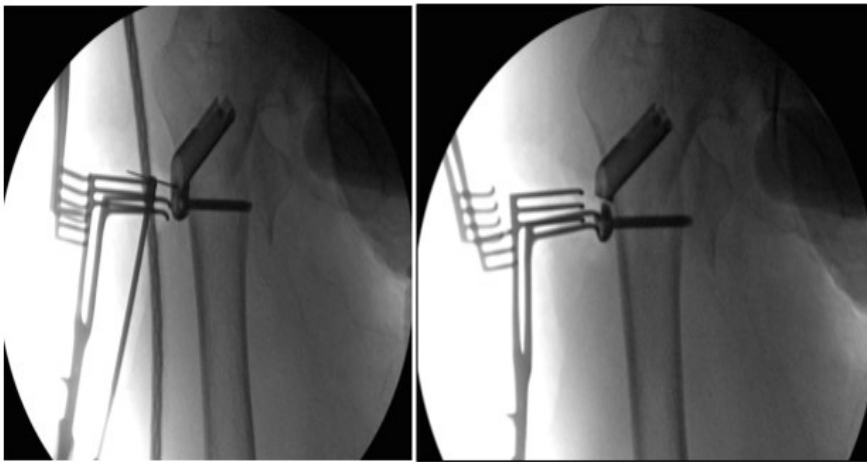
**Figure 7:** Intraoperative fluoroscopic images demonstrating the use of a circular metal cutting diamond disc (Stryker) for removal of the distal cold-welded screw.

splitting the vastus lateralis down to the level of the pre-existing FNS implant. The previous instrumentation showed no macroscopic evidence of fatigue or failure. The proximal antirotation screw and inner barrel were then easily backed out of position within the femoral neck without complication. The distal transverse screw through the one-hole plate was noted to be cold-welded to the implant, preventing simple removal with a hand screwdriver or a torque-limiting power driver. Multiple techniques for implant removal were attempted, including the use of a diamond-tipped burr and conical extraction screws. Both methods were unsuccessful at the time. Unable to free the distal screw, the side plate was then cut proximally in situ utilizing a metal-cutting diamond disc (Stryker, 2019). Then using a needle driver, the cold-welded screw and one-hole plate were successfully removed as a unit from the lateral cortex in a counterclockwise fashion (Fig. 7).

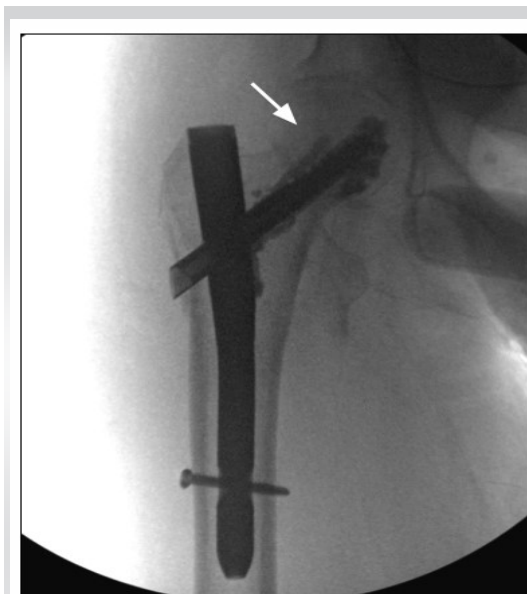
**Figure 8:** Intraoperative fluoroscopic image following short nail fixation of intertrochanteric PIF, noting cement augmentation within previous FNS antirotation screw path (white arrow).

At this point the fracture was adequately reduced with gentle traction and, secondary to adequate remaining bone stock, a decision was made to proceed with cephalomedullary nail fixation using the TFN-Advanced (TFNA) proximal femoral nailing system (DePuy Synthes, 2020). The previous FNS neck angle matched the 130° TFNA implant, so the same neck path was used with a fenestrated 85 mm lag screw through the nail. Injectable radiopaque cement was then directed through the lag screw, filling defects left from the previously placed antirotation screw (Fig. 8). Postoperatively, the patient was restricted to toe-touch weight bearing and was mobilized daily with physical therapy. She was discharged on post-operative day 5 in stable condition to a sub-acute rehabilitation center. Her post-operative period was mostly uneventful minus a brief episode of acute kidney injury which was managed and resolved by nephrology.

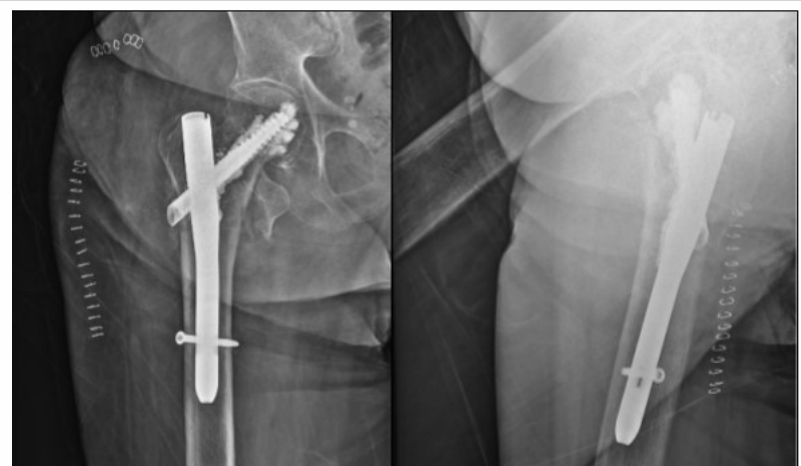
**Figure 9:** 3 week post-operative radiographic images demonstrating stable orthopedic hardware status post peri-implant fracture fixation.

The patient was seen and evaluated in the orthopedic trauma clinic 3 weeks postoperatively. X-rays were obtained demonstrating stable positioning of the orthopedic implant (Fig. 9). She was allowed to fully weight bear after this visit. The patient had returned to her baseline as a household ambulator with an assistive device.
