Article

Feasibility Assessments Using Unmanned Aerial Vehicle Technology in Heritage Buildings: Rehabilitation-Restoration, Spatial Analysis and Tourism Potential Analysis

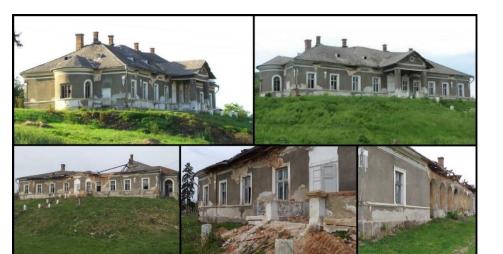
Figure 2. Image from a few years ago (top); current state of the mansion (bottom).

The Hatfaludy Mansion in Hida was built in the 19th century by the Hatfaludy family, a noble Hungarian family, for their son, István. The architecture style was eclecticism. The mansion was inhabited by the family until its nationalization during the communist regime. After nationalization during the communist regime, the Hatfaludy Mansion became the headquarters of the State Agricultural Enterprise in the region, being subjected to continuous destruction and degradation. In 2001, the heirs of the Hatfaludy family reclaimed the mansion, later selling it to a private enterprise. Currently, the mansion is in an advanced state of degradation, the roof being almost completely destroyed, and the interior heavily damaged and in danger of total loss (Figure 2).

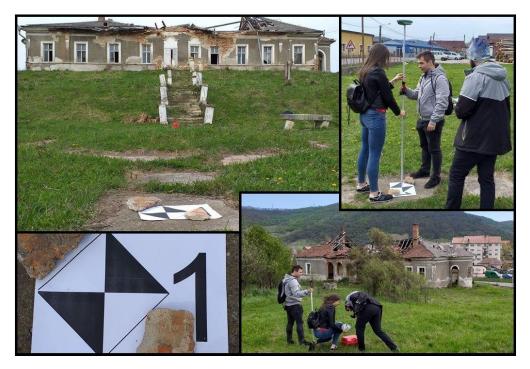
Figure 5. GCPs and CPs GNSS RTK measurement.

The topographic survey is one of the most well-established and accurate methods, but requires lengthy survey times, high logistic difficulties and was eventually replaced with modern methods that provides high resolution measurements directly in 3D, such as laser scanner or photogrammetry. Topography and single point measurements methods for ground control points (GCPs) was a crucial step necessary in the photogrammetry process (Figure 5).

For accurate planimetric and altimetric positioning of ground control points (GCPs), a Viva GS08 Global Navigation Satellite System was used in Real Time Kinematics (RTK) mode. This topographic and geodetic instrument measures the coordinates of the center of the GCPs with a horizontal precision of 0.014 m to 0.030 m and vertical precision of 0.030 m to 0.050 m at each point. To ensure this level of

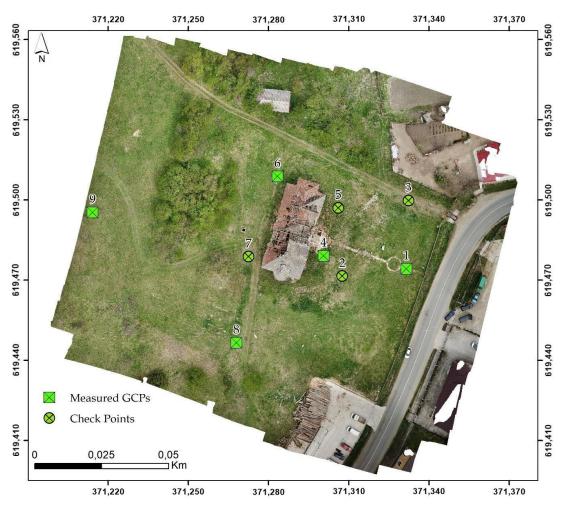
Figure 10. Obtained orthophoto.

The design of any construction, from old, degraded or severely damaged to new projects, cannot be carried out without up-to-date topographic plans, that require topographic and geodetic measurements obtained with specialized methods and instruments. In the current stage of industrialization of the construction process, land and construction surveys are indispensable in the activity of designing and elaborating investments such as a complex rehabilitation and restoration architectural project. It is the land surveyor's responsibility to procure field measurement so that the terrain surface can be accurately represented, to obtain contour levels, longitudinal profiles, transversal profiles and elevations of topographical details. Topography and geodesy are based on well-established methods and instruments, they are limited to tedious tasks, time-consuming stages, prone to injuries and relatively expensive. Throughout the presented steps, the feasibility and potential of UAV obtained data, combined with specialized software and the processing power required, to obtain accurate and complex 3D surveyed models, consisting of hundreds of thousands of point clouds. The generated deliverables consist of orthophoto and DEM that have up to centimeter-level resolution (Figure 10) further used to create useful outputs in the design and construction project, such as: contour lines, longitudinal and transversal profiles, volumetric and surface calculations. Such spatial analysis can provide useful and complementary information to geotechnical investigation and help the civil engineers in the design, construction and earthworks of foundations and retaining walls.

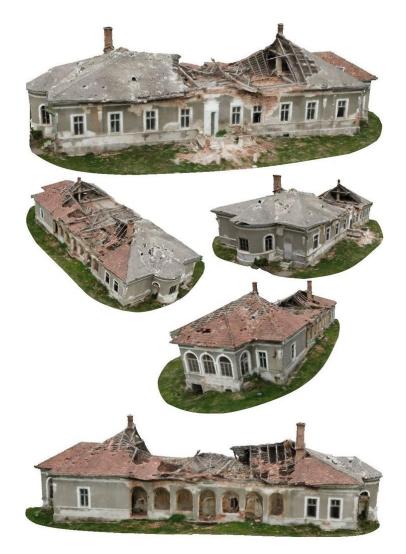
Figure 11. Photorealistic 3D model.

The final 3D reconstruction provides architects, civil engineers, land surveyors, archaeologists and local authorities with high-resolution data for rapid mapping of cultural heritage buildings [5,8,10]. The accuracy and completeness of the presented 3D model allows structural deformation analysis to also be undertaken from the comfort of office buildings in real time by interdisciplinary engineers, saving numerous on-site visits and implicitly work hours, costs and potential dangers [25].
