CASE REPORT

# Atraumatic patellar prosthesis dislocation with patellar tendon injury following a total knee arthroplasty: a case report

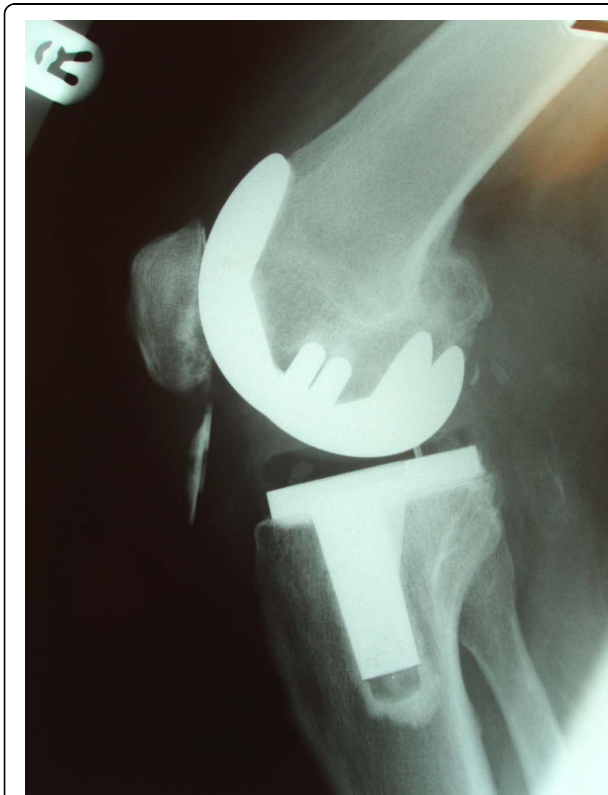
**Figure 1** Sagittal radiograph of the knee showing dislocated patellar prosthesis.

his knee from time to time. His symptoms improved and he was discharged from the clinic within one year. He presented again in January 2006 with a painful locked knee following a sudden flexion movement of his right knee. Radiographs taken in casualty showed that the prosthesis was dislodged and had displaced into the infrapatellar area (Figure 1). His blood test and inflammatory markers were unremarkable. Knee aspirate performed in theater to rule out infection was unremarkable.

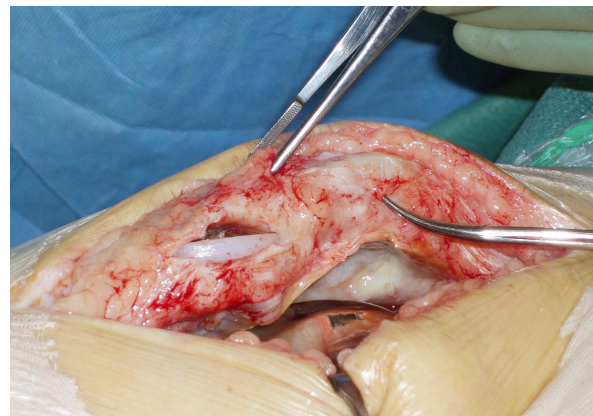
**Figure 2** Intraoperative picture showing dislocated patellar prosthesis in the patellar tendon.

He underwent revision surgery of his right knee. Intraoperatively, the prosthesis was noted to have sheared off its fixation pegs and dislocated inferiorly, thus splitting the patellar tendon and forming a pocket in it (Figures 2, 3, 4). The patella was cleaned and the patellar cut was revised to 16 mm and the cemented 38-mm prosthesis was reimplanted with a good patellofemoral tracking (Figure 5). The patella tendon was cleaned and sutured using nylon suture. The postoperative period was uneventful and the patient was subsequently discharged from the hospital. He remains asymptomatic at two years follow-up and showed no evidence of loosening in his prosthesis.

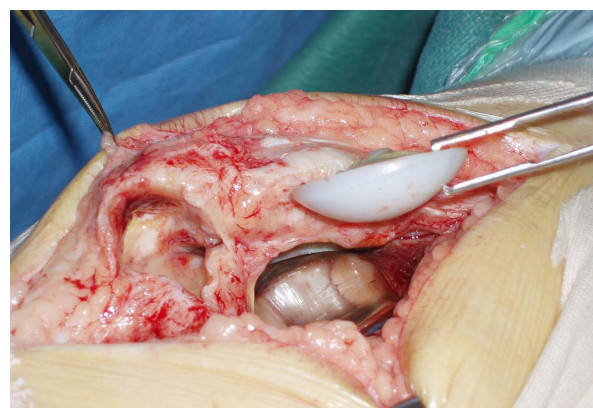
**Figure 3** Extracted patellar prosthesis with cavity in the patellar tendon.

The original thickness of the patellar prosthesis component in our patient was 41 mm, thus raising the tension in the patellofemoral joint during movements involving high flexion angles. We postulate that this means that a sudden flexion has resulted in the shearing of the prosthesis through a force that was significant enough to penetrate the patellar tendon to a degree that is able to cause damage and require repair. Subclinical infection may also cause component loosening and dislocation. In our case, however, tests to rule out any possible infection all showed negative results. Following revision surgery, the new total thickness of the prosthesis was 25 mm, thereby resembling its natural dimension and restoring the forces closer to that of a normal knee.

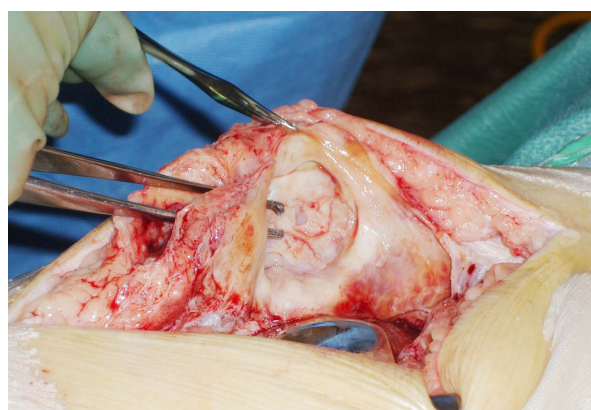
**Figure 4** Splitting of the patellar tendon due to dislocated patellar prosthesis.

There have been few case reports of intra- and extra-articular dislocation of patellar prostheses [3]. Previous reports have described dislocation but there was no damage to the tendon itself in any of the cases mentioned [1]. Furthermore, the shearing force evident in our patient was significant enough so as to have formed a pocket within the tendon and thus embedding the prosthesis itself.

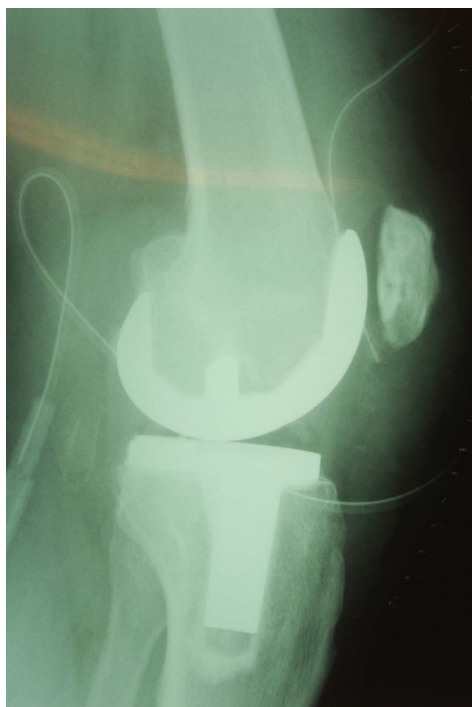
**Figure 5** Postoperative sagittal radiograph of the knee after revision of the patellar component.
