International Journal of Surgery Case Reports

Dislodgement of a cemented exeter femoral stem during closed manipulative reduction of a dislocated total hip replacement

Queen Elizabeth Hospital, Gateshead Health Foundation NHS Trust, Sheriff Hill, Gateshead NE9 6SX, UK

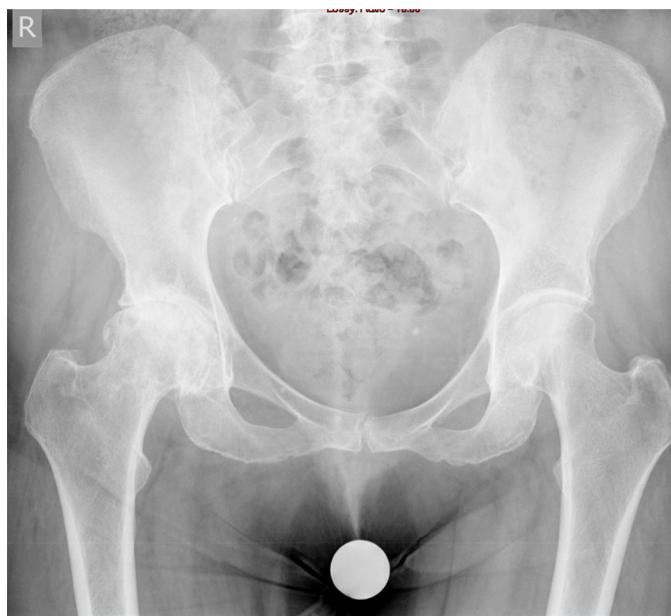
Fig. 1. Pre-operative radiograph showing right hip osteoarthritic changes.

A 73 year old lady underwent a cemented Exeter total hip replacement for severe osteoarthritis of the right hip (Fig. 1). The surgical procedure was performed through a modified Hardinge

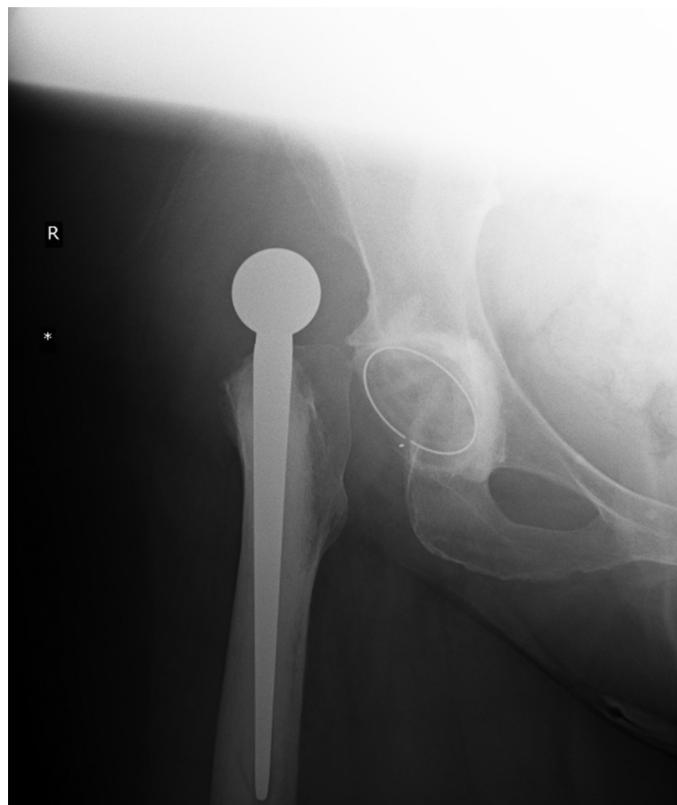
Fig. 3. Radiograph showing dislocation of total hip replacement after two weeks with no femoral stem displacement.

On examination of the right hip revealed severe tenderness in the groin. The right lower limb was shortened and externally rotated. All the movements of the right hip were painfully restricted. The X-ray of the right hip showed dislocation of the total hip replacement (Fig. 3). The patient was taken to theatre and under general anaesthesia a closed manipulative reduction of the dislocated total hip replacement was attempted under image intensifier. During reduction of the hip it was noted in the image intensifier pictures that the polished Exeter stem was dislodged by about three fourths from the femoral canal (Fig. 4a and b).

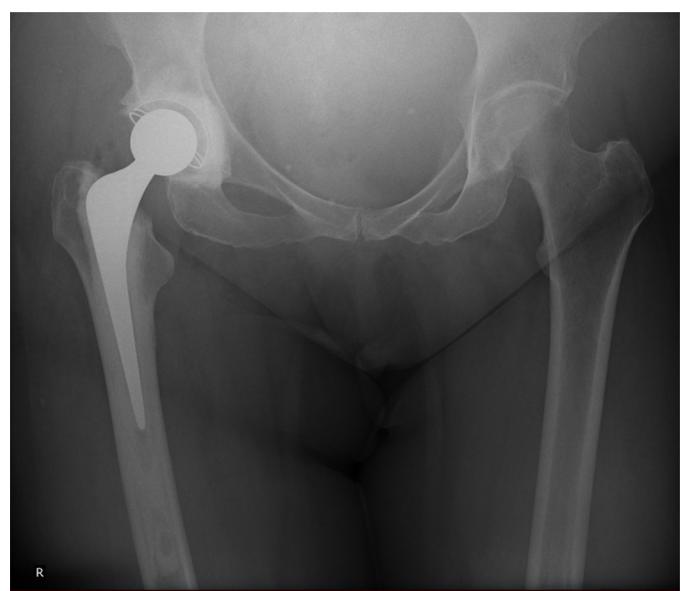
Fig. 5. Post-operative radiograph after revision surgery.

was done. A 32 mm × 0 head was inserted on to the trinion of the femoral stem. The hip was reduced and found to stable and no limb length discrepancy. The wound was closed in layers. The check X-rays after the revision surgery was satisfactory (Fig. 5). The patient was followed up at six weeks, six months and one year after the revision surgery. There were no further episodes for hip dislocation or stem displacement during this period. The Harris hip score at the end of one year was 86.
