Case Report

Synovial cutaneous fistula complicating a reverse total shoulder arthroplasty

Haley P. Letter MD^{*}, Joseph Limback MD, Christopher Wasyliw MD, Laura Bancroft MD, Kurt Scherer MD

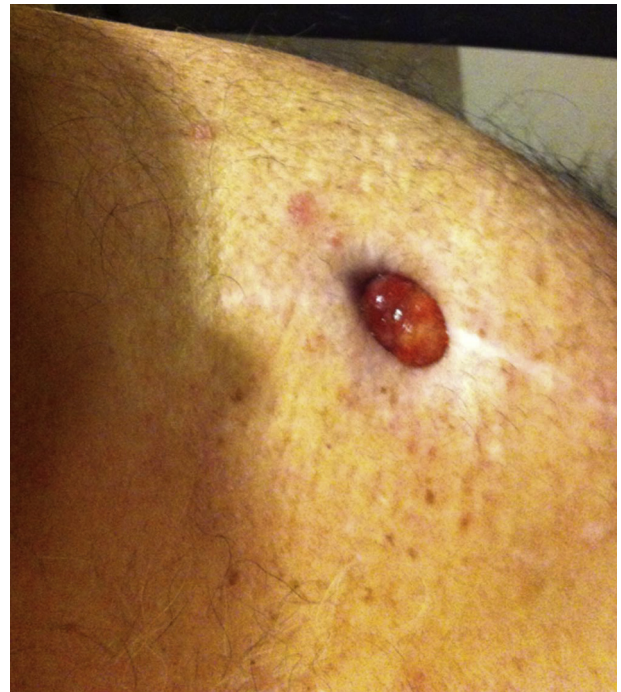
Fig. 2 – Gross image of the left shoulder. There is an exposed soft-tissue wound on the superior aspect of the patient's left shoulder.

His symptoms continued to worsen over the next 2 years, and he developed purulent drainage from a soft-tissue wound on the skin overlying the left shoulder (Fig. 2). He presented to our institution to be evaluated by an orthopedic surgeon. His C-reactive protein level was 73 mg/L (normal range is <5 mg/L), and his white blood cell count was $11.6 \times 10^3/\mu\text{L}$ (normal range is $<10.5 \times 10^3/\mu\text{L}$). Of note, his hemoglobin A1c was elevated at 8.7% (normal is <5.5%). The orthopedic surgeon wanted to know if the purulent drainage was in continuity with the reverse total shoulder arthroplasty device.

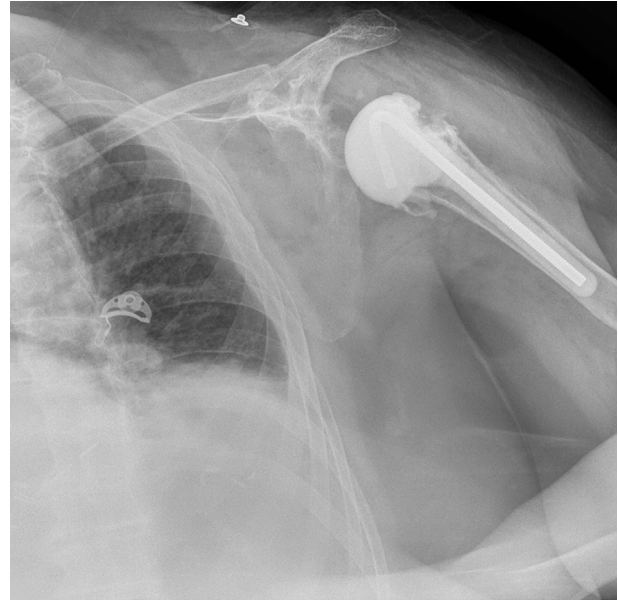
Fig. 6 – Anterior–posterior radiograph of the left shoulder acquired in the postanesthesia care unit. The patient has undergone removal of the reverse total shoulder arthroplasty, and an antibiotic-impregnated cemented device has been placed.

The patient underwent removal of the total shoulder arthroplasty device via a deltopectoral approach. The sinus tract was debrided, and the wound was excised. A frozen section of tissue from the humeral canal was taken and revealed over 20 white blood cells per high-power field, suggesting infection. Therefore, the humeral and glenoid components of the arthroplasty were removed. A Prostalac spacer (ExacTech, Gainesville, FL, USA) was assembled and loosely held into place in the humeral canal by cement (Fig. 6). *Propionibacterium* was isolated from the humeral specimen. After surgery, standard postoperative care was initiated with nonsteroidal anti-inflammatories and physical therapy, and the patient has made significant progress in regard to his shoulder mobility and pain.
