# Tower of Belém (Lisbon)–Status Quo 3D Documentation and Material Origin Determination

**Abstract:** The Tower of Belém, an early 16th century defense tower located at the mouth of the Tagus river, is the iconic symbol of Lisbon. It belongs to the Belém complex, classified since 1983 as a World Heritage Site by the UNESCO, and it is the second most visited monument in Portugal. On November 1st, 1755, there was a heavy earthquake in Lisbon followed by a tsunami, causing between 60,000 and 100,000 deaths. There is a possibility of a repetition of such a catastrophe, which could bring about the collapse of the structure. This was the reasoning behind the decision to evaluate the Tower of Belém by means of surveys using Terrestrial Laser Scanning and photogrammetry. Until now, there was no high-resolution 3D model of the interior and exterior of the tower. A complete 3D documentation of the state of the Tower was achieved with a cloud of more than 6,200 million 3D points in the ETRS89 PT-TM06 coordinate system. Additionally, measurements were made using a hyperspectral camera and a spectroradiometer to characterize the stone material used in the Tower. The result is a digital 3D repr

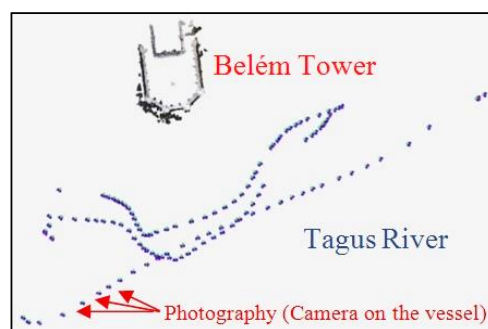
**Figure 4.** Scheme of camera positions on the vessel relative to the tower. Blue points indicate camera positions.

For the photogrammetric model of the south façade, images were taken from a vessel at a mean distance of 55 to 60 m from the tower south wall. The camera was handheld, and the acquisition geometry was conditioned by the maritime and meteorological conditions at the acquisition time. Shutter speed, aperture and ISO (light sensibility) were chosen during the first of the three shot sequences in order to obtain the less influence of the vessel movement and an optimal image from the radiometric point of view.

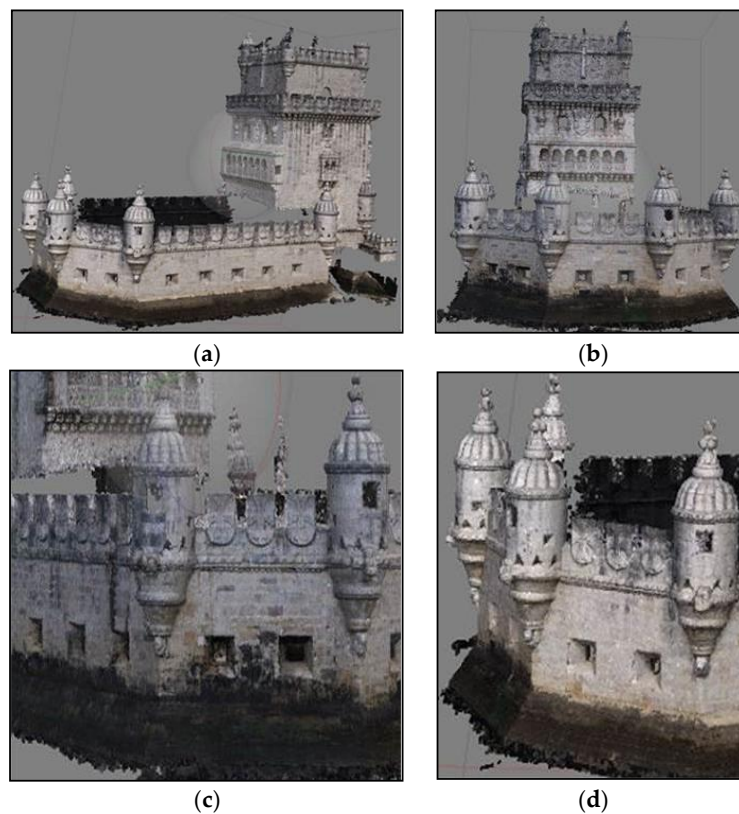
A mean density of 5000 points/m<sup>2</sup> was achieved for the exterior south walls (Figure 5), allowing individual stones and architectural details to be distinguished. Although it appears in the point cloud, the high tower itself will not be used in the final products since it had already been surveyed by laser scanning. The east and west walls were common to the laser scanned clouds and were used for georeferencing.

**Figure 5.** Photogrammetric 3D point cloud: (a) East wall; (b) South wall; (c) and (d) Details of the South wall.

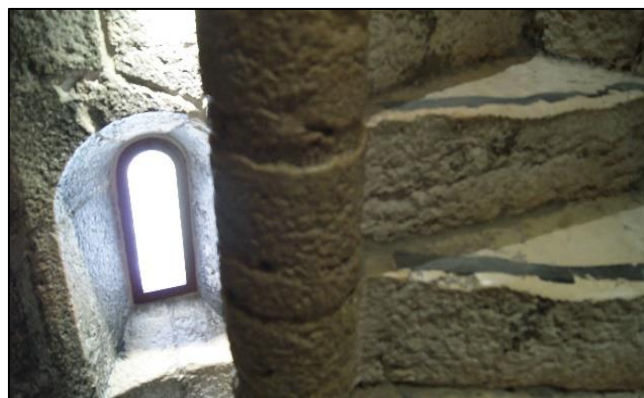
The dimensions of these stairs made it impossible, or at least very time-consuming, to survey them using a TLS. The stairs consist of 92 steps developing around a central column (Figure 7). The step width from the central column to the wall varied between 0.76 m and 0.79 m, just over the shortest distance that could be recorded by the laser scanner (0.60 m).

Figure 7. Spiral stairs of the Tower of Belém.

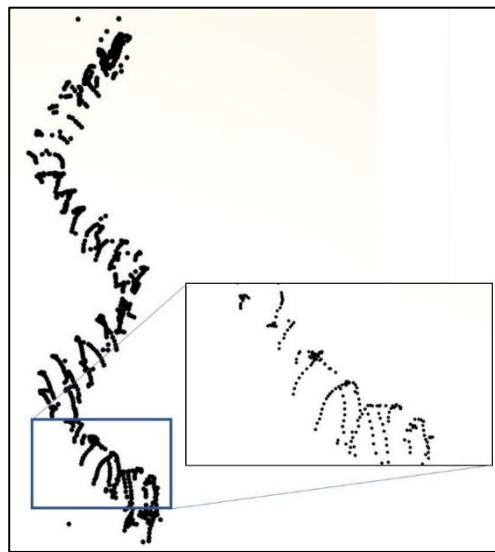
One sequence obtained with the camera following a spiral line along the stairs sweeping all surfaces continuously (step–wall–ceiling–column–next step–wall–ceiling–column–next step, etc.) (Figure 8).

**Figure 8.** Camera stations (black dots) from the survey of section N04-N05 of the spiral stairs.

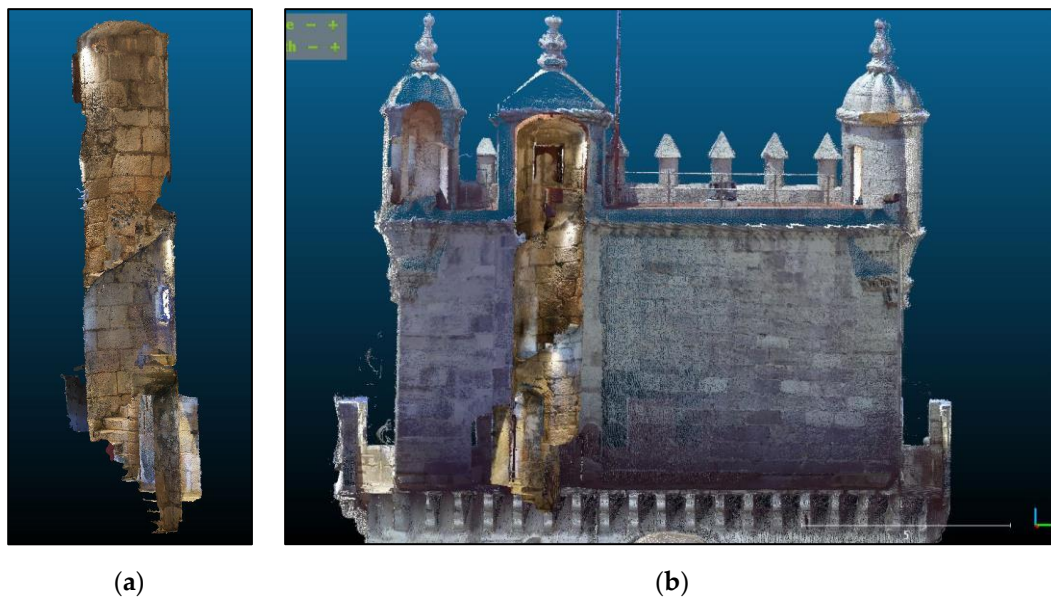
A 3D point cloud of each of the four sections was obtained with an overlapping area with the next section (Figure 9a). In this way, partial clouds of the stairs could be registered to one another. None of the approaches used in the phase of image acquisition yielded a 100 % complete dense point cloud due to the complexity of the object, short distances and weak illumination conditions. The use of a flash did not improve the quality of the images because of reflections. Nevertheless, the continuous spiral sequence approach yielded a better result regarding completeness. The width of each door was measured “in situ” on the base of the arch in order to scale the cloud and facilitate the alignment with the main cloud obtained by TLS. The registration of the partial clouds and the final alignment were done using the software CloudCompare [42]. Several pairs of corresponding points (at least 3 well distributed) in each pair of clouds were interactively marked in common areas. For the alignment of stairs and main cloud, those points were situated around the doors and in the window sills which

were located on opposite sides along the whole cylinder (doors in the east and windows in the west) (Figure 9b).

**Figure 9.** (a) Part of the point cloud of the spiral staircase between N05 and N06; (b) Point cloud of the spiral staircase aligned with main cloud.

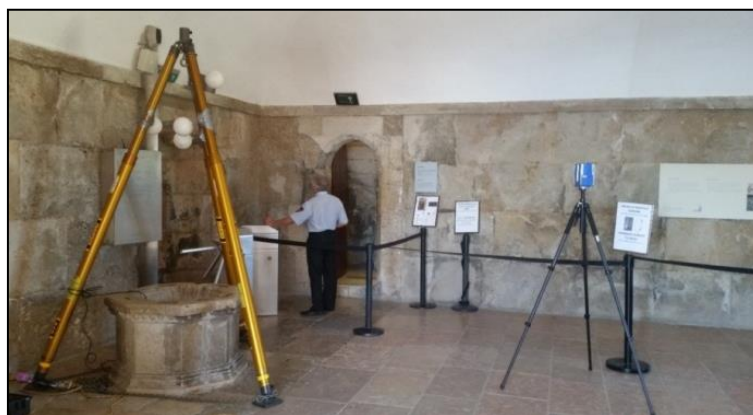
The tower has seven levels accessible by stairs and one level (cistern) accessible by other means (Figure 10). To register different spaces with a TLS there must be enough space to make scans in which the field of view is broad enough to capture part of the two spaces to be registered. As already mentioned, the connection of levels N02 to N05 is by means of a spiral staircase, the dimensions of which make it impossible to use the laser scanning technique to register the different levels. This made it necessary to seek support in the first terrace (N01), that can be sighted from the levels above, to register the clouds that refer to the rooms at levels N02 to N05. The support in the first terrace was made through spheres of 24 cm of diameter in the central area. These spheres were viewed through balconies and windows at the different levels, so at each level a registering scan had to be made near the window or balcony simultaneously capturing a part of the interior of the room (with two spheres) on one side and the terrace N01 with the reference spheres on the other side.

**Figure 10.** Structure required to access the cistern.

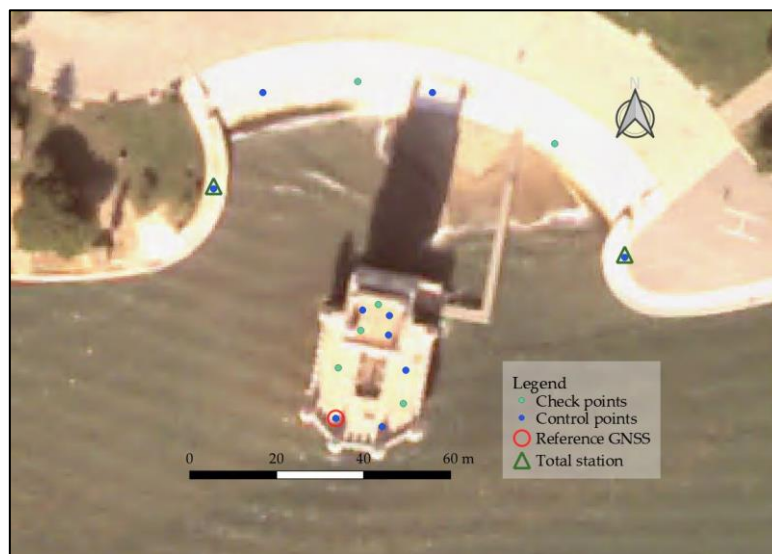
The relative positioning of the point clouds is achieved through the georeferencing of the point clouds obtained individually by each method. For this, a point network was established with GNSS measurements longer than 15 min in static positioning. The acquired support for the georeferencing was adjusted to the space available for determining GNSS points and to locations where there were no multipath effects or other possible problems presented by the GNSS technology. The points arranged for georeferencing the group N-01 to N05 were located in N01. In N06 the available area was small (~10 m × 10 m), so the distribution of control and check points was not ideal. In NE the points were distributed along the outer perimeter of the walkway surrounding the tower on the north side (Figure 11).

**Figure 11.** Location of control and check points.

The network points were materialized on the exterior of the tower by means of nails in the ground, and with marks made on the floor in the terraces of the Tower (which were erased once the work was completed). In order to obtain a greater precision in the determination of the network points, forced centering was used, thus reducing eventual miscentering. To calculate the points, a reference was established in N01 (Figures 6 and 11) with a static post-processing GNSS positioning longer than 4 h, calculating its position with respect to the network of permanent GNSS stations (RENEP) of the Direção Geral do Território (DGT). For the rest of network points, an intersection was made between the baselines from the reference, the nearest RENEP station and the GNSS observed points. The coordinates obtained for all points were determined in the official coordinate reference system of Portugal, ETRS89 PT-TM06, with orthometric heights.

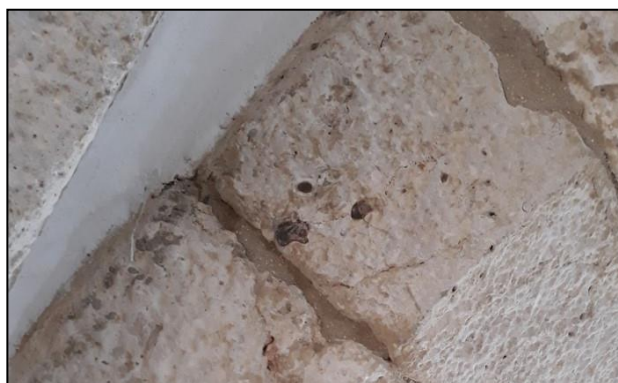
of hydrated silica were found in some ashlars, a series of radiometric shots was taken in order to compare them with the ones measured at the Rio Seco quarry (Figure 12).

Figure 12. Silica (dark spots) found in an ashlar of the Tower of Belém.

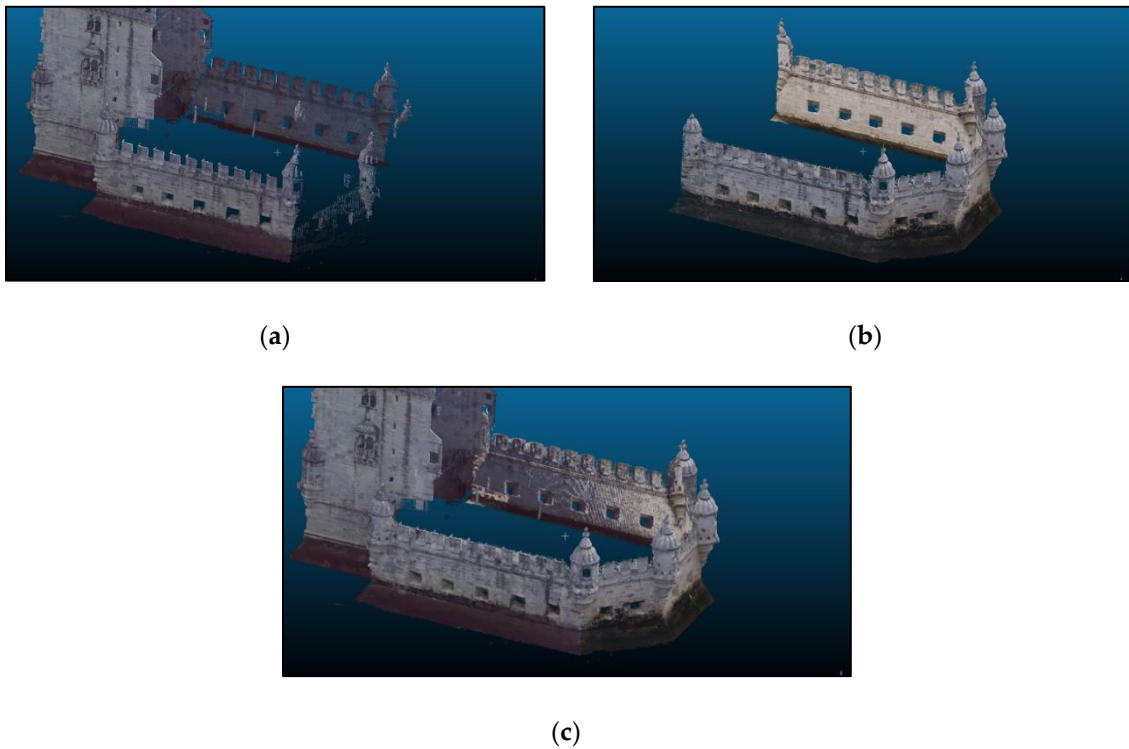
**Figure 13.** Point clouds from different sources: (a) from TLS; (b) from close-range photogrammetry; (c) same clouds after georeferencing of the photogrammetric point cloud. The upper left corner is pointing North.

Due to the problems associated with the registration of point clouds originating from different techniques, further than trusting only in RMS values calculated on 16 points, the quality of the three adjustments was analyzed for the whole common areas of photogrammetric and TLS point clouds. Figure 16 to 18 show the differences between the two clouds, TLS and photogrammetric, after georeferencing the latter with each of the three approaches.

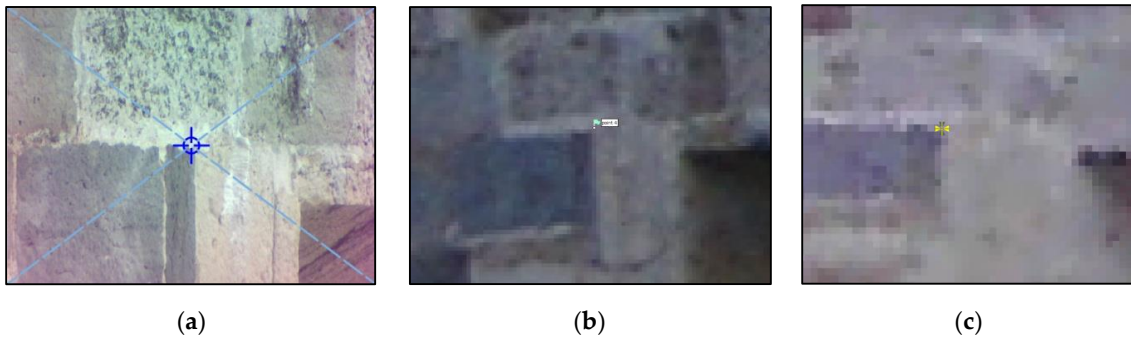
**Figure 15.** The same control point as appearing: (a) the total station image; (b) one photogrammetric image; (c) the TLS point cloud.

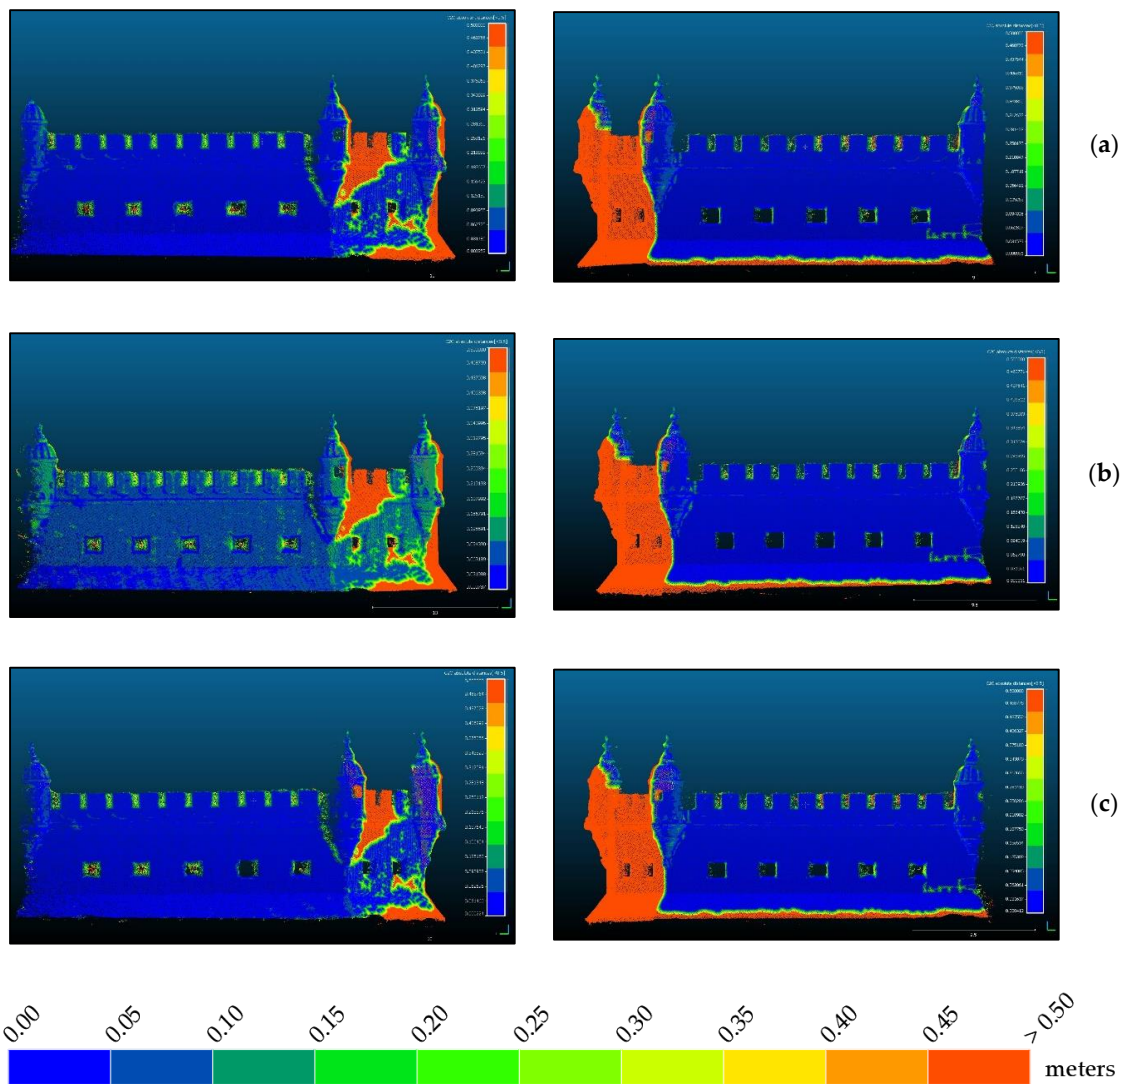
**Figure 16.** Differences between photogrammetric and TLS point clouds in common areas: (left) West bulwark façade; (right) East bulwark façade. (a) ICP; (b) Total station points; (c) TLS points. (Bottom) enlarged color scale.

From the analysis of Figure 16, it is evident that most regions are blue or dark green denoting most differences are smaller than 10 cm. Regions in red are not to consider since they correspond to points that are not existing in the reference TLS cloud. The east façade, (right column), shows smaller differences in all approaches than the west façade (left column), thus appearing in a darker blue.

The thin red stripe on the base of the bulwark that appears in all images in the right column is due to the presence of water, showing that the tide during the photogrammetric survey was lower than during the TLS survey of the east side. Water absorbs infrared laser so that there are no surveyed points in water. On the left column there is no red stripe on the base, indicating the tide during the TLS survey of this side (not simultaneous to the other) was similar to the one existing during the photogrammetric survey. Obvious is also that the approach shown in (b), georeferencing with control points measured with a total station, does not behave so good as the other two (mostly green instead of blue) although it presents the smallest RMS at control points (Table 3). In order to increase the resolution of the color scale, Figures 17 and 18 present only the map of points with differences to the reference smaller than 2 cm and 5 cm respectively.

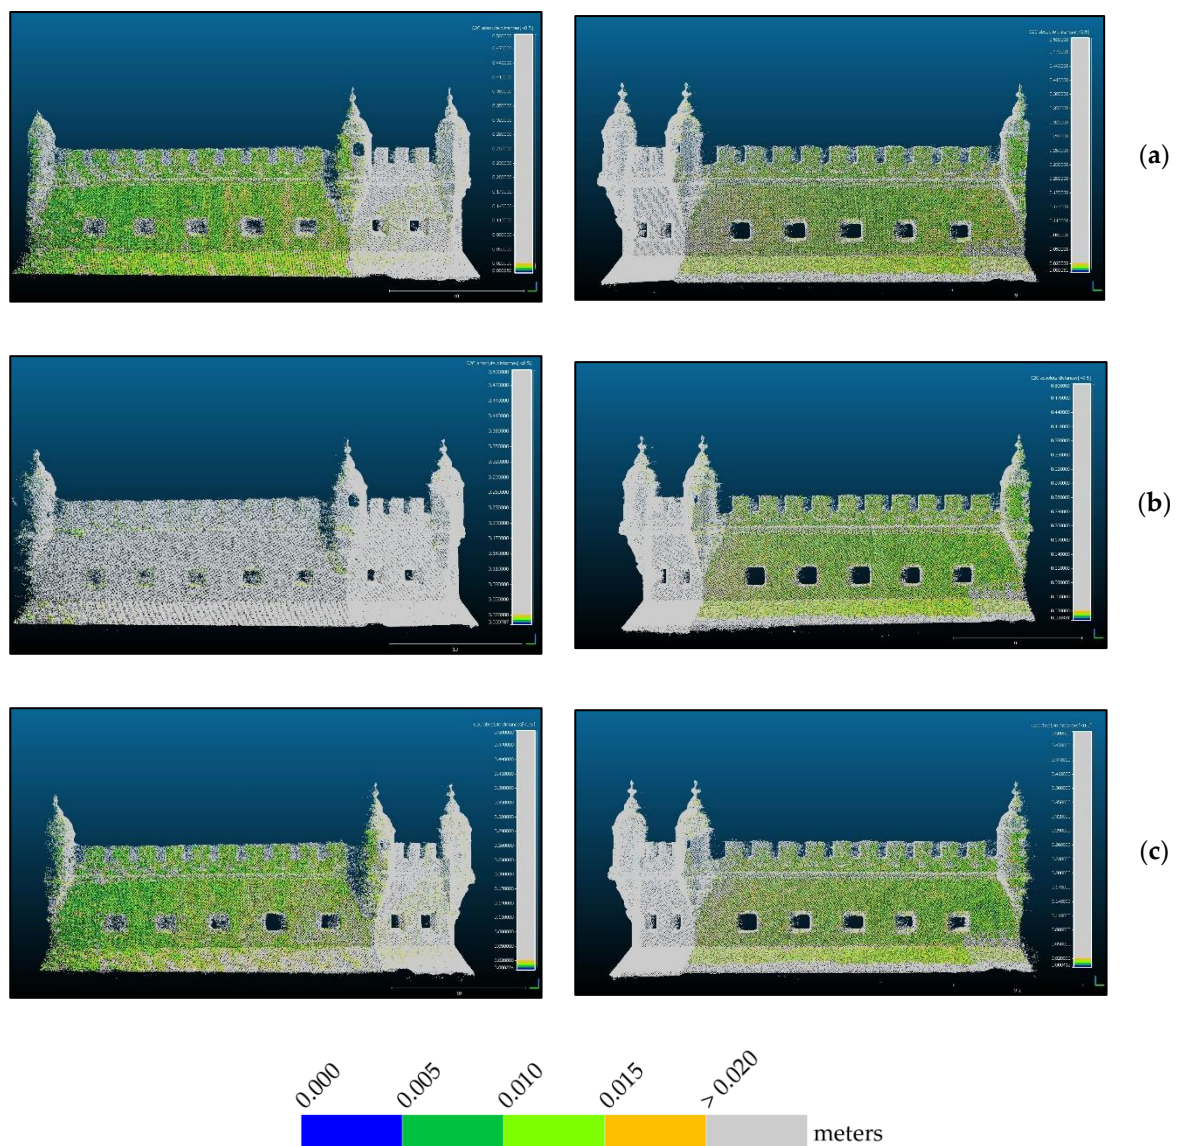
**Figure 17.** Distribution of points where residuals are smaller than 2 cm: (left) West bulwark façade; (right) East bulwark façade. (a) ICP; (b) Total station points; (c) TLS points.

From Figure 17 we see that in: (a) there is a homogeneous distribution of the points with residuals smaller than 2 cm, being the most even smaller than 1 cm. In (b), especially in the west façade (left column) almost all points present residuals greater than 2 cm. Approach (c) presents an inhomogeneous distribution of residuals both spatially and in magnitude. The fact that the west façade behaves worse than the east façade can be due to the lighting conditions during survey. Figure 14 shows the difference in lighting existing between east (Figure 14a) and west (Figure 14b) façades. Since the camera had to compensate for the less light in the west side increasing exposure, it is possible that, being on a vessel, the waves movement during a longer exposure affected the image sharpness. Homologous points detection algorithms are very sensitive to blur and some noise appearing in the point cloud can be originated by blur caused by the acquisition conditions, explaining this result.

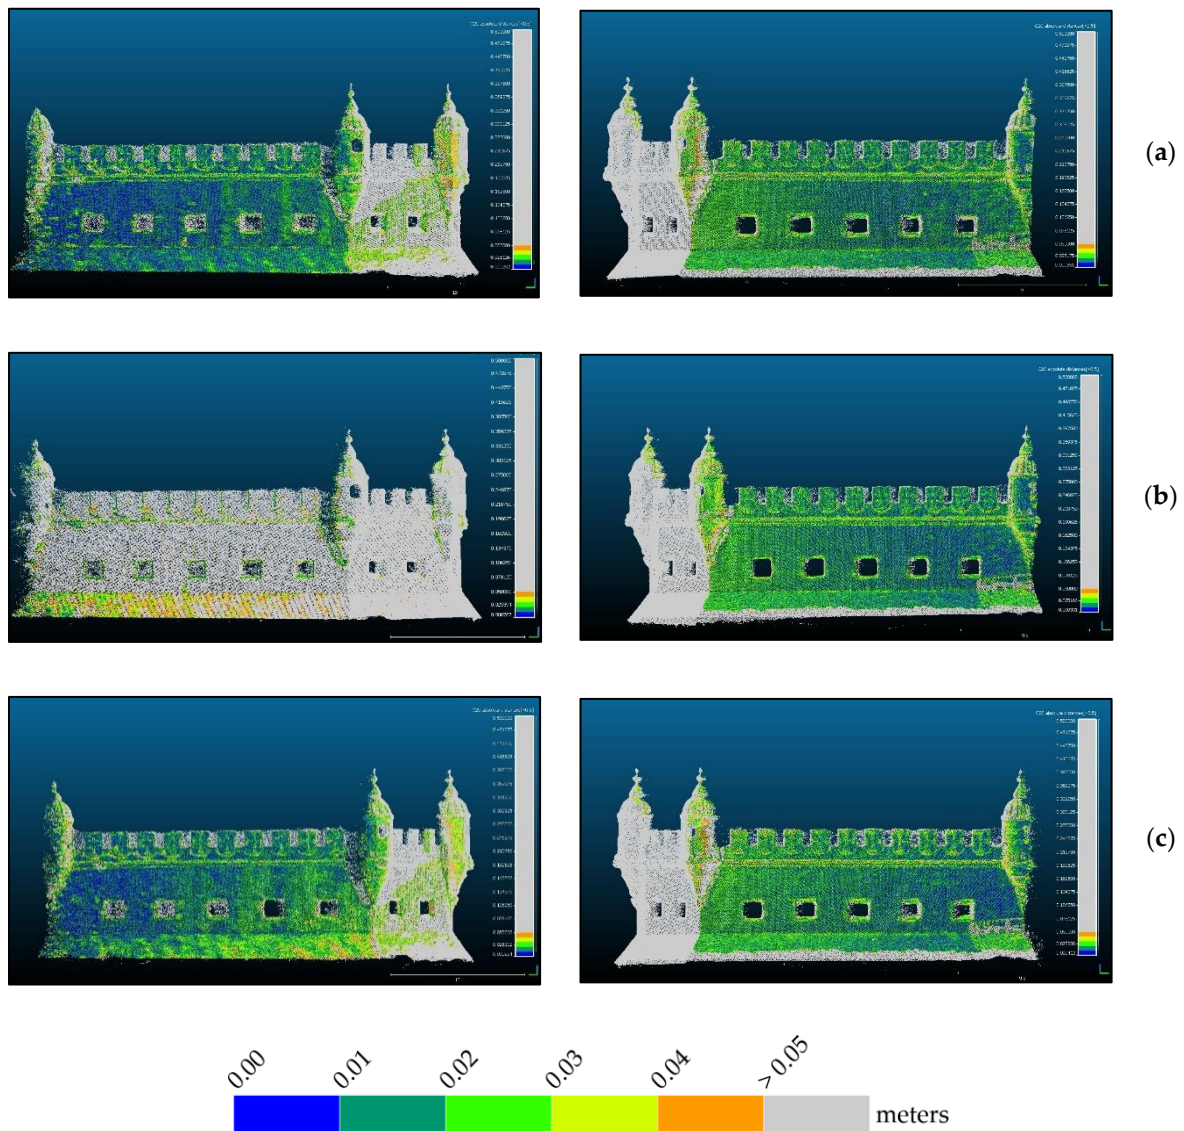
**Figure 18.** Distribution of points where residuals are smaller than 5 cm: (left) West bulwark façade; (right) East bulwark façade. (a) ICP; (b) Total station points; (c) TLS points.

Figure 18 corroborates the analysis done for Figure 17. In the (b) approach, west façade, differences are even bigger than 5 cm, while the other maintain their behavior, letting us conclude that the best adjustment is the one illustrated in (a), which corresponds to the ICP algorithm for cloud alignment, performed with Cloud Compare. This way we consider the RMS value of this transformation, 2.72 cm, as the accuracy of the georeferencing of the photogrammetric point cloud.

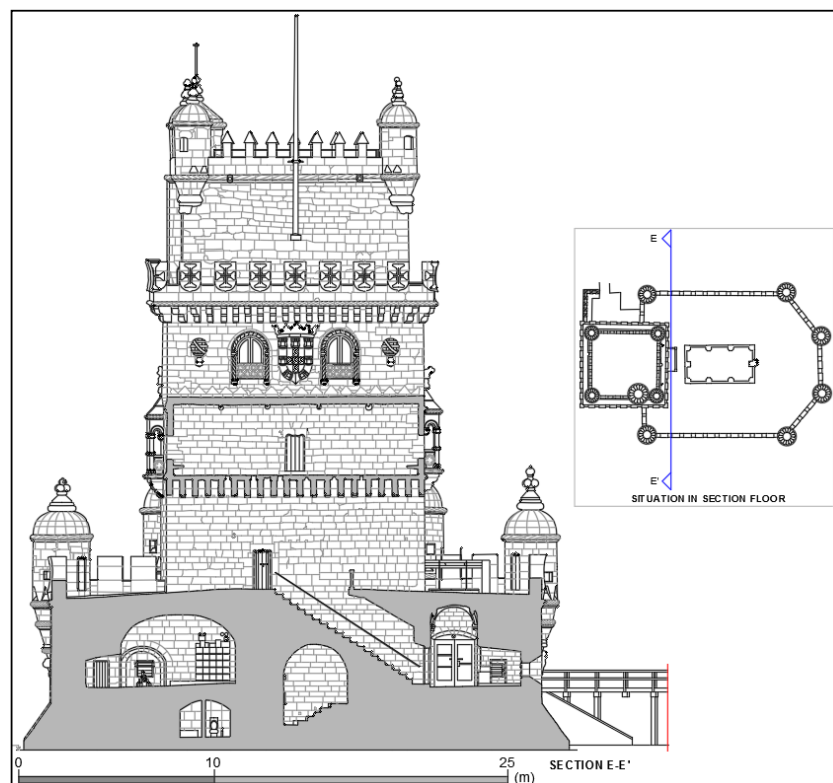
The complete geometry of the tower is the source from which detailed plans and elevations obtained from cloud cuts can be generated in any desired direction. Given the spatial resolution of the documentation, the products generated reveal details of elements such as vaults and floors. Figure 19 is a projection of the tower on a vertical plane viewed from the south, where both photogrammetry and TLS were integrated.

**Figure 19.** Elevation drawn from a vertical slice tangent to the Gothic tower south facade.

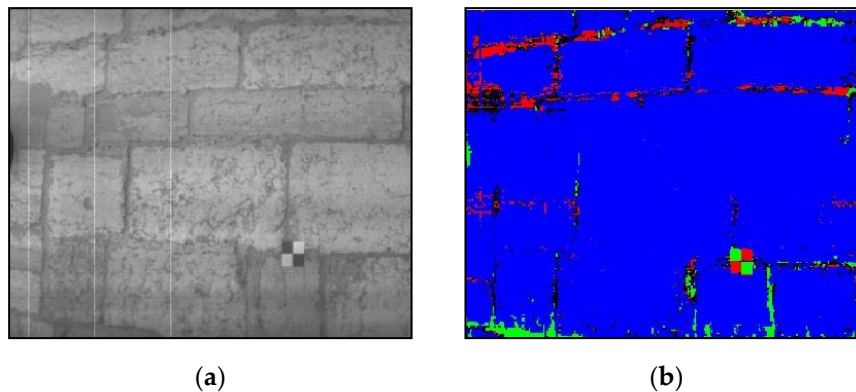
The data obtained from the quarries and the Tower of Belém using the hyperspectral camera (Figure 20a) underwent a classification process by means of an MLP neural network. It was thus ensured that data collection by the spectroradiometer would be carried out in the areas where the study object was located (Figure 20b).

**Figure 20.** (a) Hyperspectral image; (b) Material classification obtained with a neural network (Blue = white Lioz limestone).

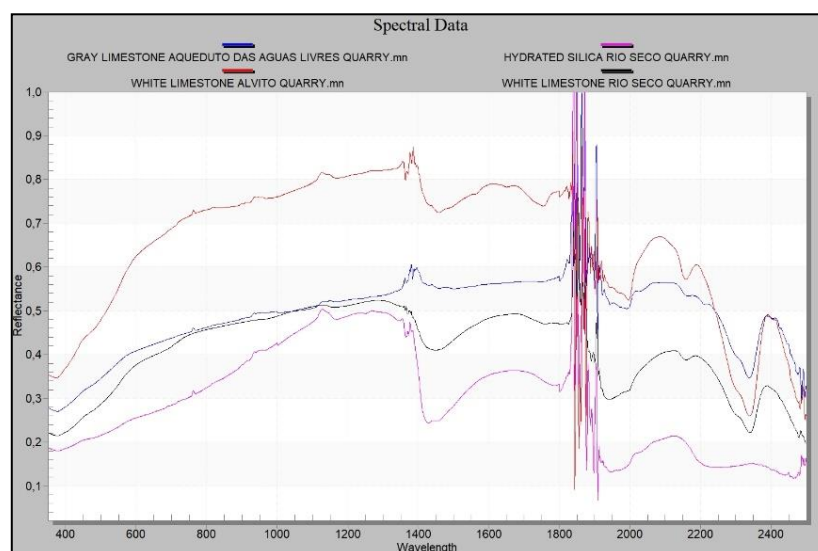
Spectral data are acquired using the spectroradiometer because its spectral range is larger and its accuracy better than those of the hyperspectral camera. The spectral curves of the materials of the quarries were compared (Figure 21). From the classification process by the described method, a RMS Exit Criteria of 0.00184 is obtained. This value is very low and indicates that the root mean square error obtained in the process is acceptable. The classified image contains 115,520 total pixels of which 92.151% of pixels have been classified correctly. Therefore, the purpose of this process is to determine the homogeneity of the analysed material, in this case it is confirmed that the analysed scene is Lioz.

**Figure 21.** Reflectance spectral signatures of materials in the quarries. Gray limestone from Aqueduto das Aguas Livres Quarry (Blue) and hydrated silica Rio Seco Quarry (Purple) differing significantly from the white limestones in Alvito Quarry (Red) and Rio Seco Quarry (Black).

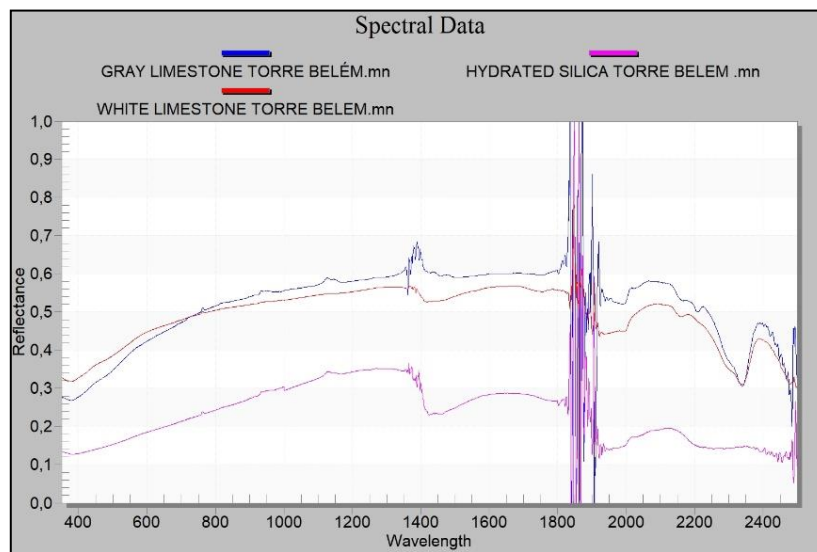
The materials measured at the Tower of Belém present spectral similarities with the exception of hydrated silica, whose signature differs from the carbonates (limestone) since it is a silicon oxide.

Silica shows lower reflectance and its absorbance peaks do not correspond to those in the carbonates in the limestones (Figure 22).

Figure 22. Reflectance spectral signatures of ashlars in the Tower of Belém.

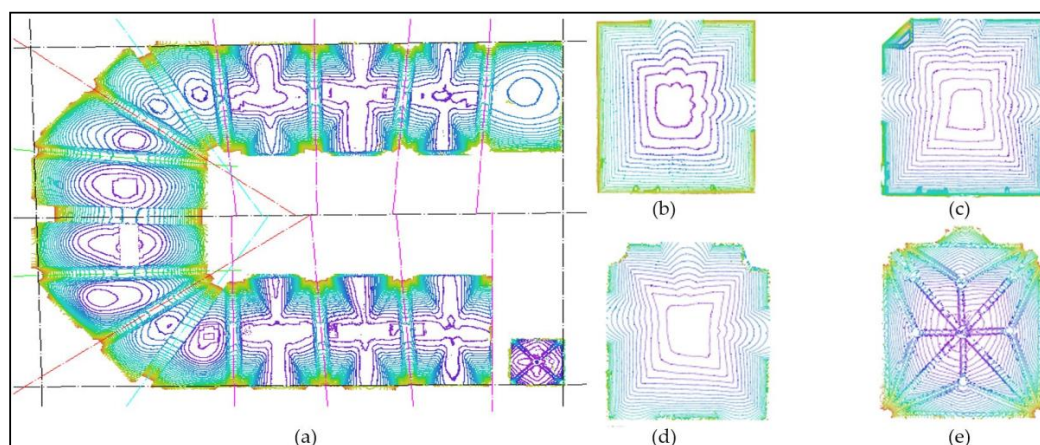
The present geometric evaluation reveals that the geometry of the structural elements (walls and vaults) is correct. Figure 23 shows a representation of the vaults in their present state in the form of height contours. The vaults of the bulwark (Figure 23a) present stable geometry without significant deformations, although there is an evident misalignment of the vaults when seen as a plan view. This misalignment indicates staking errors during construction at the base of its geometry and not the existence of structural problems. Regarding the vaults in the rooms of the tower (Figure 23b–e), their geometry is regular, with few deformations and without evident structural deficiencies.

Figure 23. Height contour geometry of the vaults in the Tower of Belém: (a) Bulwark vaults–Level N00; (b) Level N02; (c) Level N03; (d) Level N04; (e) Level N05.

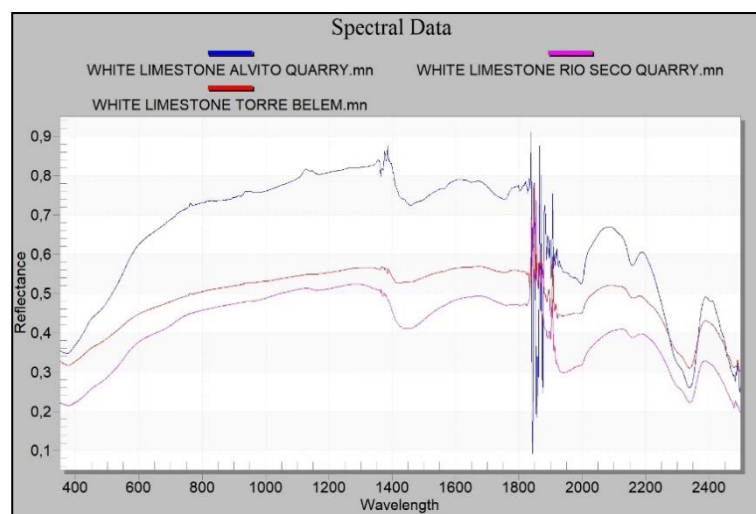
As for the results obtained from the spectral signatures of the materials in the Tower of Belém and in the quarries analysed (Rio Seco, Alvito and Aqueduto das Águas Livres), the results of the reflectance and absorbance of the materials making up the white limestone ashlar in the Tower of Belém matches with the materials of the Rio Seco quarry. There is also spectral similarity between a silica nodule in one ashlar and the silica found at the same quarry. The same cannot be said of the results of the Alvito quarry. The reflectance is similar to the other white limestones, but the signature shows different slopes. This fact means that there is less likelihood that the material to build the Tower of Belém was extracted from the Alvito quarry. The carbonate from this latter quarry is similar to the others analysed in this study, but it shows differences that prevent corroboration with the hypothesis that it was used in the construction of the Tower. The study lends more weight to the hypothesis that the material of the Tower of Belém came from the Rio Seco quarry, since the spectral signature is similar to that found in the Lioz used in the Tower of Belém (Figure 24).

**Figure 24.** Spectral comparison between Lioz white limestone in the quarries and in the Tower of Belém. Evidence of spectral similarity of absorption peaks and slopes between the limestone at Tower of Belém (Red) and the limestone in Rio Seco Quarry (Purple).

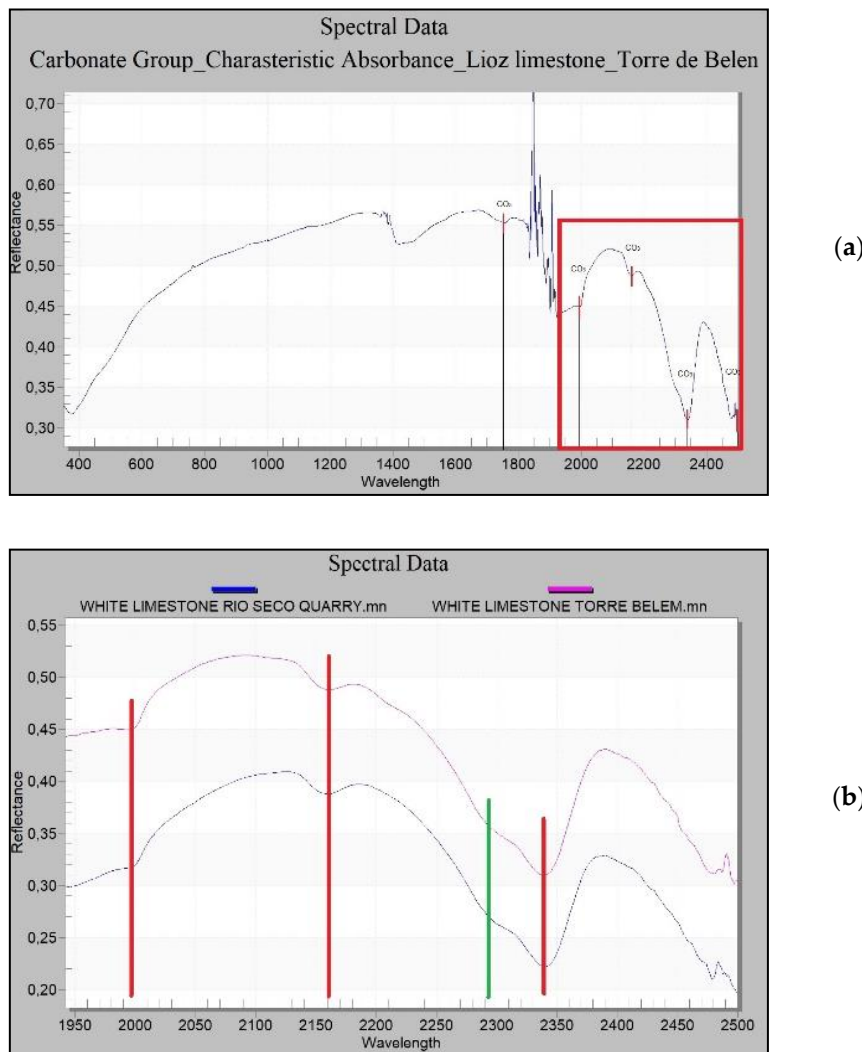
Owing to the nature of these limestones, their characteristic absorption peaks appear at 1750, 1980, 2160, 2340 and 2500 nm [66] (Figure 25a). By analysing with increased resolution the range presenting more information about carbonates, which is between wavelengths 1900 nm and 2500 nm, the absorbance peaks of the Lioz white limestone at the Rio Seco quarry and in the Tower of Belém lie within the same wavelengths and correspond to those previously mentioned, which are characteristic of the group of carbonates.

**Figure 25.** Comparison between the samples from the Tower of Belem and from the area of the white limestone in Rio Seco quarry. (a) Absorbance peaks of the carbonates group ( $\text{CO}_3$ ) of the white limestone of the Tower of Belém; (b) Enlargement between wavelengths 1900–2500 nm for comparison. Common absorbance peaks (Red) and slope change (Green) for Tower of Belém and Rio Seco quarry signatures.

Common to the carbonates of both the Tower of Belém and the Rio Seco quarry, there is a change in the slope of the curve at 2292 nm. This reinforces the case for this quarry as the source of the Lioz supply for the construction of the Tower of Belém (Figure 25b).

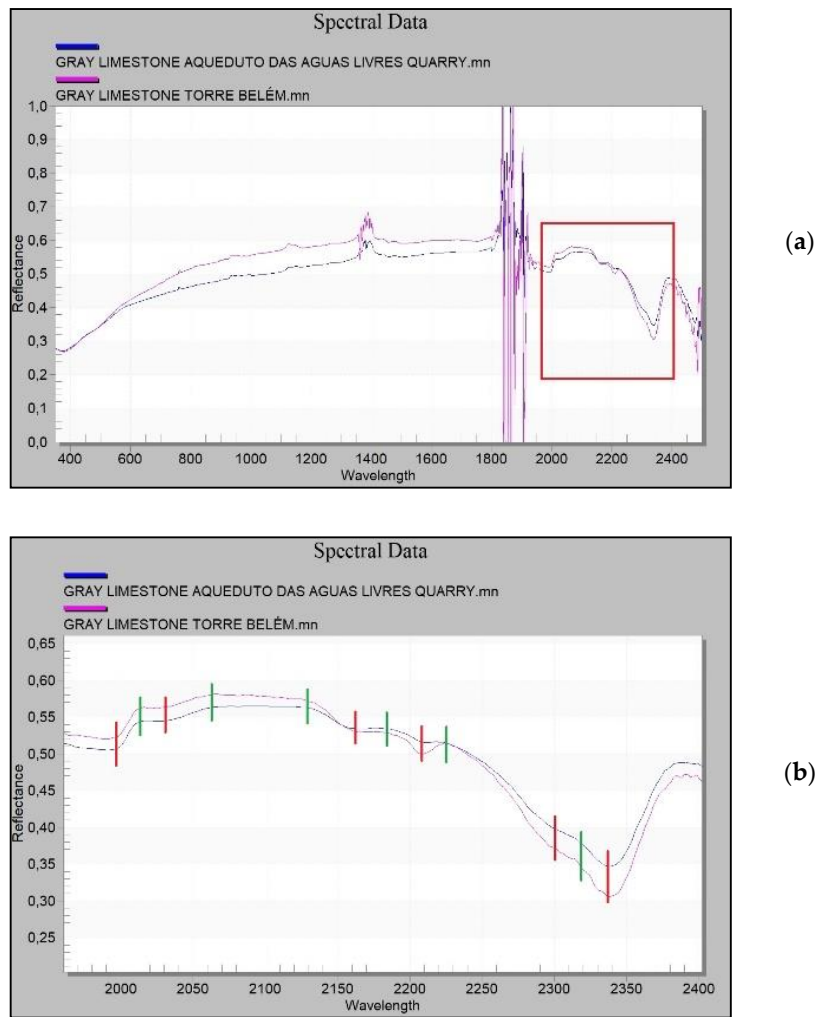
As for the gray limestones found in the Tower of Belém, these show reflectance values that are very similar to those found at the Aqueduto das Águas Livres quarry (Figure 26a). Absorbance and reflectance peaks of the gray limestones in the Tower of Belém and the quarry are found at the same wavelengths. These reflectance values confirm it is a carbonate and that the geological material is the same (Figure 26b).

**Figure 26.** Comparison between the samples from the Tower of Belem and from the area of the gray limestone in the Aqueduto das Águas Livres quarry. (a) Similarity between spectral signatures of the gray limestones; (b) Absorbance (Red) and reflectance (Green) peaks for the gray limestones studied between 2000 and 2400 nm.

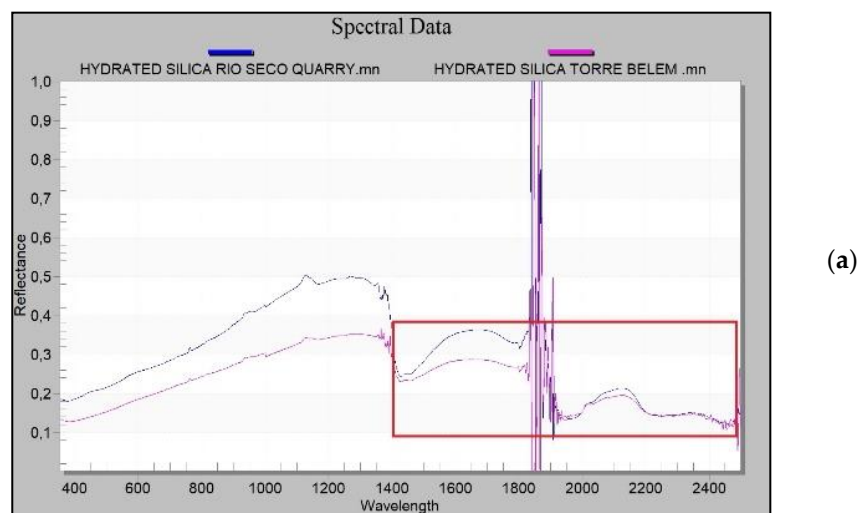
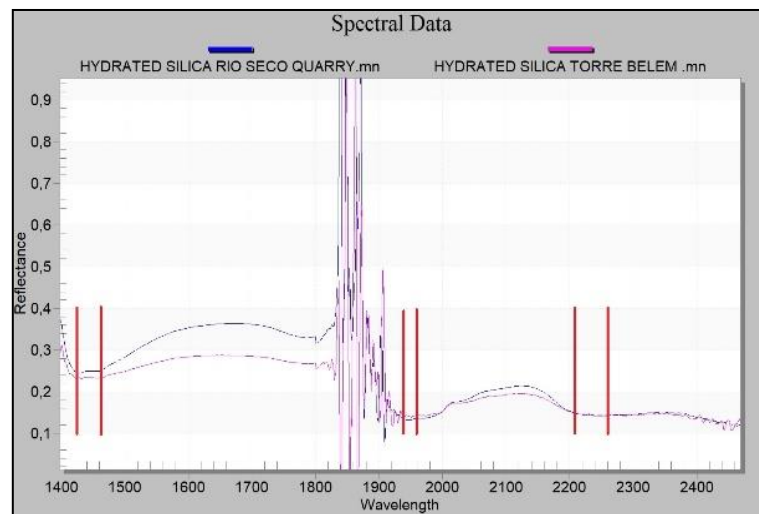
**Figure 27.** Cont.

The silica measured in the ashlar of the Tower of Belém and the silica at the Rio Seco quarry have very similar reflectance curves. The silica from the quarry has a little more reflectance due eventually to both a different type of fracture and to erosion. This is not significant since absorbance and reflectance peaks are found at the same wavelengths (Figure 27a).

**Figure 27.** Comparison between the samples from the Tower of Belém and from the area of hydrated silica in the Rio Seco quarry. (a) Spectral signatures of the studied silica; (b) Common and characteristic absorption peaks of the silica types analyzed.

Enlarging the area of interest to include a spectral analysis of the silica (Figure 27a), it can be seen that the curves share the same wavelengths at the absorption peaks (Figure 27b). These values confirm this to be a hydrated cryptocrystalline kind of silica spectrally situated between the values for opal and calcedony. The absorption peaks for the groups Hydroxide (OH), Water (H<sub>2</sub>O) and Silicon Hydroxide (Si-OH), which define these hydrated types [67] are found at the same wavelengths in both cases studied (Tower of Belém and Rio Seco) (Figure 27b).
