Fatigue Failure of Outer Metal Dome of Bipolar Monoblock Shell in Hemiarthroplasty Hip: Case Report and Review of Literature

Keywords: Bipolar hemiarthroplasty, revision total hip arthroplasty, bipolar monoblock shell, polyethylene inner liner.

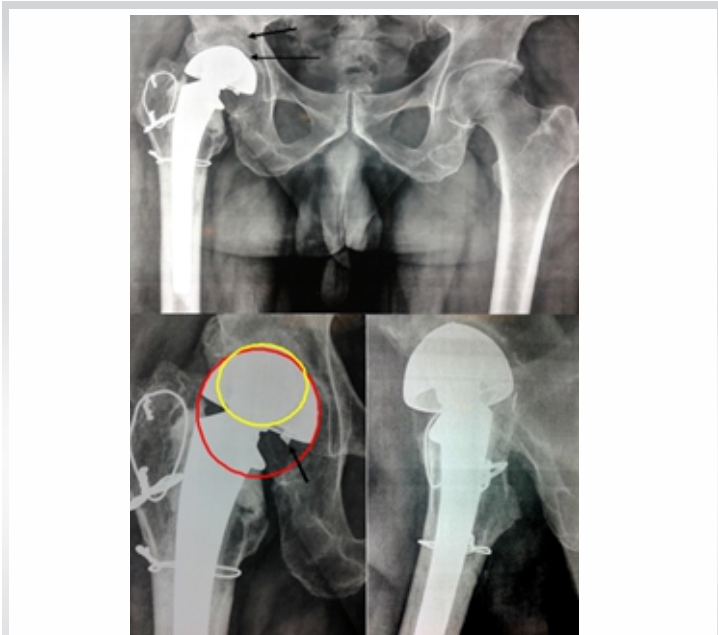
Figure 1: (a) Anteroposterior and (b) Cross-table lateral radiographs 5 years after right cemented bipolar hemiarthroplasty, Anteroposterior radiographs demonstrating complete wear-through of the femoral head through the polyethylene liner and outer metal dome of monoblock shell into the weight bearing roof of the acetabulum. The arrows indicate: zone of osteolysis (upper); head is in direct contact with the acetabulum (lower), Cross-table lateral radiographs demonstrating complete wear-through of the femoral head through the polyethylene liner and the bipolar cup into the weight bearing roof of the acetabulum. (toward the acetabulum: red circle delineate the outer metallic dome of monoblock shell; yellow circle delineate the head. Different colors are used to show the breach in outer metallic case). The arrow indicated the avulsed metallic fragment.

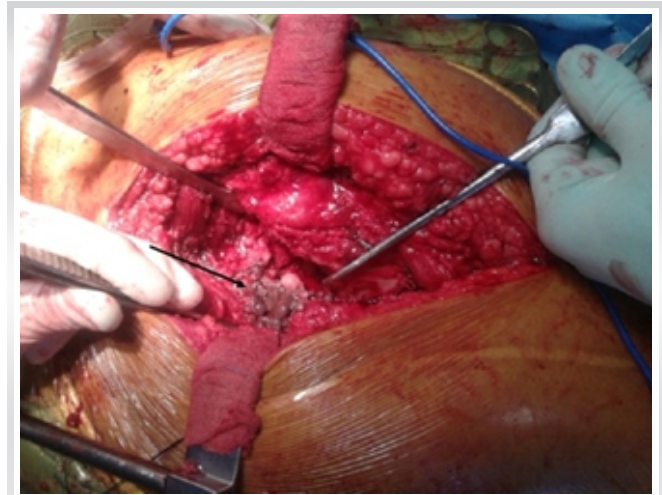
Figure 2: Black metallosis debris (arrow).

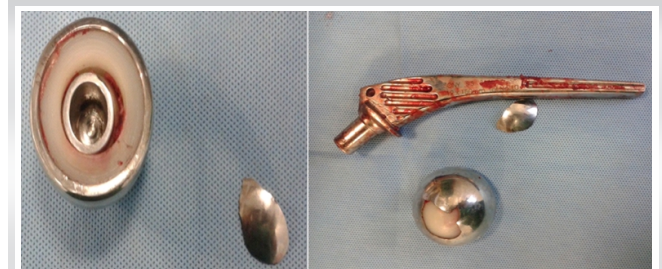
Figure 3: Bipolar head dissociated; the whole bipolar assembly; femoral head with monoblock shell; an avulsed fragment of metallic dome.

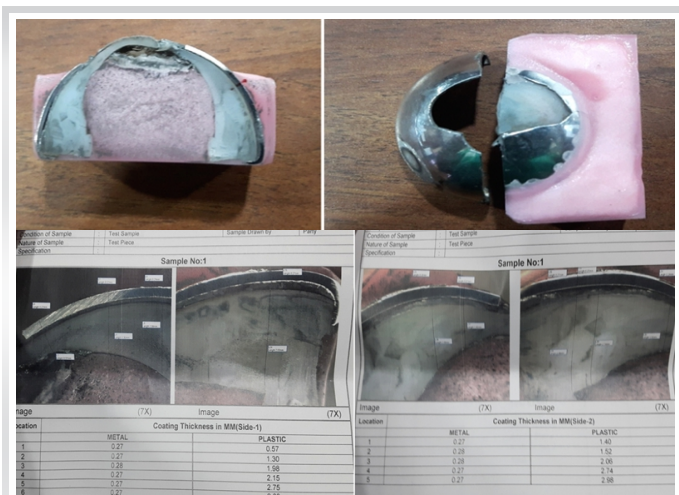
Figure 4: Spectro-analysis showing the wear of polyethylene and thickness of outer metallic dome.

The bipolar monobloc shell was sent to our biomechanics laboratory for critical analysis (Fig. 4). Femoral head had penetrated total thickness of polyethylene, and also damaged metallic outer dome leading to fatigue failure. Metallic broken piece was identified and removed. There could be two possibilities of this catastrophic failure, one excessive wear and second thickness of metal case was in-adequate (metal defect).

polyethylene liner eventually caused the head to articulate in direct contact with the outer metal dome and further activity of the femoral head leading to fatigue failure of the metal dome with a metal chip avulsion. We compared the polyethylene liner thickness and the bipolar metal dome thickness of the prosthesis used in this patient with a standard bipolar prosthesis (Depuy, Warsaw, Indiana). The polyethylene thickness in failed implant was equal to standard bipolar prosthesis however the outer metal dome thickness was less compared to standard bipolar prosthesis. This discrepancy in hardness is underscored which leads to fatigue fracture of metallic shell further by the fact that the femoral head revealed no obvious signs of wear. These findings corroborate the observation made by other reports [13, 14].

The contributing factors for present catastrophic failure include physiological young patient age leading to excessive and early wear; lack of appropriate follow-up causes delayed recognition of erosive polyethylene wear. Over time, the outer metallic dome lost its intended movement and assumed a fixed position. We assumed that this fixed position caused asymmetric load carriage affects with stress concentration effect at the center, compounded by repeated articulation of the compatible modular femoral head with the inner liner that leads to transmural wear-through of polyethylene and ultimately fatigue fracture of the outer metallic dome. Furthermore, inadequate thickness of outer metal-dome as suggested by biomechanical analysis also contributes significantly to this rare complication.

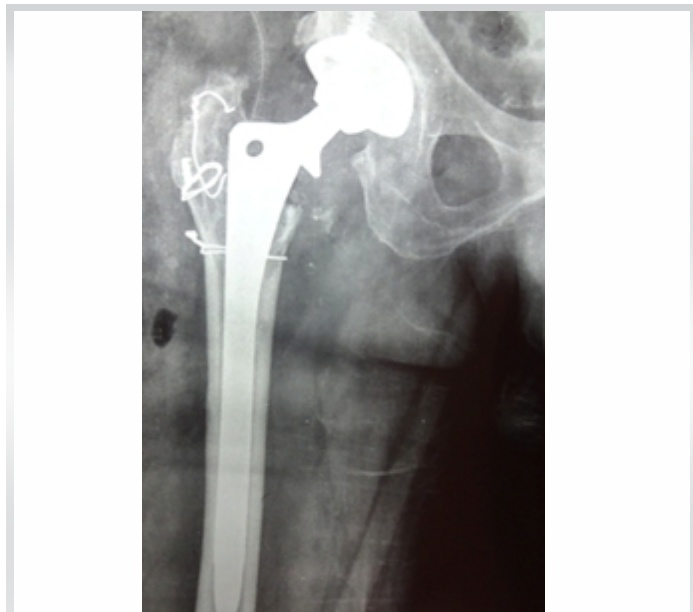
Figure 5: An anteroposterior view of pelvis showing right hip: latest follow-up demonstrating stable implant component.

At 3 months after revision, he was allowed to do full weight-bearing walking and routine activities of daily living. His recovery was good. Few months postoperatively, he was pain free and had returned to his routine activities. During his last follow-up, 5-years post-surgery, Harris Hip score was improved from poor to excellent, radiographs show both components stable, and clinical examination did not reveal any abnormality
