## Tibial stress fracture after computer-navigated total knee arthroplasty

**Abstract** A correct alignment of the tibial and femoral component is one of the most important factors determining favourable long-term results of a total knee arthroplasty (TKA). The accuracy provided by the use of the computer navigation systems has been widely described in the literature so that their use has become increasingly popular in recent years; however, unpredictable complications, such as displaced or stress femoral or tibial fractures, have been reported to occur a few weeks after the operation. We present a case of a stress tibial fracture that occurred after a TKA performed with the use of a computer navigation system. The stress fracture, which eventually healed without further complications, occurred at one of the pinhole sites used for the placement of the tibial trackers.

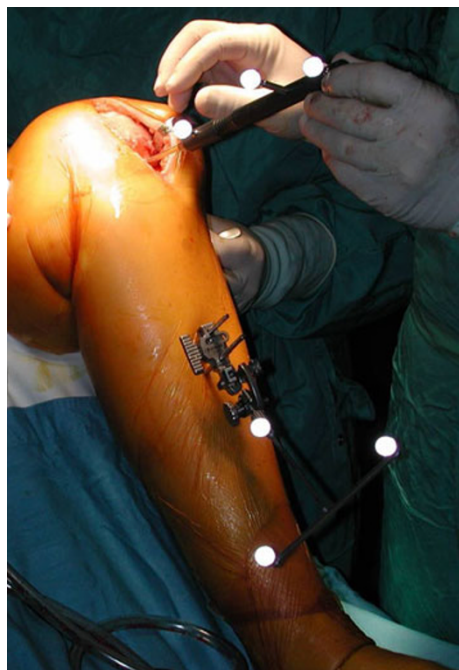
The operation was performed by the same expert surgeon who had already performed more than 100 computer-assisted procedures before this operation with the same software and hardware. A computed tomography (CT)-free navigation system (Ci<sup>TM</sup> navigation system, DePuy I-Orthopaedics, Munich, Germany) was used. To perform the electronic measurements, one bicortical navigation tracker (5 × 200 mm) was set at the distal part of the femur and two bicortical navigation trackers (4 × 130 mm) were set on the tibial diaphysis (Fig. 1).

**Fig. 1** Trackers set on the tibial diaphysis

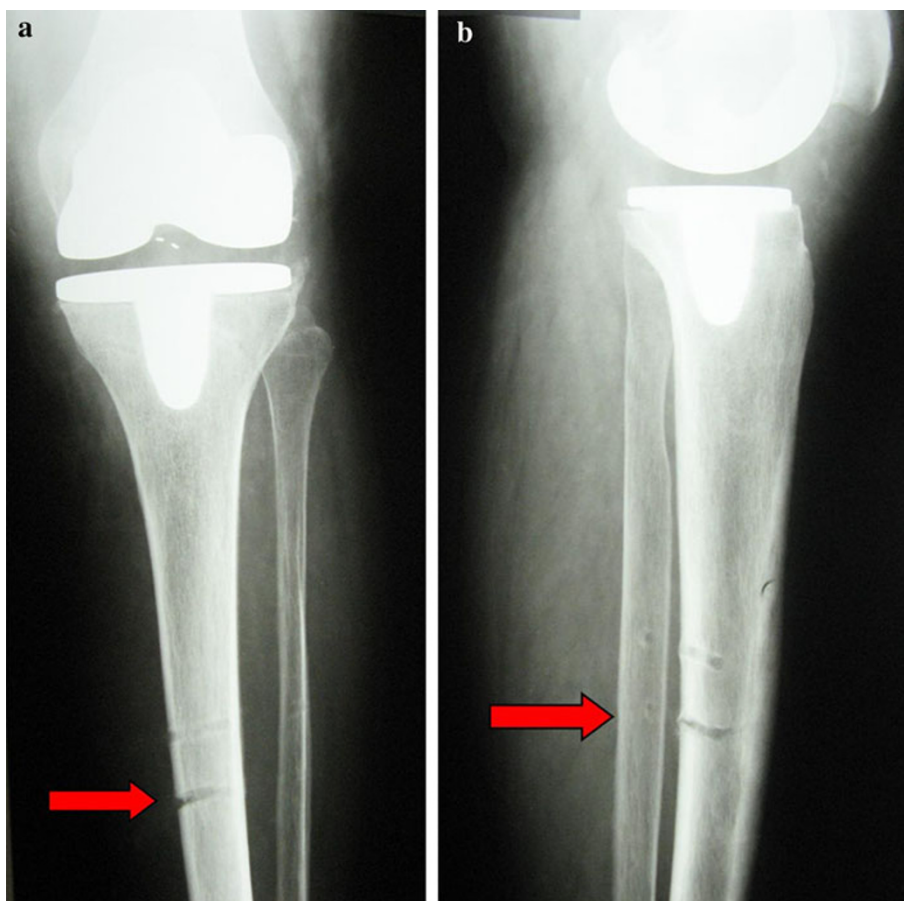
patient was able to walk with use of crutches without pain or restrictions. However, at the beginning of the fourth postoperative week, an acute pain appeared in the operated leg with local tibial pain and swelling. The patient immediately had an X-ray check-up which revealed a stress fracture of the diaphysis of the tibia, at the level of the more distal tibial tracker (Fig. 2a, b).

**Fig. 2** **a** Antero-posterior (AP) X-ray: stress fracture at the level of the distal tibial tracker. **b** Latero-lateral (LL) X-ray: stress fracture at the level of the distal tibial tracker

in which they are inserted in the cortical bone as a result of several attempts performed to obtain a perfect stability of the pin. This is exactly what happened in our case, as the distal tibial pin was inserted twice due to a lack of stability of the tracker obtained after the first attempt. Indeed, a critical review of the postoperative X-ray shows a slightly larger diameter of the distal tibial hole. The use of a bicortical pin, especially if inserted more than once, could increase weakness of the local bone; however, this hypothesis contrasts with the results provided by Kuo et al. [14] that showed how bone stress concentration after single-cortex defect was similar to double-cortex defect. However, the use of bicortical pins provides a better stability of the navigation trackers, which is a priority in performing a correct computer-assisted knee surgery.

As a result, the patient wore a brace and she was instructed to avoid weight bearing for the following 4 weeks; then she was allowed to gradually weight bear with use of a leg cast for another 4 weeks. Subsequent X-rays at the 14th week showed good healing of the fracture (Fig. 3a, b).

In summary, we recommend paying particular attention so as to perform a unique insertion of the pins in an orthogonal way, reaching the distal cortical bone without completely penetrating it; this should provide an adequate

stability of the trackers, reducing the risk of loss of strength of local tibial bone.
