Article

UAV-Driven Structural Crack Detection and Location Determination Using Convolutional Neural Networks

Citation: Choi, D.; Bell, W.; Kim, D.; Kim, J. UAV-Driven Structural Crack Detection and Location Determination Using Convolutional Neural Networks. *Sensors* **2021**, *21*, 2650. <https://doi.org/10.3390/s21082650>

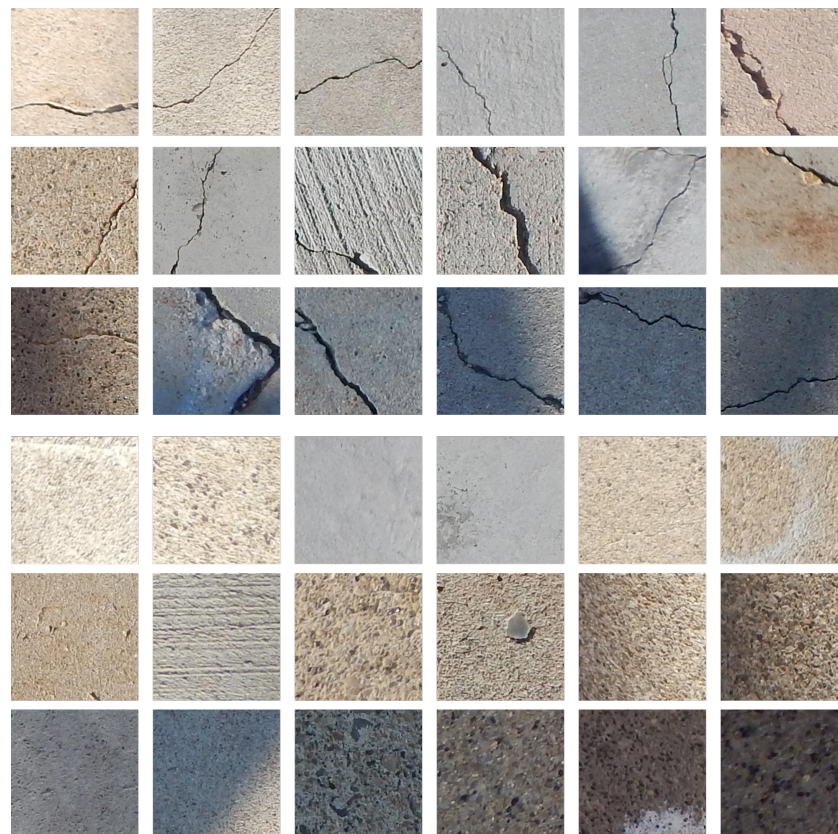
Figure 7. Representation of the images used to train labelling of crack images (the first three rows) and no-crack images (the last three rows).

Before inspection of the stitched image, a model was trained using the 3600 hand-picked images from the SDNet data set. The model was trained in batches of 36 images, so in every step, 36 images were inspected by the model and used to calculate loss and gradient for the optimization algorithm. Examples of the images used in the crack and no-crack categories are shown in Figure 7. Since image acquisition is generally performed during the daytime, the images taken in a normal daylight condition are selected as a training data set. There were 80 steps per epoch of training and 20 steps per epoch of validation. Training continued until either the validation accuracy stopped improving or the training reached 100 epochs. Each epoch required only 26 s to be completed, averaging 326 milliseconds per step. The history for the training is shown in Figure 8. Figure 8a is the result for the loss calculated using Equation (2), and Figure 8b shows the accuracy of the model during training and validation, which is the percentage of images classified correctly during training and validation. During both validation and training, the accuracy is well above 99%.

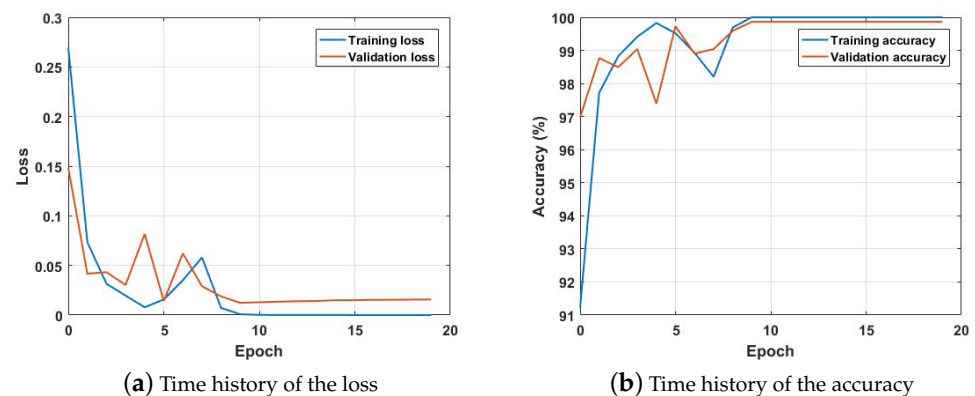
Figure 8. Time history of the loss and accuracy for the initial training.

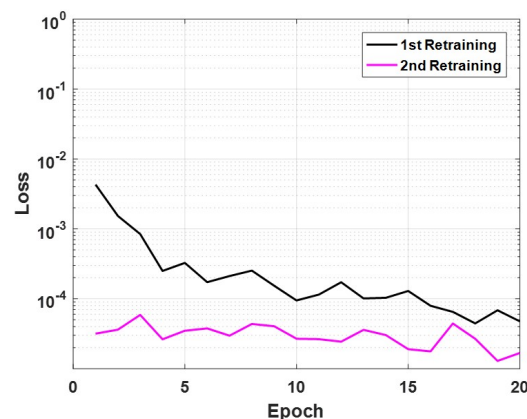
Figure 12. Time history of the loss for retraining the model in Method 1.

The value of the loss function during each retraining step is shown in Figure 12. The plots of these values demonstrate that retraining increases the model's performance when given augmented data, which are 18 crack and 18 no-crack images. The reduction of loss in the first step was small, only on an order of magnitude of 10^{-3} , but it was enough to change the judgement of 10 sections. The change in the second step was even smaller, but again, it changed the judgement of a section.

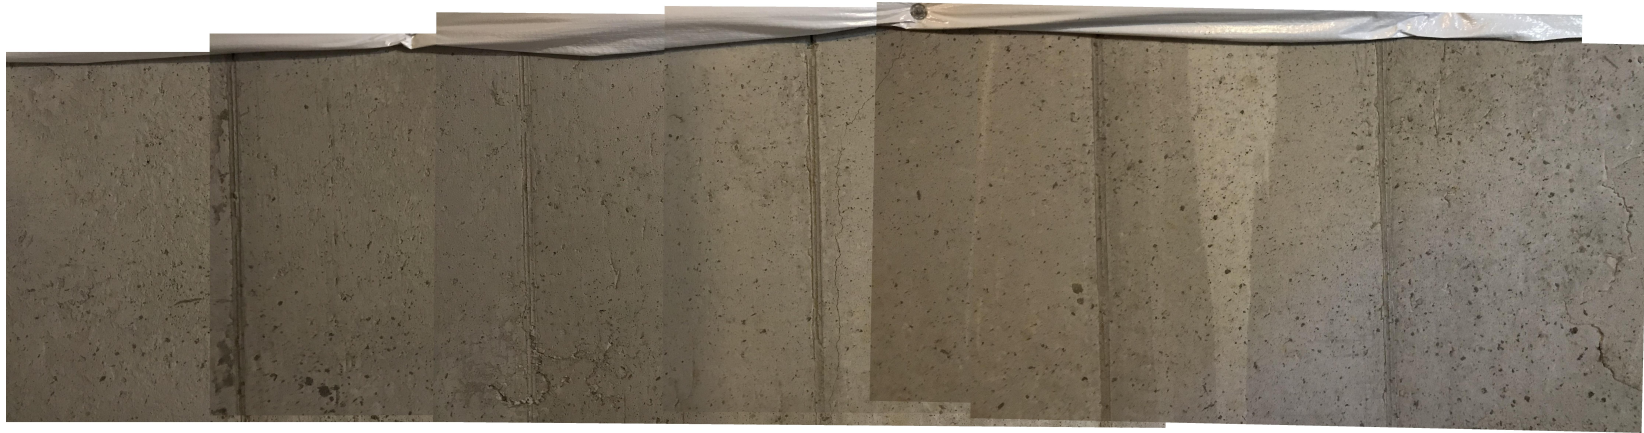
Figure A1. Stitched image.

A total of 6 images are obtained to cover a 5 m × 1.5 m region, and the stitched image is depicted in Figure A1. The stitched image was broken up into 440 sections, divided 40 times along the x -axis and 11 times along the y -axis, with 224 by 224 pixel resolution. The thresholds for identifying cracks and no cracks are set as $\gamma_c = 0.94$ and $\gamma_{nc} = 0.18$ for this experiment. Again, these thresholds can be defined by users to determine the algorithm's classification of the image. Figure A2 shows the initial results of crack detection using Method 1, and Figure A3 contains the results of grouping the labeled sections into crack and uncertain regions as well as the amalgamated location information from H9, which is the origin of the reference coordinate.
