Analysis of thermal characteristics of electrical wiring for load groups in cattle barns

Abstract: The purpose of the current study is to analyze the thermal characteristics of electrical wirings depending on the number of operating load by connecting four types of electrical wirings that are selected by surveying the conditions for the electric fans, automatic waterers and halogen warm lamps that were installed in cattle barns in different years. The conditions of 64 cattle barns were surveyed and an experimental test was conducted at a cattle barn. The condition-survey covered inappropriate design, construction and misuse of electrical facility, including electrical wiring mostly used, and the mode of load current was evaluated. The survey showed that the mode of load current increased as the installation year of the fans, waterers and halogen lamps became older. Accordingly, the cattle barn manager needed to increase the capacity of the circuit breaker, which promoted the degradation of insulation of the electrical wires' sheath and increased possibility for electrical fires in the long-run. The test showed that the saturation temperature of the wire insulated sheath increased

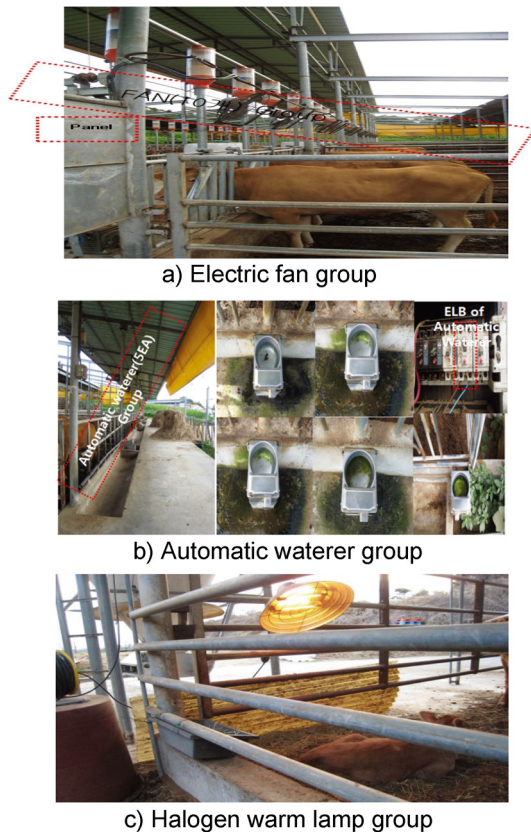
Fig. 1. Electric load groups in cattle barn.

Figure 1 describes the major loads in cattle barn with a) electric fan group, b) automatic waterer group and c) halogen warm lamp group.

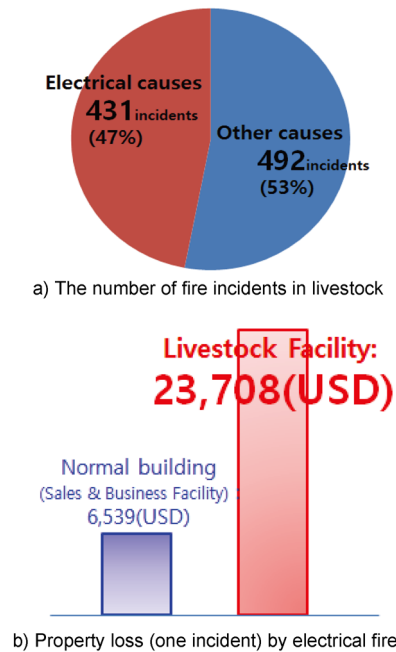
Fig. 2. Electrical fire and property loss in livestock fires, 2013.

Figure 2 a) presents the percentage of different causes of fire in livestock barn. The total number fire incidents in livestock barns was 932 out of which the number of electrical fire incidents was 431. Figure 2 b) shows property loss due to electrical fire of normal building facility (sales & business facility) and livestock facility. The property loss of normal building facility per incident was 6,539 USD and livestock facility per incident was 23,708 USD.

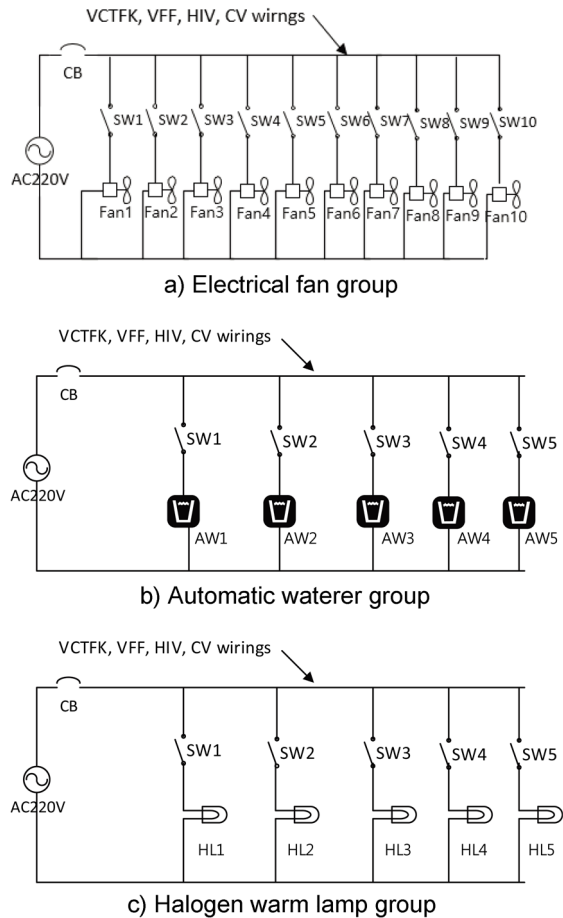
Fig. 3. Experimental test set ups for load groups and wirings.

Electric fan of 220 W (small, ten units) by M Electricity company, automatic waterer of 660W (five units) by H Machine company and halogen warm lamp of 700W (five units) by Y Company were installed on-site that are more than ten years old and less than a year old. VCTFK (0.75 mm^2), VFF (0.75 mm^2), HIV (1.6 mm^2) and CV (2.0 mm^2) were also used in the experimental test. A622 AC/DC current probe of Tectronix Company was chosen to measure the current and NI-9215 of the same company was used to collect the signal coming from the current probe. FLIR 4 series that can analyze the temperature ranging from -40 to $1,000^\circ\text{C}$ and thermal imaging camera that can record and save video in real time were used. Fig. 3 describes the experimental circuit diagram of a) electric fan group, b) automatic waterer group and c) halogen warm lamp group.

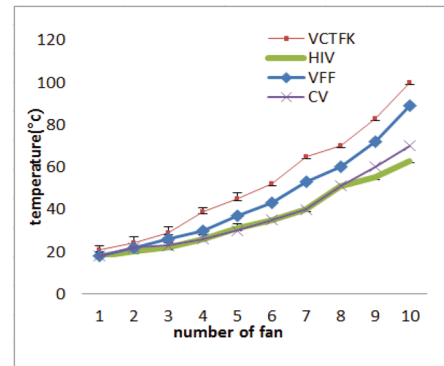
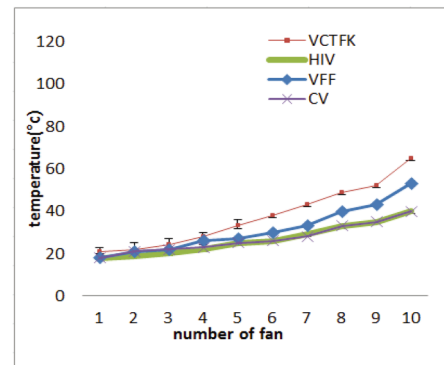
a) More than ten years

b) Less than one year

Fig. 4. Thermal characteristics of VCTFK, VFF, HIV and CV wirings by number of operating electric fans.

wire (seven units) and VFF wire (eight units) exceeded the allowable temperature. Although the cross-sectional diameter of the insulators was the same, the temperature was found different because of different insulator thickness. On the other hand, the fans by HIV and CV wires did not exceed the allowable temperature. The fans less than a year connected by VCTFK wire (ten units) exceeded the permissible temperature, whereas the fans connected by the other wires did not. Figure 4 presents the thermal characteristics of VCTFK, VFF, HIV and CV wirings depending on the number of operating electric fans that were more than ten years and less than a year old.

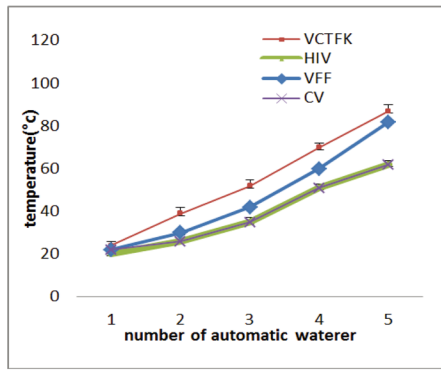
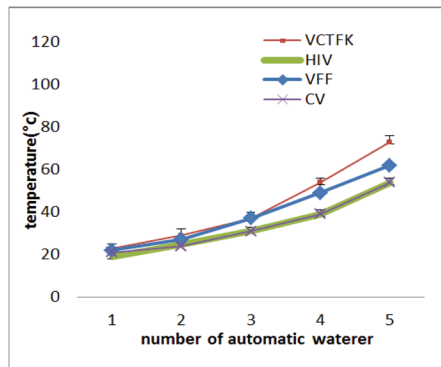
a) More than ten years

b) Less than one year

Fig. 5. Thermal characteristics of VCTFK, VFF, HIV and CV wirings by number of operating automatic waterers.

had never been checked nor had their wire been replaced, which caused problems as time went by. The saturation temperature on each electrical wire's insulation was higher than the allowable temperature and was measured for the number of operating automatic waterers more than ten years and less than a year old. The waterers that were more than ten years old and connected by VCTFK wire (three units) and VFF wire (four units) exceeded the allowable temperature. On the other hand, HIV and CV wires did not exceed the allowable temperature. For those which are less than a year old, the VCTFK and VFF (five units) exceeded the allowable temperature but the other wires did not. Figure 5 illustrates the thermal characteristics of VCTFK, VFF, HIV and CV wirings depending on the number of operating automatic waterers more than ten years and less than a year old.

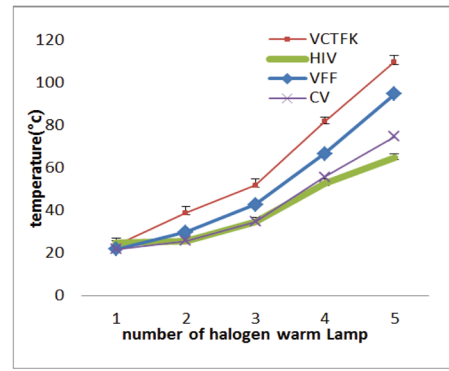
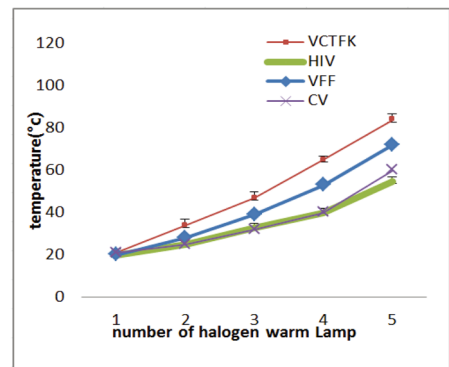
a) More than three years

b) Less than one year

Fig. 6. Thermal characteristics of VCTFK, VFF, HIV and CV wirings by number of operating halogen warm lamps.

The saturation temperature on each electric wire's insulation higher than the allowable temperature was measured for the number of operating halogen warm lamps that were more than three years and less than a year old. The halogen lamps that were more than three years old and connected by VCTFK wire (three units) and VFF wire (four units) exceeded the allowable temperature. On the other hand, the lamps connected by HIV and CV wires did not exceed the allowable temperature. The lamps less than a year old and connected by VCTFK (five units) and VFF (five units) wires exceeded the permissible temperature. Figure 6 presents the thermal characteristics of VCTFK, VFF, HIV and CV wirings depending on the number of operating halogen warm lamps more than three years and less than a year old.
