The Utility of a Plain Film Arthrogram to Confirm Acute Liner Dissociation in the Setting of Primary Total Hip Arthroplasty

Categories: Orthopedics, Trauma

Keywords: liner dissociation, orthopaedics trauma, hardware malfunction, arthrogram

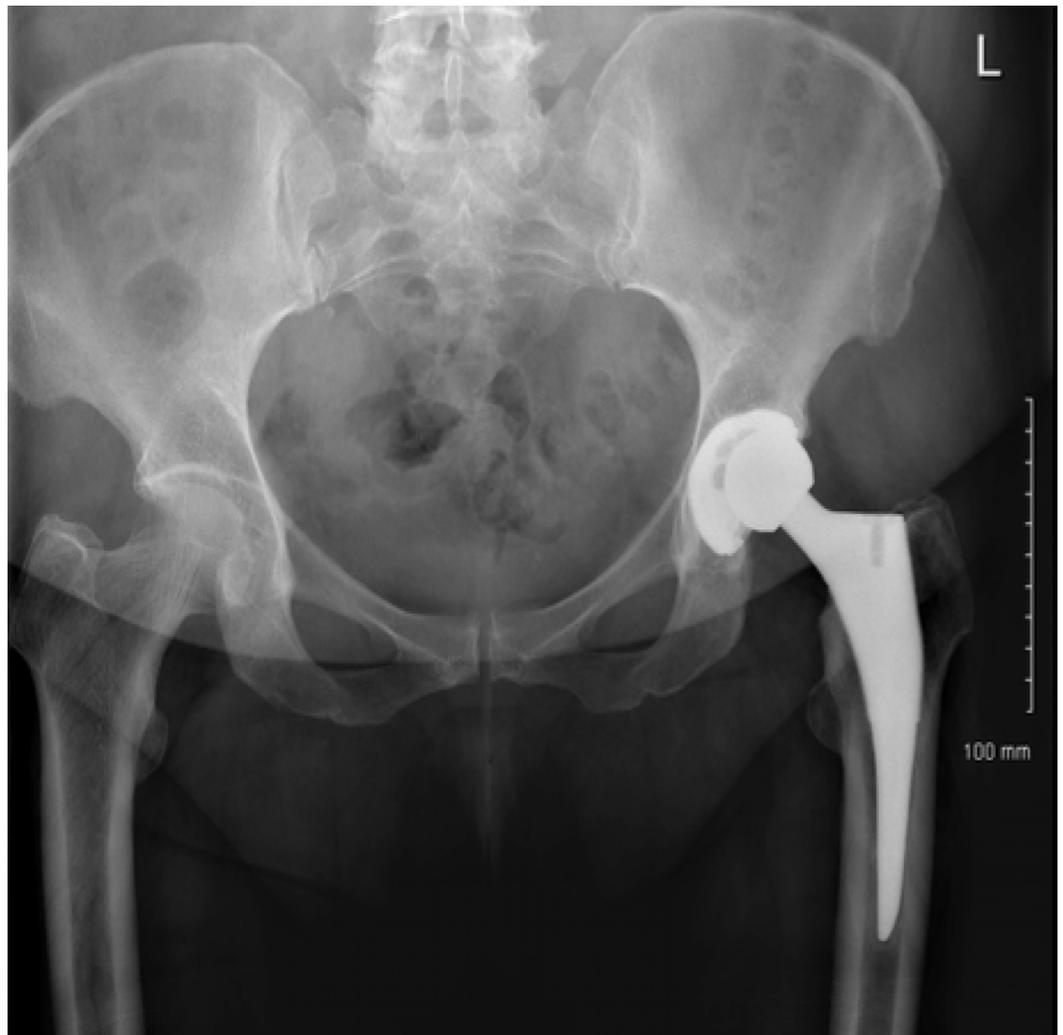
The ED physician referred the patient to the orthopaedic service on call as a posteriorly dislocated left total hip replacement. An isolated antero-posterior (AP) pelvic X-ray was obtained on referral which showed mild eccentric placement of the femoral head within the acetabular shell (Figure 1). The tangential lateral x-ray requested by the orthopaedic team confirmed joint enlocation; however, with the femoral head situated eccentrically within the acetabular cup (Figure 2).

FIGURE 1: AP view of left hip on presentation demonstrating eccentric femoral head placement with the uncemented acetabular component

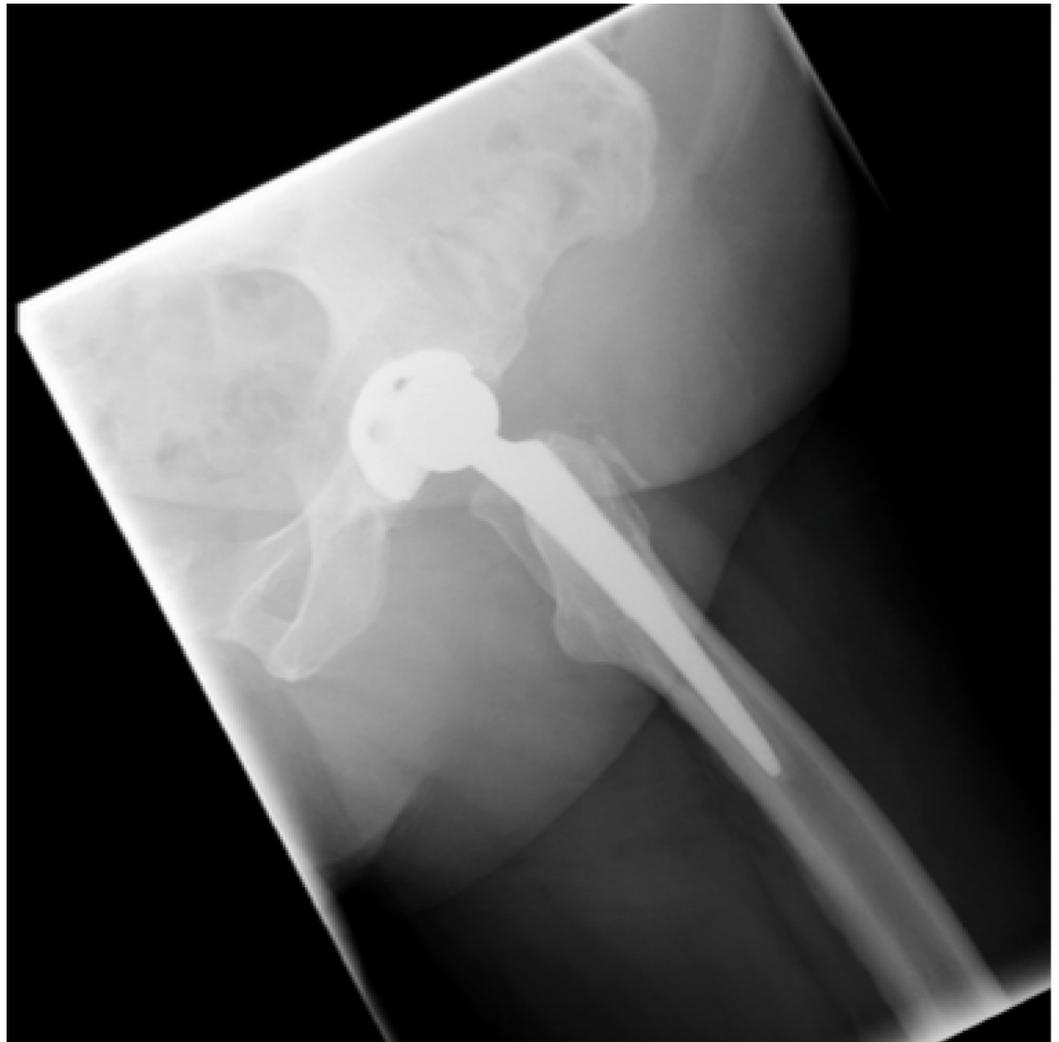
FIGURE 2: Lateral view of left hip on presentation

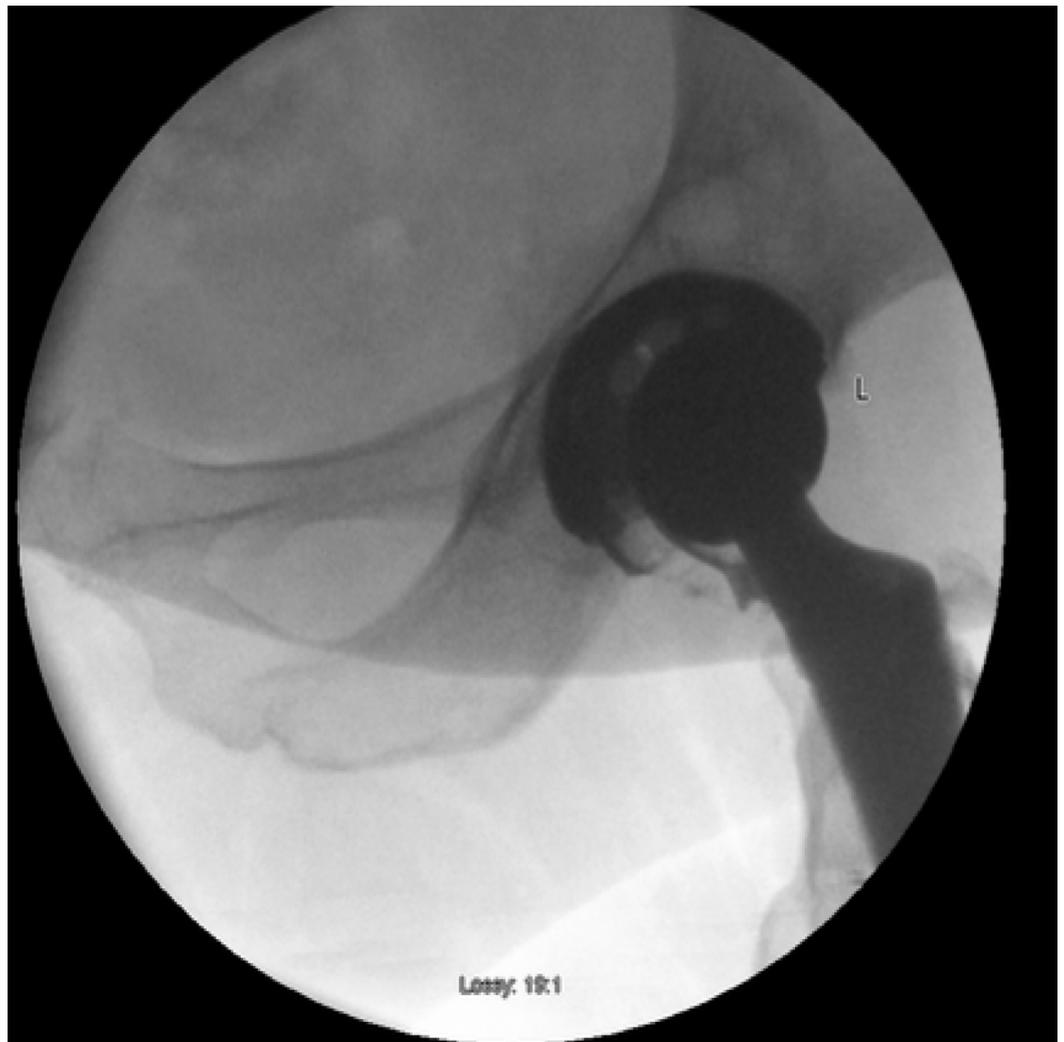
An arthrogram of her left hip was performed the following day in theatre under local anaesthesia. A 20-gauge spinal needle was inserted into the left hip joint under x-ray guidance. Joint fluid was aspirated to outrule infection and 4 mls of iodinated contrast was injected into the joint. This confirmed needle placement within the joint and femoral head enlocation within the acetabular cup. It delineated integrity but inferior dissociation of the polyethylene liner from the Pinnacle acetabular cup component (Figures 3, 4).

FIGURE 3: Left hip arthrogram demonstrating an intact but inferiorly dissociated liner and eccentric placement of the femoral head within the acetabular shell

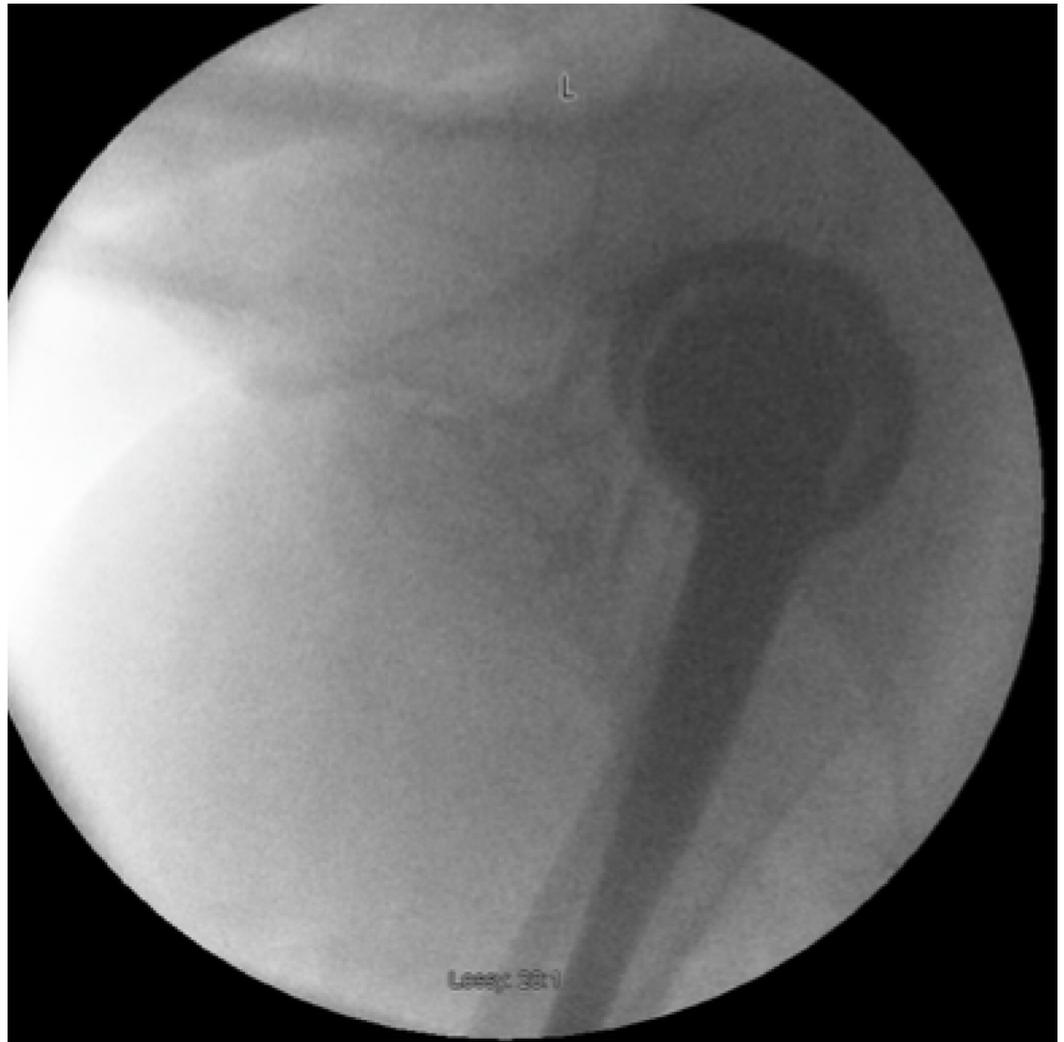
FIGURE 4: Left hip arthrogram

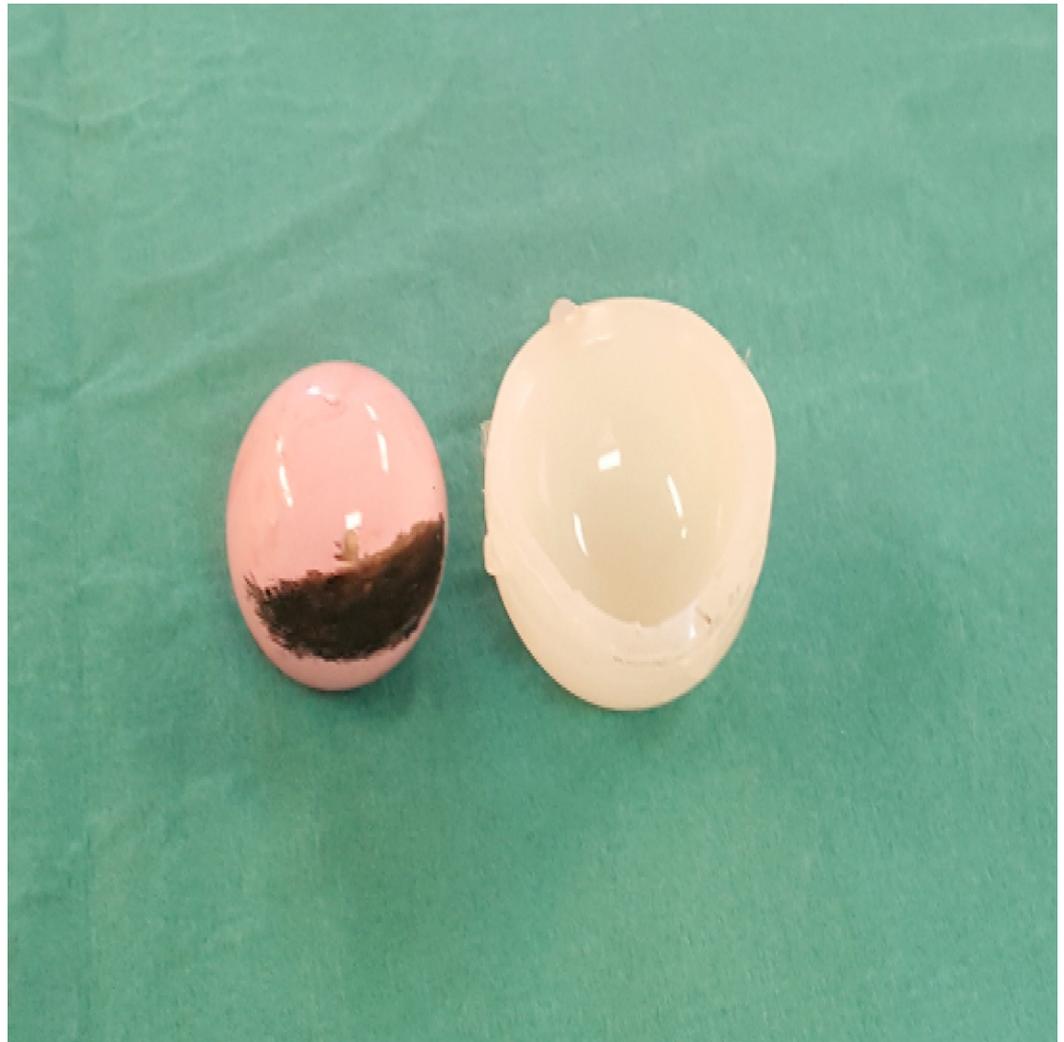
Intra-operatively the liner was found to be dissociated from the acetabular cup and displaced inferiorly. The explanted ceramic size 32mm head demonstrated dramatic evidence of stripe wear due to edge loading on the implanted acetabular cup and liner rim (Figure 5).

FIGURE 5: Explanted acetabular cup with marked stripe wear seen as dark discolouration of pink ceramic head and deformed explanted acetabular liner

The patient subsequently underwent a planned revision two days later following confirmation that the joint fluid culture was negative for infection. The femoral head and liner were exchanged through the previous incision via an anterolateral approach to the hip. The acetabular cup component had no evidence of loosening, nor did the implanted femoral stem. They were not revised as component integrity, stability and positioning were acceptable. The taperlock mechanism within the shell was also grossly unaltered.

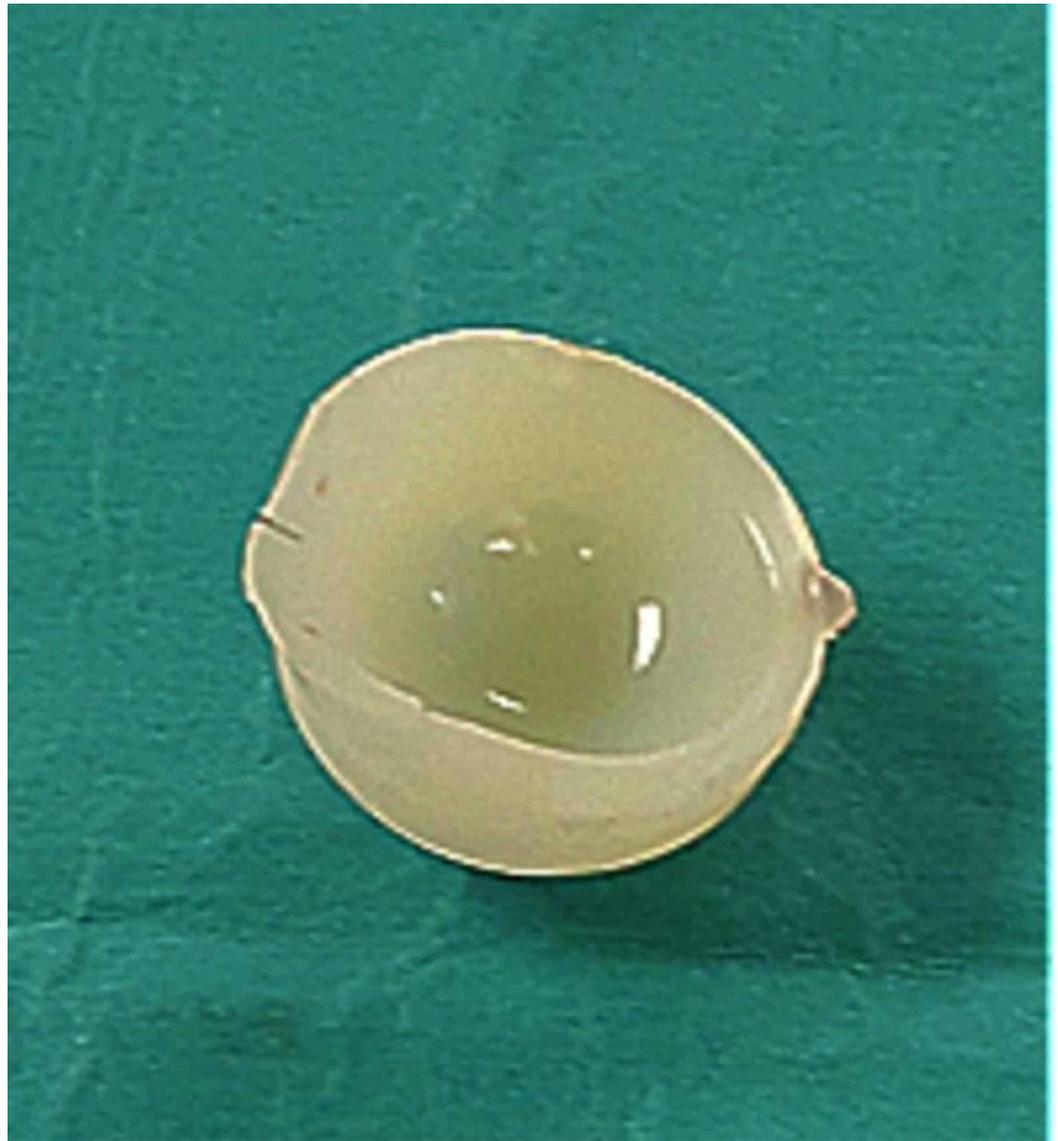
The Pinnacle shell design incorporates both a taperlock mechanism to secure the liner within it, in addition to multiple anti-rotation device crescentic concavities that accept the liner tines, increasing the overall stability of the liner within the shell. Our patient's explanted polyethylene liner had evidence of shearing of all but two peripheral anti-rotational locking tines in addition to gross plastic deformation of the rim predominantly at the 1-4 o' clock position (Figure 6).

FIGURE 6: Explanted dissociated polyethylene liner with marked plastic deformation of the rim, new oval shape and multiple tine loss

The most likely precipitating event for liner dissociation in our patient was the failure of the locking mechanism of the polyethylene liner, resulting in direct contact between the ceramic head and metal acetabular cup and mode two wear. The precise failure cause of the locking mechanism, however, is difficult to determine. It may be related to a defect in the material, fatigue failure of the material, poor implantation technique, inaccurate component positioning, prominent screw heads within the acetabular cup or from an acute hip dislocation where the liner rotated and the sharp edge of the metal cup severs the tines during dislocation [2,15].

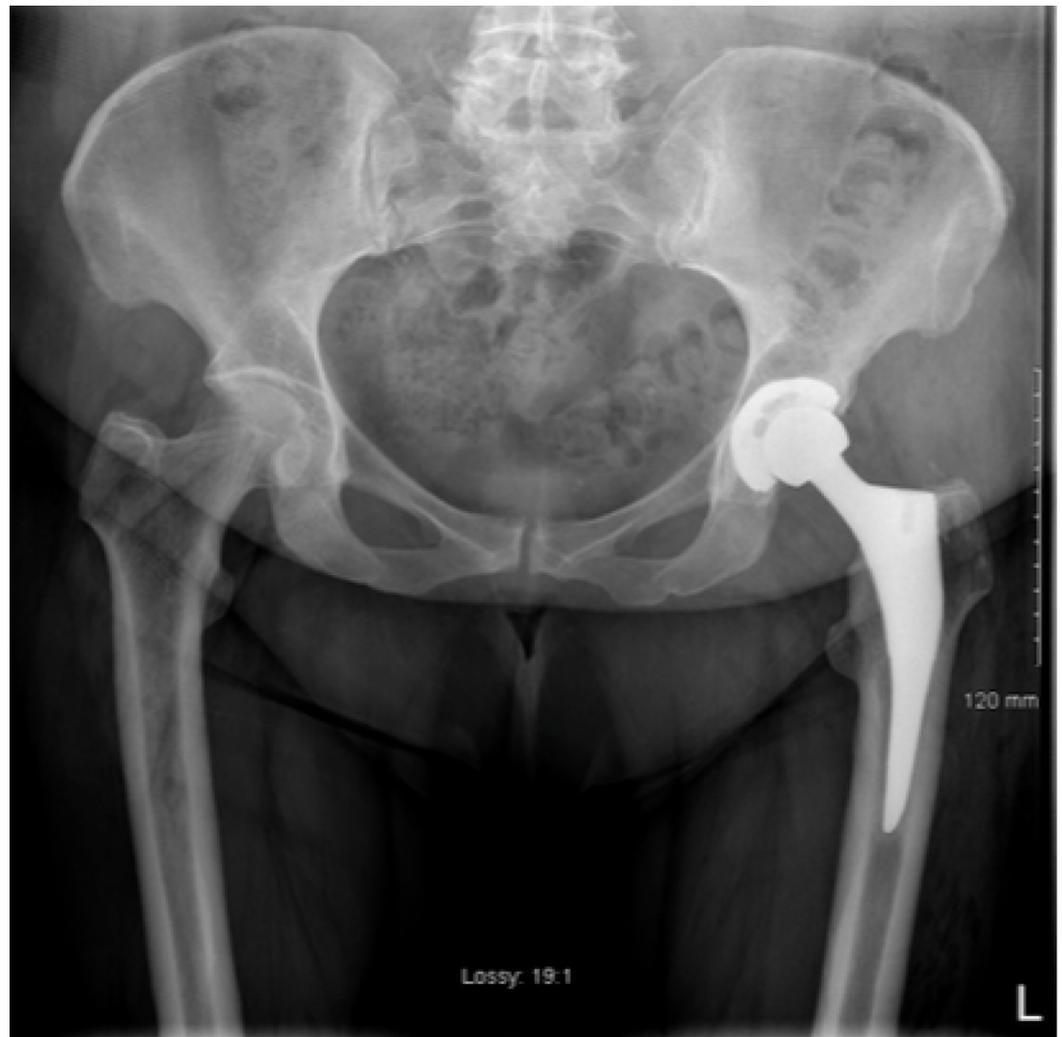
FIGURE 7: Post-operative AP radiograph of her left hip post head and liner exchange with concentric placement of the femoral head in the acetabular cup

A new polyethylene liner was successfully seated in the acetabular cup, and a ceramic head was press fit onto the trunnion of the retained femoral component. The revision components were stable on testing with excellent impingement free range of motion preserved. Post-operatively, the patient had immediate relief of the pre-operative groin pain and underwent an uncomplicated post-operative recovery. She was discharged home on the fourth post-operative day. Her post-operative radiograph is seen in Figure 7 and Figure 8.

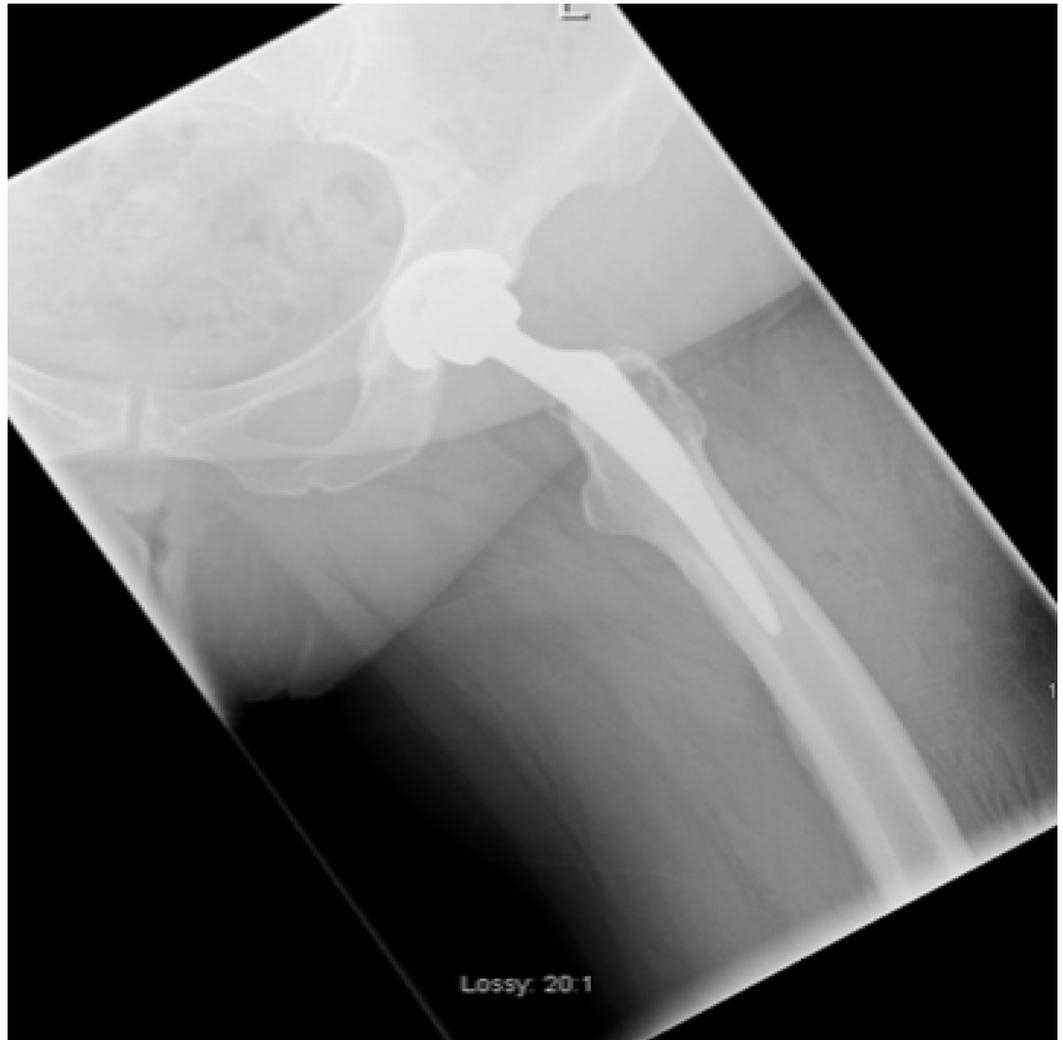
FIGURE 8: Post-operative lateral radiograph of her left hip post head and liner exchange with concentric placement of the femoral head in the acetabular cup
