Article

Numerical and Experimental Verification of a Multiple-Variable Spatiotemporal Regression Model for Grout Defect Identification in a Precast Structure

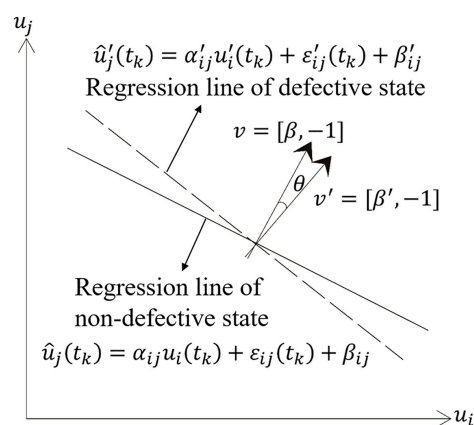
Figure 1. Geometric significance of the damage indicator θ in a single-variable regression (SVR) model.

where $v = [\beta, -1]$ is the normal vector of the regression line of the non-defective state and $v' = [\beta', -1]$ is the normal vector of the regression line of the defective state. Figure 1 shows the geometric significance of θ in the SVR model.

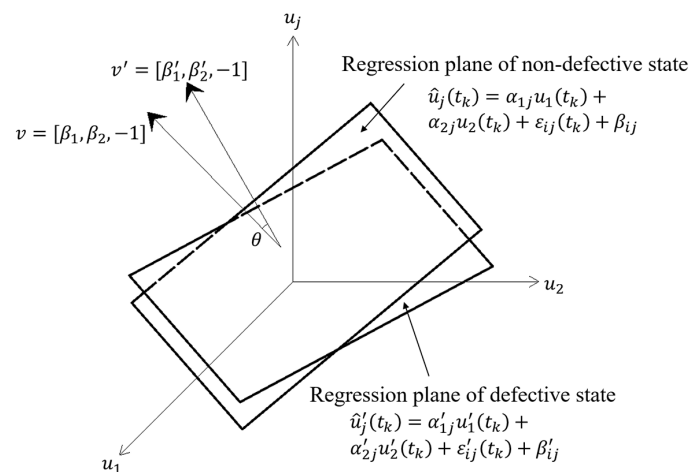
Figure 2. Geometric significance of the damage indicator θ in a two-variable spatial regression (TVSR) model.

where $v = [\beta_1, \beta_2, -1]$ and $v' = [\beta_1', \beta_2', -1]$. Figures 2 and 3 show the geometric significance of θ in the TVSR and TVSTR models, respectively.

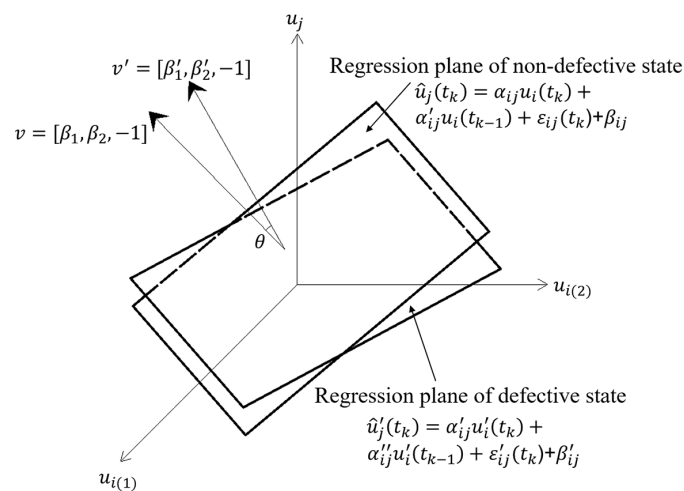
Figure 3. Geometric significance of the damage indicator θ in a two-variable spatiotemporal regression (TVSTR) model.

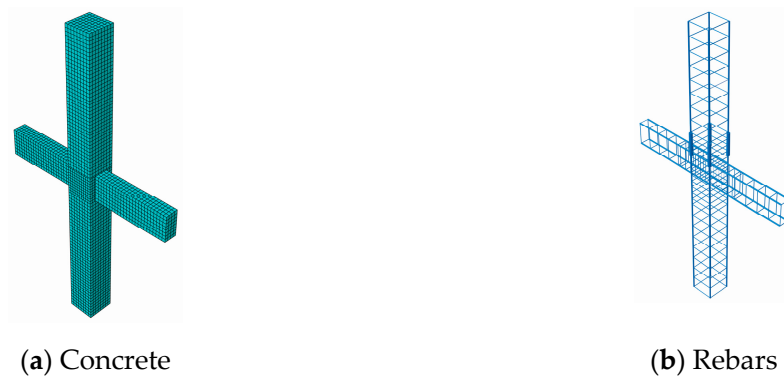
Figure 4 shows the concrete and rebars of a precast beam–column joint model. The joint consisted of a precast column with a cross-section of 400 mm × 400 mm and a height of 4500 mm, and a precast beam with a cross-section of 200 mm × 400 mm and a length of 2800 mm. The concrete compressive strength was 30 MPa, and the tensile strength of the longitudinal reinforcement and stirrup was 400 MPa. Based on the sensitivity study of mesh convergence, an optimal FE mesh that could provide a relatively accurate solution within an acceptable computation time was determined, where the element size of the beam and column was 50 mm, and the element size of the connection was 40 mm.

Figure 4. Concrete and rebars of a precast beam–column joint model.

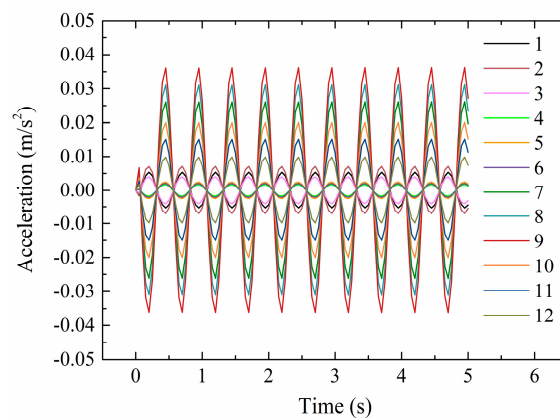
Taking case 1 as an example, the acceleration responses of the 12 nodes are shown in Figure 6 with different maximum amplitudes.

**Figure 6.** Acceleration response of case 1 in the beam–column connection.

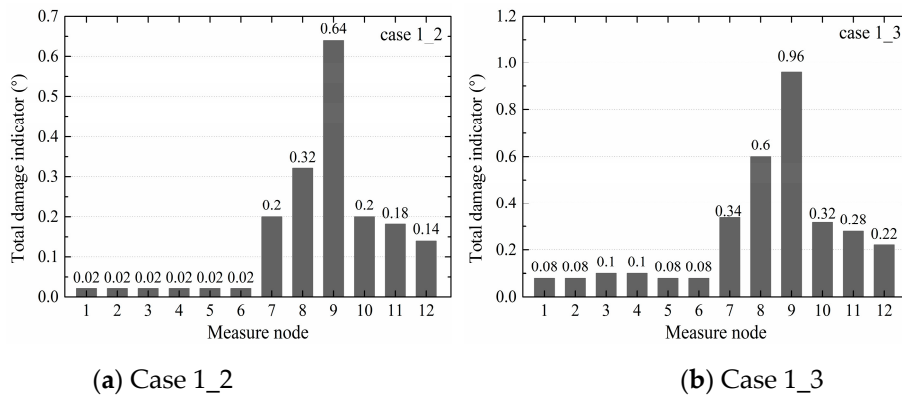
Figure 7. Total damage indicators of cases 1_2 and 1_3 from the SVR models.

When comparing the total damage indicators of cases 1_2 and 1_3 from the three models, as shown in Figure 7, Figure 8, and Figure 9, it was noticed that the values of nodes 7–9 in Figure 7b were larger than in Figure 7a, those in Figure 8b were larger than in Figure 8a, and those in Figure 9b were larger than in Figure 9a, indicating that the total damage indicator became larger with the increase of the degree of defects. Furthermore, from all three models, the differences between nodes 7–10 and other nodes in case 1_3 were greater than in case 1_2, showing that the SVR, TVSR, and TVSTR algorithms could more accurately identify components with defects as the degree of defects increased.

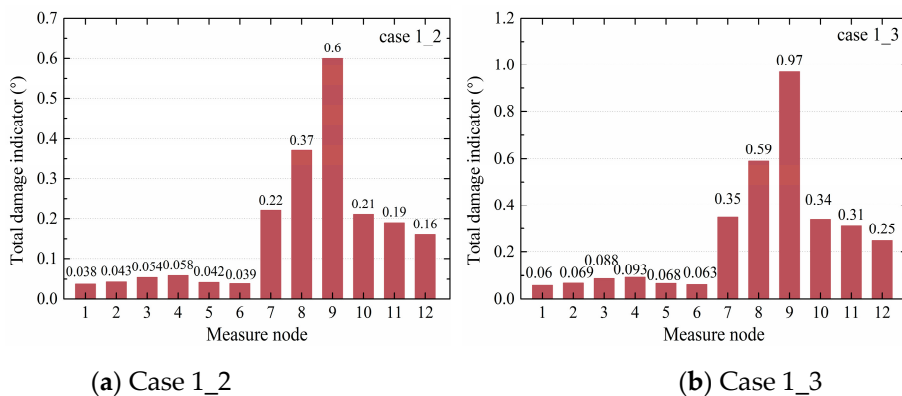
Figure 9. Total damage indicators of cases 1_2 and 1_3 from the TVSTR models.

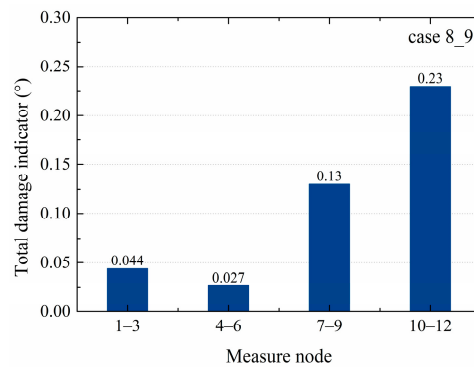
Figure 10. Total damage indicator of case 8_9 from the TVSR model.

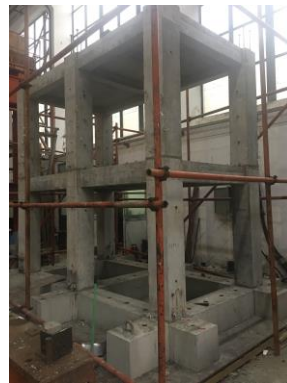
A half-scaled, two-floor, precast concrete frame structure with a column space of 1500 mm was constructed, as shown in Figure 13. The structure consisted of precast columns, precast beams, precast foundation beams, cast-in-place slabs, and slurry layers, where all rebars in precast columns were spliced using grout sleeves, as shown in Figure 14. The concrete compressive strength was 30 MPa and the tensile strength of the longitudinal reinforcement and stirrup was 400 MPa.

Figure 13. Precast concrete frame structure.

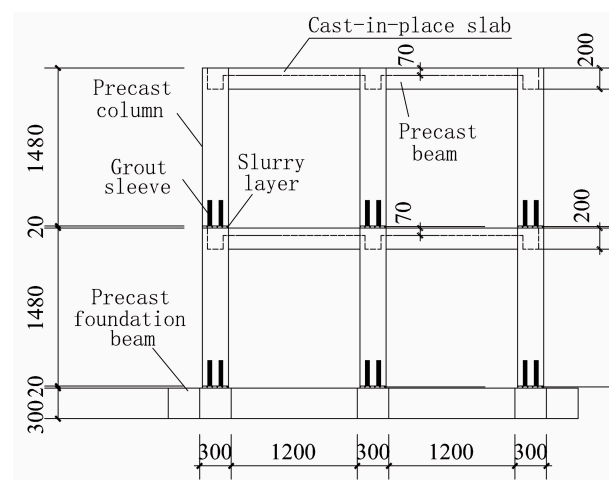
Figure 14. Elevation of the precast concrete frame structure (unit: mm).

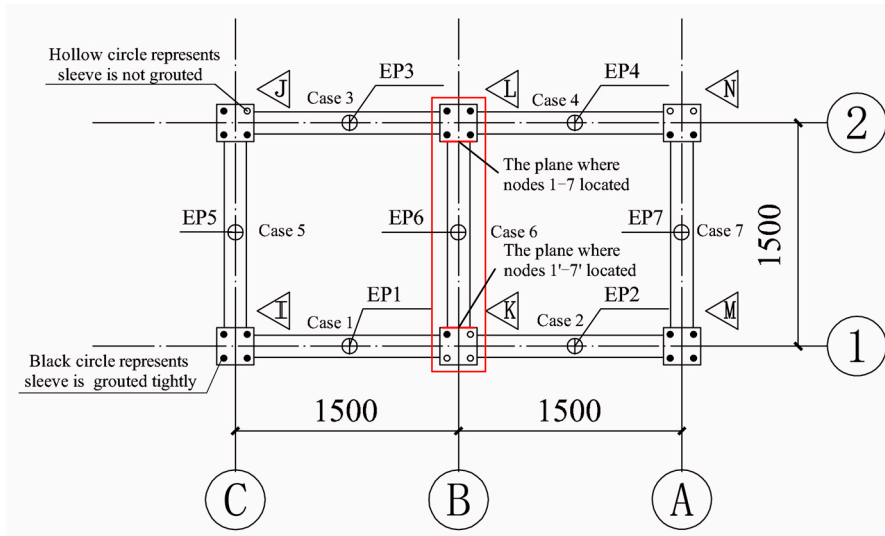
For structural safety, the sleeve grout defects were designed to be in the second floor. There were seven cases, as shown in Figure 15. For the convenience of construction, a sleeve with a grout defect was designed without grouting. A hollow circle in a column indicates the sleeve was not grouted completely, and a black circle indicates that it was grouted tightly. It should be noted that in each case, one column was defective and the other was non-defective. To ensure the two columns received the same excitation in each case, the excitation point (EP) was in the middle of the beam, hence there were seven EPs, where EP_i indicates an EP in case i . For each case, the locations of the measure nodes were the same. Taking case 6 as an example, the measure nodes arranged along the column and beam are shown in Figures 15 and 16, respectively. There were seven nodes in each column, where nodes 1–3 and 1'–3' were located at the beam end, and nodes 4–7 and 4'–7' were located along the column.

Figure 15. Defects and excitation point (EP) layout of the second floor.

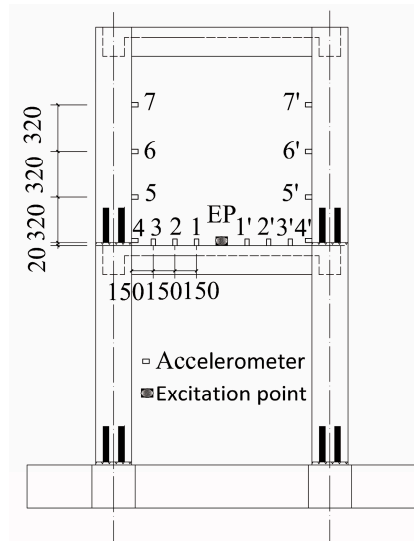
Figure 16. Locations of accelerometers and excitation point in case 6.

1. The accelerometers were arranged near the sleeve defects on the columns and beam, whose locations are shown in Figures 16 and 17.
2. The vibration exciter was arranged at the excitation point in the middle of the beam, whose location is shown in Figure 17. At the same time, the annunciator, power amplifier, and acquisition system were arranged as well.
3. Once the external force was applied, the acceleration time history curves of each measuring point were recorded by the acquisition system.
4. Using the proposed multiple-variable regression model, the damage indicators were calculated based on the acceleration responses to identify the defects.

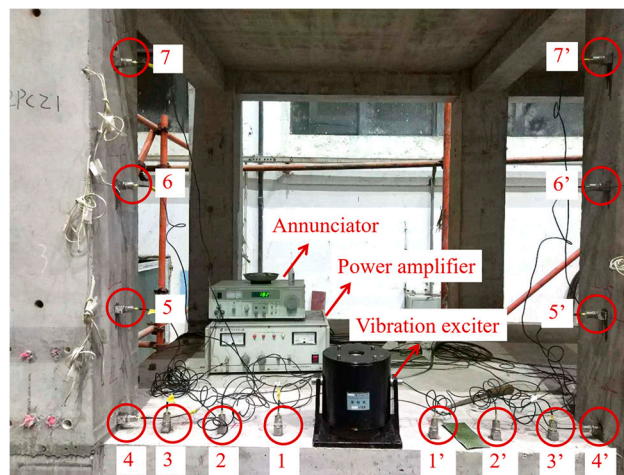
Figure 17 shows the arrangement of the experimental equipment and Table 9 shows the instrument parameters. The acceleration sensors collected the node data, and external excitation was applied using the vibration exciter, signal source, and power amplifier, which were produced by Yangzhou Kedong Electronics Co. LTD in Yangzhuo, China. At the same time, a data acquisition system was used to collect the acceleration responses, which was produced by China Orient Institute of Noise & Vibration in Beijing, China. The excitation force was 200 N and the acquisition frequency was 1024 Hz.

Figure 17. Arrangement of the experimental equipment.

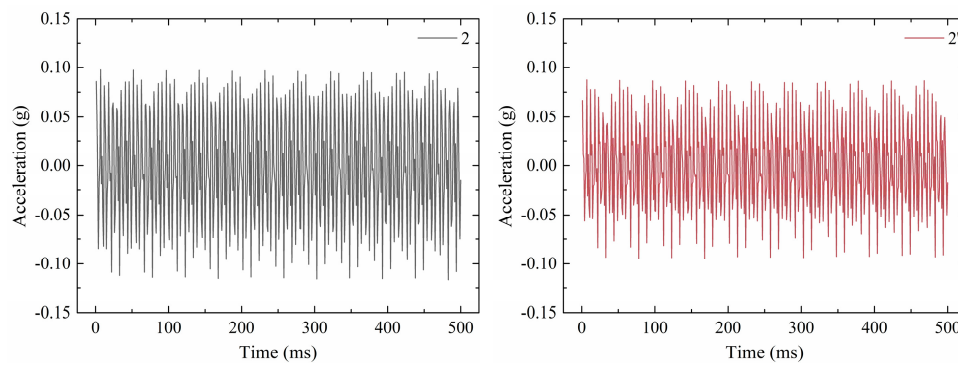
The acceleration responses of all measuring points in cases 1–7 were similar. Taking nodes 2 and 2' of case 3 as an example, Figure 18 shows representative portions of the acceleration responses. In the macro view, the responses of nodes 2 and 2' were different, showing that the grout sleeve defects influenced the structural acceleration responses.

(a) Acceleration response of node 2

(b) Acceleration response of node 2'
