Case Report

Dissociation of Bipolar Hemiarthroplasty of the Hip and Review of Literature

Department of Orthopaedics, Patras University Hospital, Patras, Greece

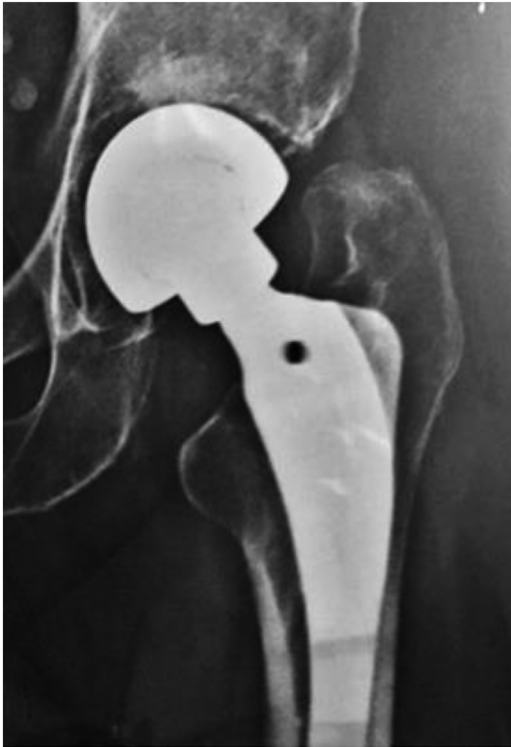
Figure 1. Patient's initial postoperative anteroposterior radiograph of a left hip bipolar hemiarthroplasty.

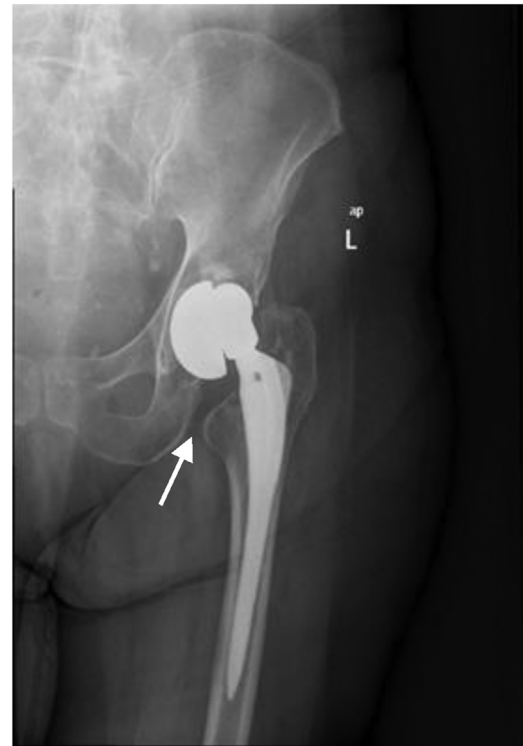
Figure 2. Anteroposterior radiograph demonstrating a dissociation of a left hip bipolar hemiarthroplasty. The outer head is in extreme varus position (arrow)—osteoarthritic changes of the acetabulum.

the outer head was still in the acetabulum. Varus position of the outer head and osteoarthritic changes of the acetabulum were identified (Fig. 2). No closed reduction maneuver was attempted and the patient was admitted to the orthopaedic ward. The erythrocyte sedimentation rate and C-reactive protein levels were normal. Four days later, the patient underwent a conversion of the bipolar hemiarthroplasty to total hip arthroplasty under spinal anesthesia. The patient was placed in the lateral decubitus position, the skin was incised over the previous scar, and a posterior approach to the left hip was used. Dislocation between the inner head and the polyethylene was observed, while the locking ring was dislodged but still attached to the inner head, with an excessive amount of wear (Fig. 3a-c). The prosthetic acetabular component was found to be intact, with no signs of wear, and still located inside the native acetabulum. We did not observe any findings of trunnionosis at the time of revision. The stem was well fixed and left in place, while the inner head, the polyethylene ring, and the outer head were removed. An uncemented, hemispherical, multiple-hole, acetabular component with 52 mm diameter was placed (Zimmer Biomet, Warsaw, Indiana) along with a polyethylene-bearing surface and a skirted metallic femoral head (12/14, 32 mm, XXL) (Fig. 4). Intraoperative cultures were negative. Although we had a medial acetabular wall breach complication due to over-reaming, the cup was well fixed and no additional screws were used. However, we decided to limit weight-bearing for 6 weeks until cup ingrowth could be achieved. There were no postoperative complications, and the patient was discharged 4 days after the operation. At 1-month follow-up, no complications were observed, partial weight-bearing was obtained using crutches, and the radiograph showed ongoing integration of the acetabular component (Fig. 5). The patient was encouraged to gradually return to full weight-bearing after 6 weeks. She was able to walk without any restrictions after 3 months. Finally, at 12-month follow-up, the

Our case is a type II dissociation of a bipolar hemiarthroplasty due to polyethylene wear and locking ring failure that occurred 10 years after initial intervention. Osteoarthritic changes of the acetabulum lead to a varus position of the outer head, causing impingement on the femoral stem neck and wear on the polyethylene ring. Intraoperatively, the polyethylene locking ring was found detached from the insert and with significant wear, causing the bipolar shell to separate from the polyethylene insert. This was a category II locking mechanism failure, according to Hasegawa et al. No attempt for closed reduction was performed, and the patient underwent conversion to total hip arthroplasty.

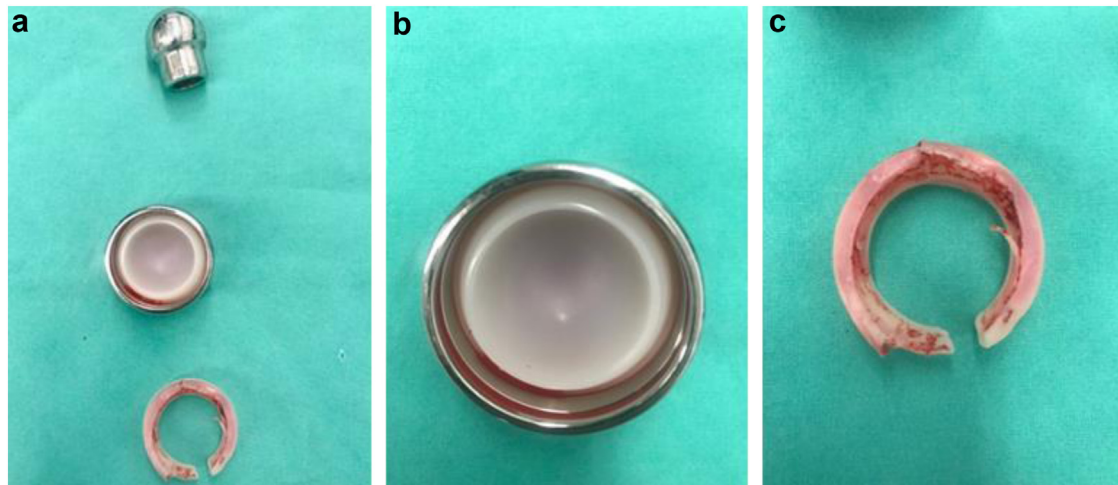
Figure 3. Retrieved bipolar component and femoral head (a). No macroscopic wear was found at the articulating surface of the polyethylene insert (b). Excessive wear was found at the slots and groove of the polyethylene that contributed to the locking mechanism (c).

The second type of dissociation arises when the polyethylene liner of the prosthesis wears out. Fixed varus position of the outer head of the prosthesis can cause damage to the locking mechanism, resulting in component separation between the polyethylene and the inner head. Osteophyte growth and granular proliferation around the osteoarthritic acetabulum, as well as acetabular cartilage loss, are related with varus position of the outer head. By causing impingement on the femoral stem neck and inducing dislodgment of the inner locking ring, these variables may exacerbate wear on the beveled rim of the bearing insert [15]. The use of a skirted femoral head component with a decreased head-to-neck diameter ratio may compromise the prosthetic range of motion,

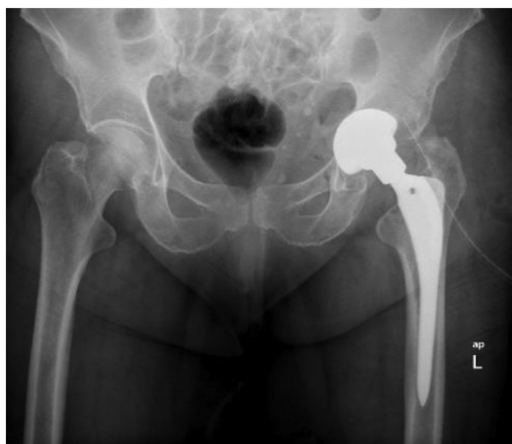
Figure 4. Postoperative anteroposterior radiograph after conversion of the bipolar hemiarthroplasty to total hip arthroplasty.

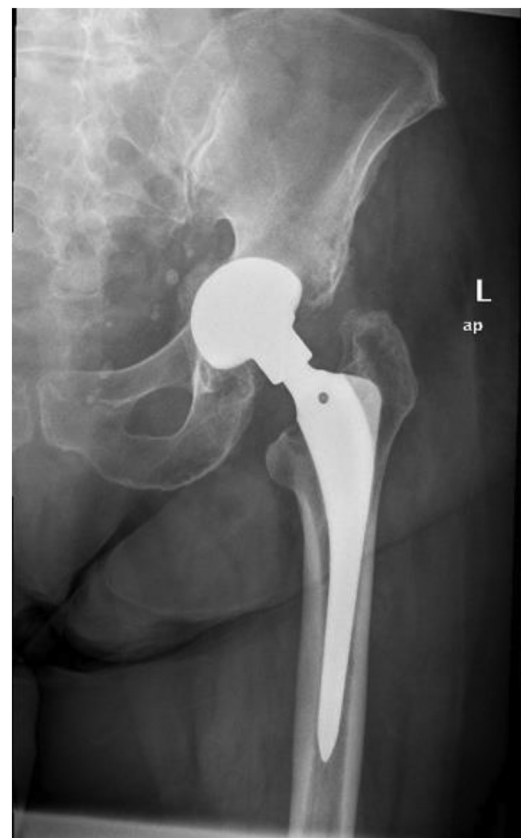
Figure 5. Anteroposterior radiograph of the left hip at 1-month follow-up after conversion to a total hip arthroplasty.
