## Case Report

# Dislodged Bonded Molar Tube into Wound during Orthognathic Surgery

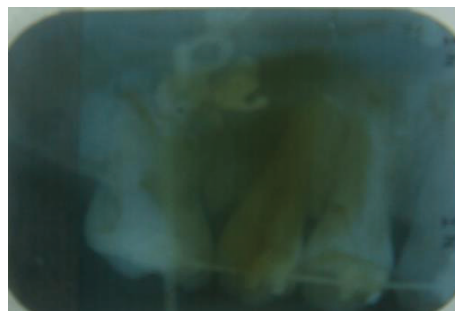
FIGURE 1: Periapical radiograph with gutta-percha (GP) in situ which had been inserted through the sinus. The GP pointing towards the area of plate and screws with the dislodged molar tube in its vicinity.

On examination, there was no extraoral swelling noted. The mandible and maxilla seemed firm indicating good healing following previous mandibular sagittal split and maxillary Le Fort I osteotomy sites and a stable class I dental occlusion. Intraorally, there was a sinus with slight pus discharge on the upper right buccal sulcus region adjacent to the upper right first premolar. All teeth in that quadrant were firm and vital. Tenderness was elicited upon palpation on the upper right vestibular region. We suspected the sinus track may originate from the dislodged appliance embedded in the cheek soft tissue. A periapical view was then taken with gutta-percha inserted into the sinus for foreign body localization purpose. The radiograph revealed the gutta-percha pointed towards the site of titanium plate and screws placed used for rigid fixation, and with the molar orthodontic tube appliance in its vicinity (Figure 1). A cone beam CT was performed to provide a 3D detailed location of the appliance (Figures 2(a) and 2(b)) and confirmed it to be located outside the maxillary antrum.

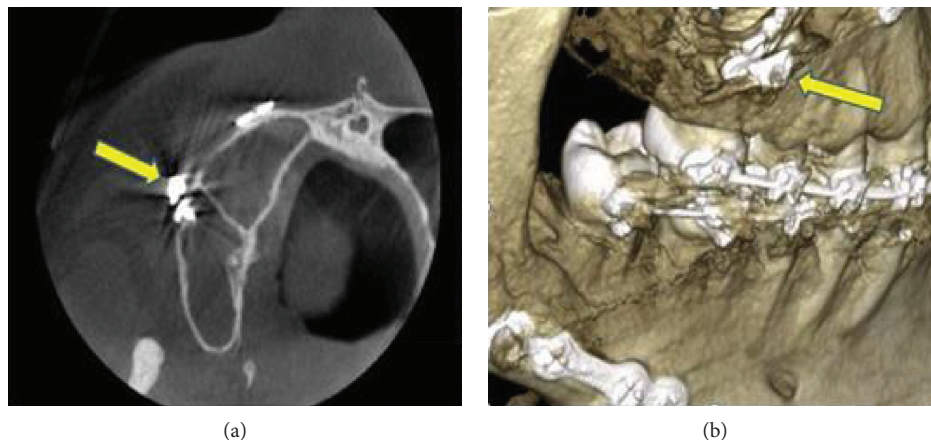
FIGURE 2: Cone Beam CT images showing the dislodged molar tube lying outside the right maxillary antrum, as indicated by the arrow in axial view (a), while its position in relation to the rigid plate and screws on the zygomatic buttress can be seen clearly in 3-D image (b).

Preexploration localization X-ray of the molar tube demonstrated that it is positioned close to the titanium bone plates and screws which were used for rigid fixation of the Le Fort I osteotomy site. This interesting situation recalled the manufacturer's advice on cautions against mixed metals in vivo [14]. Both the titanium implants and the molar tubes, each with its own corrosion potential, can react together and produce currents, if they are in contact together in an electrochemically conductive fluid such as body fluid. In turn, this can lead to accelerated corrosion of both metals, leaching metal ions into the surrounding area, and stimulate an inflammatory or hypersensitivity response, thus producing symptoms of recurrent pain and swelling at the operated site. Macro movements of the jaw and micromotion of titanium implants and dislodged molar tube may accelerate the corrosion process. This process may have been delayed in this case due to the routine intermaxillary fixation done for six weeks following the orthognathic operation with the aim of achieving adequate bony healing at the osteotomy site to achieve a stable occlusion. The patient continued on soft diet feeding for one month following release of the intermaxillary fixation which further explains the delay in producing the symptoms of inflammation and hypersensitivity secondary to the foreign body.

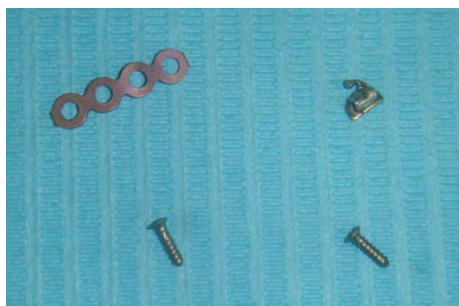
FIGURE 3: Titanium plate and screws and the stainless steel molar tube removed in the surgery.

The presence of the molar orthodontic tube foreign body reaction was suspected as the most probable cause of the recurrent right cheek pain and swelling associated with an intraoral discharging sinus. Exploration of the site was performed through the sulcular incision under general anesthesia. The dislodged molar tube was identified lying on the zygomatic bone just beneath the raised flap. It was removed by dividing some surrounding fibrous tissue strands. Just below it, one titanium straight bone plate with four screws used for fixing the previous Le Fort I osteotomy site was inspected and found to be rigidly embedded in normal bone. However, a decision was made to remove them based on the fact that they are present in an infected area. (Figure 3). The Le Fort I osteotomy site showed good healing with new bone formation. Patient had an uneventful recovery thereafter, and the orthognathic surgical team who attended him previously was informed of his progress.

Most orthodontic metal appliances such as brackets and tubes are generally made of stainless steel. They contain a mixture of iron, chromium, nickel, and a small amount of molybdenum together with small traces of other metals [13]. Despite having molybdenum in its alloy, the molar tube may still undergo corrosion and induce an inflammatory response or foreign body reaction. This is evidenced in this case by the need to divide the fibrous tissue surrounding the tube during its removal.
