# Mode I and II Wear in Ceramic on Ceramic Total Hip Arthroplasty: A Case Report

**Case Report:** This case describes a 68-year-old Caucasian male who underwent revision of ceramic on ceramic THA due to pain, with intraoperative analysis revealing evidence of gross Mode I acetabular ceramic component wear with a resultant Mode II wear articulation between the ceramic femoral head and acetabular liner.

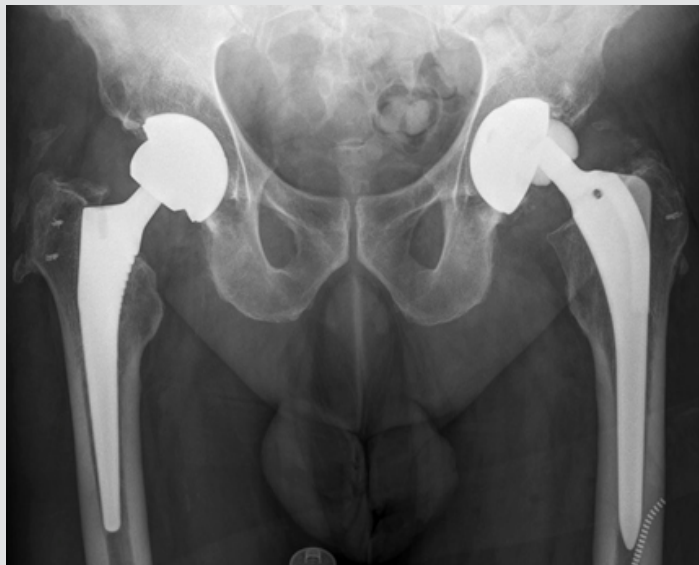
**Figure 1:** Pre-operative AP plain pelvic radiograph showing superior migration of femoral head of primary left total hip arthroplasty.

Plain radiographic evaluation revealed superolateral subluxation of the ceramic femoral head in relation to the ceramic acetabular component with no associated periprosthetic fracture or dislocation (Fig. 1). Serological evaluation revealed normal infectious markers, consistent with clinical assessment showing no evidence of infection. Further imaging using computerized tomography revealed

Outside of implant factors, a number of surgical and patient factors have been shown to precipitate an accelerated wear process in THA involving MoP articulations [6, 10]. Extrapolation of these factors to this patient's CoC THA may offer other potential explanations behind the encountered wear. Surgical factors such as cup inclination, cup lateralization, femoral head size, and combined component version have all been suggested to affect the rate of wear in THA [10], with the appropriate component alignment of particular relevance in preventing complications in CoC articulations [6]. Indeed, the steep abduction angle of this patient's left acetabular component on the index AP radiograph (Fig. 1) is likely

particular relevance in the subsequent failure of this prosthesis. This, in addition to the other factors outlined above, may have caused excessive superolateral acetabular component loading and accelerated the wear process that precipitated this patient's symptoms. In addition, the patient's relatively young age and high activity levels at the time of his index THA may have predisposed him to increase the likelihood of wear, with physical demands suggested to be a significant factor in wear rate [10].

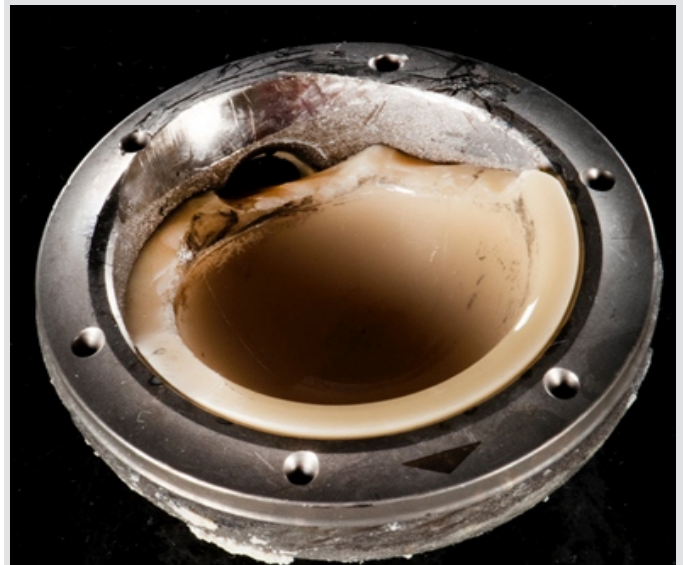
**Figure 2:** Clinical photograph showing wear of superolateral aspect of ceramic acetabular component.

Evaluation of the acetabular component was, however, more significant, revealing evidence of gross wear of the superior ceramic acetabular liner, with a resultant Mode II wear articulation of the ceramic head with the underlying titanium acetabular shell (Fig. 2). There was no evidence of associated ceramic component particulate debris or fracture as had been suspected preoperatively.

The native acetabular liner and shell were thus removed and revised to a titanium alloy externally-coated acetabular shell and

corresponding fourth-generation alumina-ceramic composite liner. The native femoral stem was left in situ as it was well fixed, with the ceramic femoral head being replaced by a corresponding fourth-generation ceramic head. The post-operative radiograph is illustrated in Fig. 3.

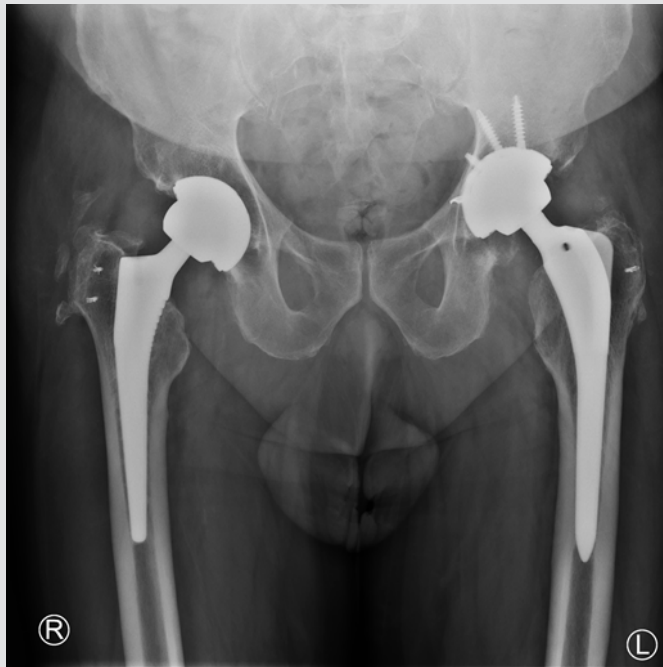
**Figure 3:** Post-operative AP plain pelvic radiograph showing revision of acetabular shell, ceramic acetabular liner, and ceramic femoral head.
