# Extensive dystrophic calcification of eroded artificial urinary sphincter cuff—a rare cause of urethral obstruction: a case report

Kevin C. Lewis, Scott D. Lundy, Kenneth Angermeier

Cleveland Clinic Foundation, Glickman Urologic and Kidney Institute, Cleveland, OH, USA

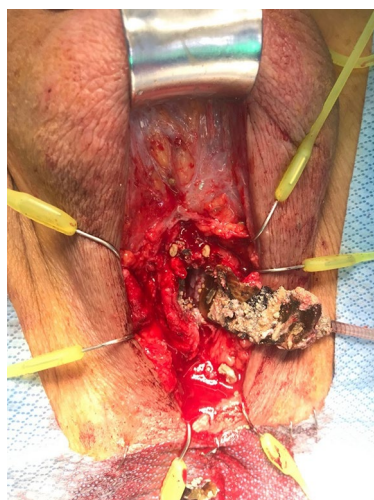
**Figure 1** A perineal dissection has been carried down to the urethra. The bulbospongiosus muscle is retracted laterally with yellow hooks. The urethra has been mobilized and a vertical urethrotomy performed to extract the calcified and eroded AUS cuff. AUS, artificial urinary sphincter

A perineal incision was carried down to the palpable stone. A vertical urethrotomy was performed and the cuff, along with the surrounding stone, was removed. The remainder of the device components were removed and the urethrotomy was closed primarily in two layers. A #20 French urethral catheter was placed and maintained for ten days postoperatively. Due to this patient's heavily trabeculated bladder and detrusor instability, a repeat AUS was felt to have a low probability of long-term success. Eight months later, he underwent augmentation cystoplasty and formation of catheterizable appendicovesicostomy with ligation of the bladder neck.

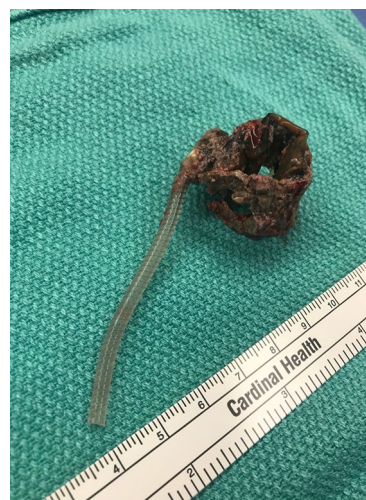
**Figure 2** Explanted AUS cuff with extensive dystrophic calcification. AUS, artificial urinary sphincter

Chronic erosion causes urine to be in constant contact with the cuff and can result in calcification. Calcification around the cuff can become so extensive, it can result in urethral obstruction, as demonstrated by these patients. Reports of calcification of an eroded AUS device are rare, and most commonly occur in the urethra. However, this is not exclusive to the urethra, as one report describes erosion of the reservoir into the bladder in a patient who had undergone prior pelvic radiotherapy (2).
