Polyethylene Fractures in Mobile-Bearing Total Ankle Arthroplasty: Report of 2 Cases

Foot & Ankle Orthopaedics
2022, Vol. 7(1) 1–6
© The Author(s) 2022
DOI: 10.1177/24730114211069134
journals.sagepub.com/home/fao

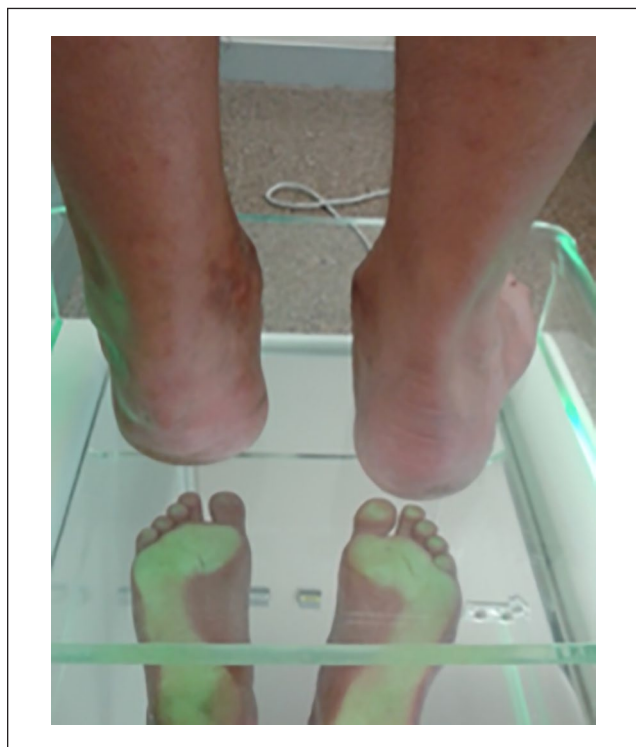
One year after surgery, the patient developed a continuous pain in the medial ankle. The clinical examination revealed a slight varus in the hindfoot (Figure 1), although the radiographic appearance was correct (Figure 2) and no misalignment of the implants was observed. Given the persistence of pain despite conservative treatment, we decided

Figure 1. Clinical appearance after left total ankle arthroplasty in case 1.

In our aforementioned case 1, a slight varus tilt of the hindfoot was seen after the arthroplasty, which may have contributed to polyethylene fracture.

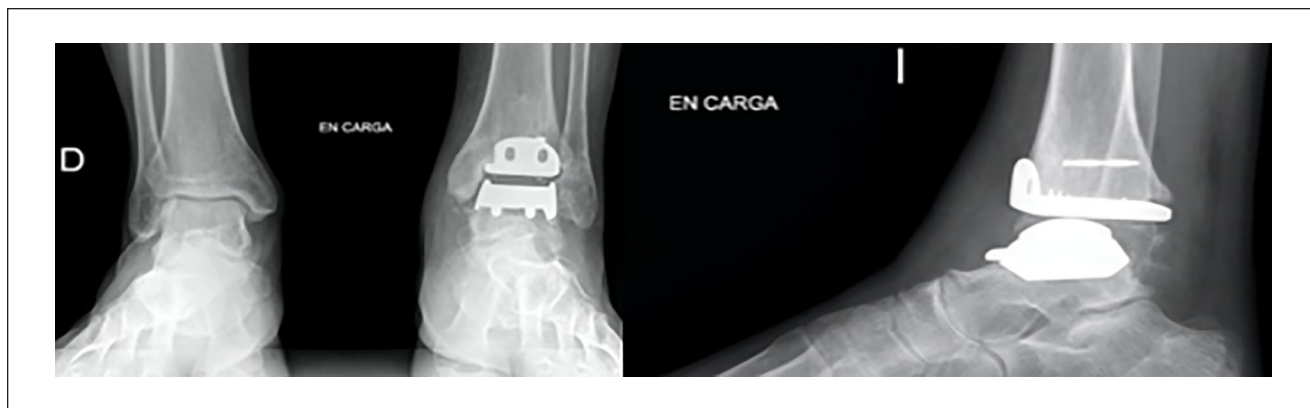
Figure 2. Case 1. Anteroposterior and lateral loading radiographs.

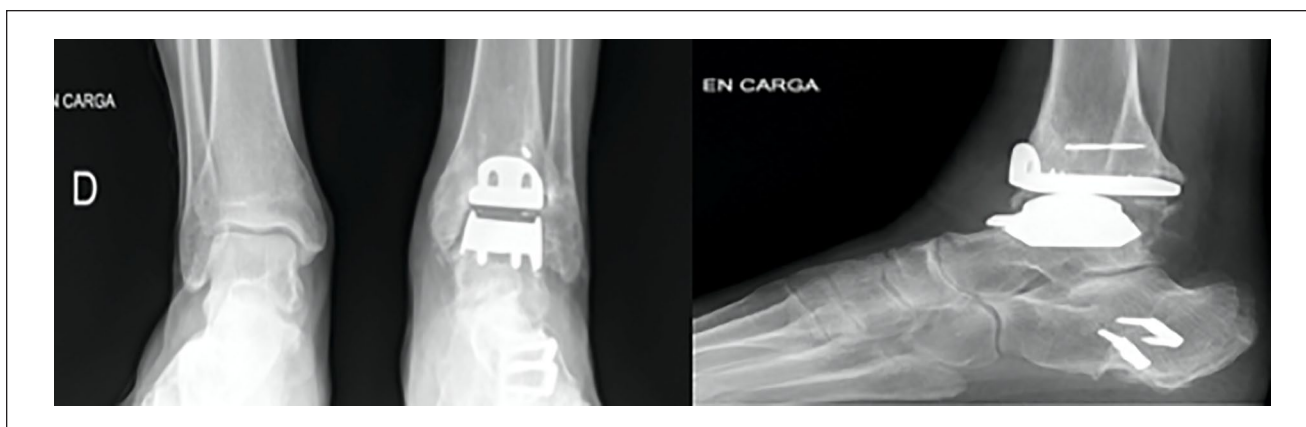
Figure 3. Case 1. Radiographic appearance after Dwyer osteotomy in anteroposterior and lateral views.

to perform a percutaneous Achilles lengthening and a Dwyer osteotomy of the calcaneus in order to get some hindfoot valgus (Figure 3). The patient had an unremarkable postoperative course, the pain disappeared, and the ankle and foot alignment improved. Seven years later, he reported a recurrence of the symptoms in the medial side of the ankle and, consequently, in 2018 we decided to perform an arthroscopic debridement leading to the improvement of the symptoms, and where the polyethylene was seen as normal and without attrition.

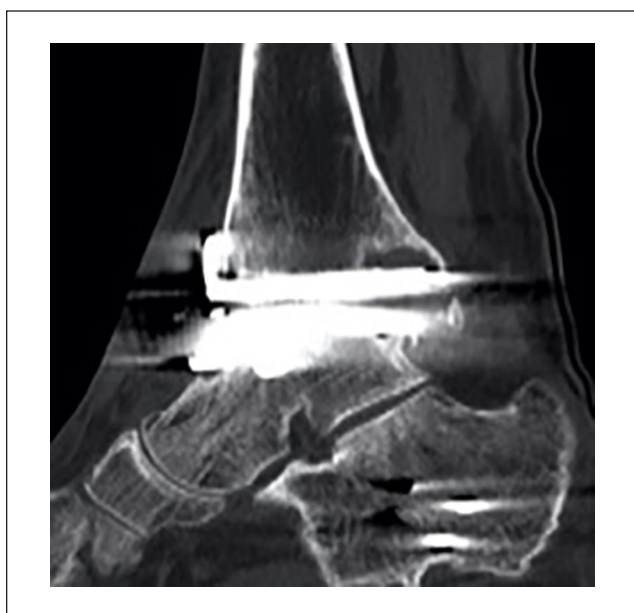
In 2019, 8 years after the arthroplasty, the patient reported severe pain in the anterior part of the ankle, associated with some neuropathic pain in the area of the superficial peroneal nerve. This pain appeared suddenly, without previous trauma, and without having performed any type of unusual activity. During the physical examination, no significant findings were revealed with the exception of pain, because the gait was not affected. We could not detect any pathology in conventional radiographic studies; therefore, a computed tomographic (CT) scan was performed. In the CT scan, a rupture of the insert was suspected by observing an anterior

displacement of its metallic marker, and a direct contact between the metallic surfaces of the tibial and talar components (Figure 4).

Figure 4. Computed tomographic scan where the anterior displacement of the polyethylene's metallic marker and the contact between the tibial and talar components can be seen in case 1.

The initial diagnosis of polyethylene fracture is not easy but it can be predicted if the displacement of the metallic marker is appreciated in simple radiographs. The diagnosis can be confirmed by CT scan, where we can see 2 key images: a displacement of the metallic marker and a close contact between the tibial and talar components (Figure 4). In fact, Dahabreh et al⁵ present a case of another TAA model with mobile-bearing polyethylene, the Ankle Evolution System (Biomet Merck), where a displacement of the posterior metallic mark of the polyethylene insert is observed, in an arthroplasty that presents some varus misalignment.

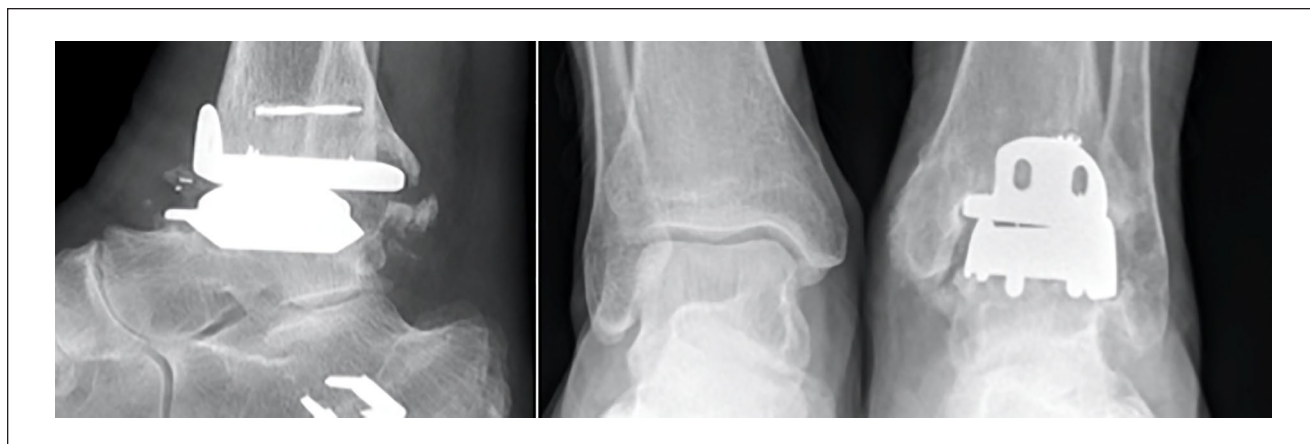
One month after the CT scan, in a radiographic study, the anterior displacement of the polyethylene's metal marker and a varus tilt of the ankle joint were clearly appreciated (Figure 5). A revision surgery was performed and a polyethylene fracture was seen in a coronal plane (Figure 6A). The polyethylene was replaced by another

Figure 5. Lateral radiograph where the anterior displacement of the polyethylene's metallic marker can be seen and anteroposterior radiograph where we can see an ankle joint varus tilt.

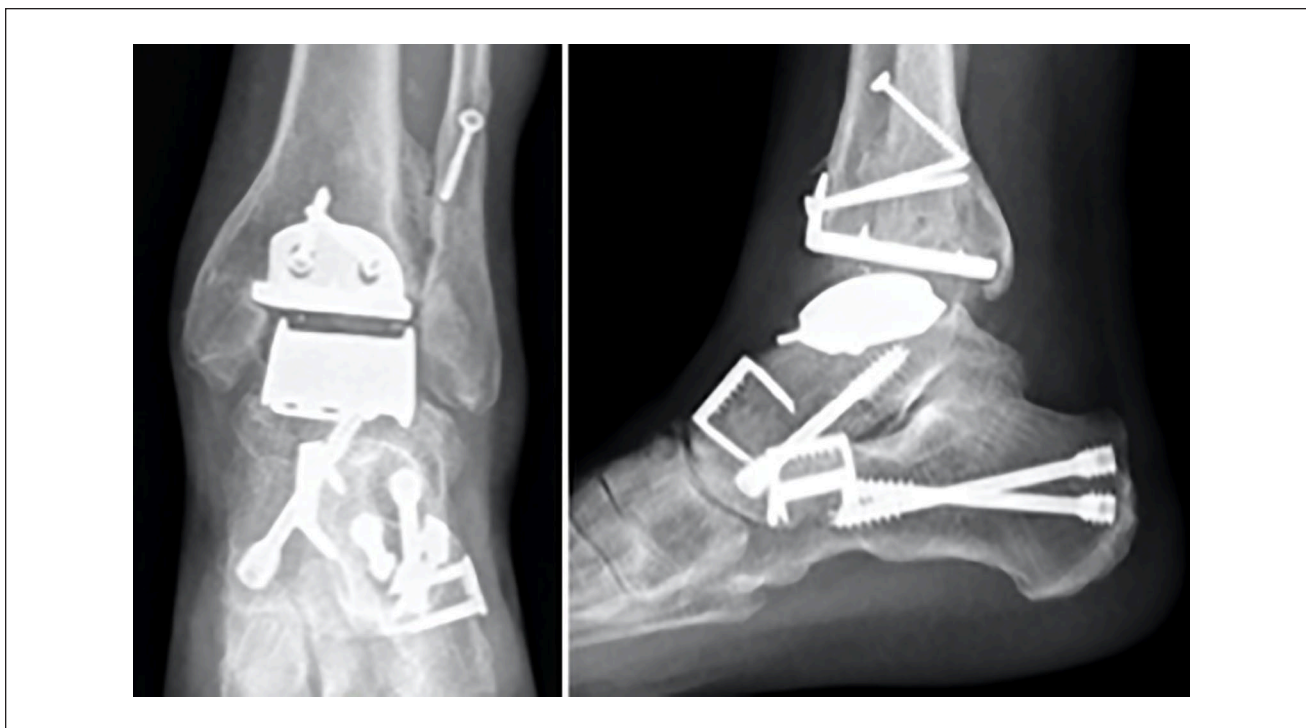
In 2019, 8 years after surgery, the patient reported an acute pain in the anterior and lateral sides of the ankle, associated with some neurologic symptoms in the area of the superficial peroneal nerve, without previous trauma. The radiographic study was normal (Figure 7). Therefore, a CT scan was performed, but no significant findings were observed in the subtalar joint (Figure 8). A sympathetic dystrophy was suspected, and we decided to continue with observation and periodic control by a pain specialized team.

Figure 7. Case 2. Anteroposterior and lateral radiographs when pain started. It can be seen how the polyethylene metallic marker is not displaced.
