## Case Report

# Fixation of a Periprosthetic Intertrochanteric Hip Fracture below a Birmingham Hip Resurfacing

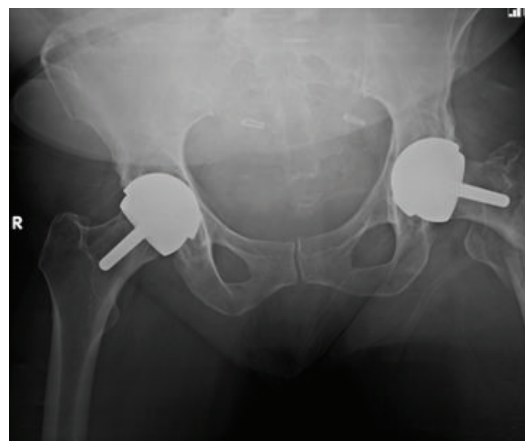
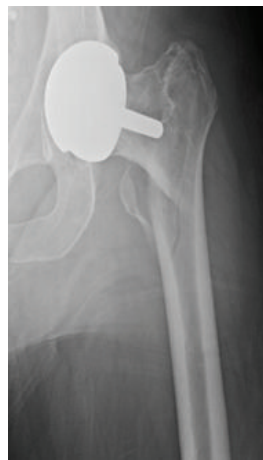
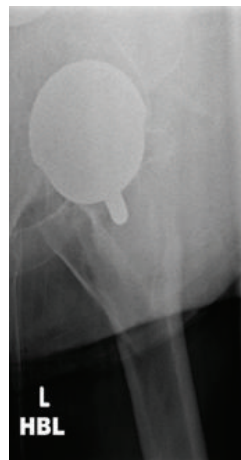
FIGURE 2: (a) and (b), AP views. (c) Lateral view.

A 56-year-old lady presented to hospital after a fall onto her left hand side, after which she was unable to weight bear. On examination her leg was shortened, externally rotated, and neurovascularly intact. There was a history of previous bilateral Birmingham hip resurfacing (Smith & Nephew) with the left side five years prior to admission and the right side one year before. Other past medical history included, osteoarthritis affecting hands, hips, knees and spine, as well as hypertension and diet controlled type 2 DM. There had also been a recent history of increased alcohol consumption. A pelvic X-ray taken in 2007 demonstrated significant bilateral hip osteoarthritis. Figure 1 shows a radiograph from 2009 after her right hip resurfacing and prior to surgery on the left. Figure 2 demonstrates the injury sustained in early December 2012.

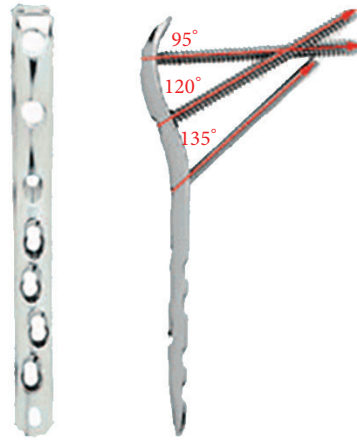
FIGURE 3: LCP locking plate.

On discussion with the patient and reviewing what equipment was available locally it was decided that using a LCP proximal femoral locking plate (Synthes) would provide the needed fixation without interfering with the current prosthesis. See Figure 3.

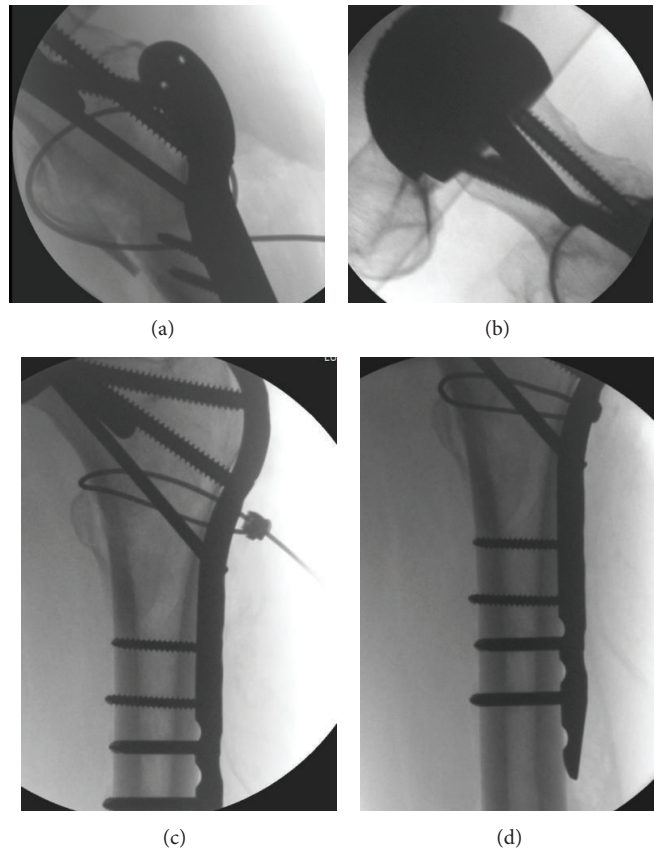
FIGURE 4: (a)–(d) Showing intraoperative screening.

Operative procedure: Mrs X was positioned on the traction table and closed reduction was achieved. Through a lateral approach a LCP proximal femoral plate was placed. A combination of locking and nonlocking screws was used with two passing posterior and one passing anterior to the stem of the Birmingham hip resurfacing prosthesis. Finally, a cerclage wire reduced and held the lesser trochanter fragment. Figure 4 shows the intraoperative screening images.

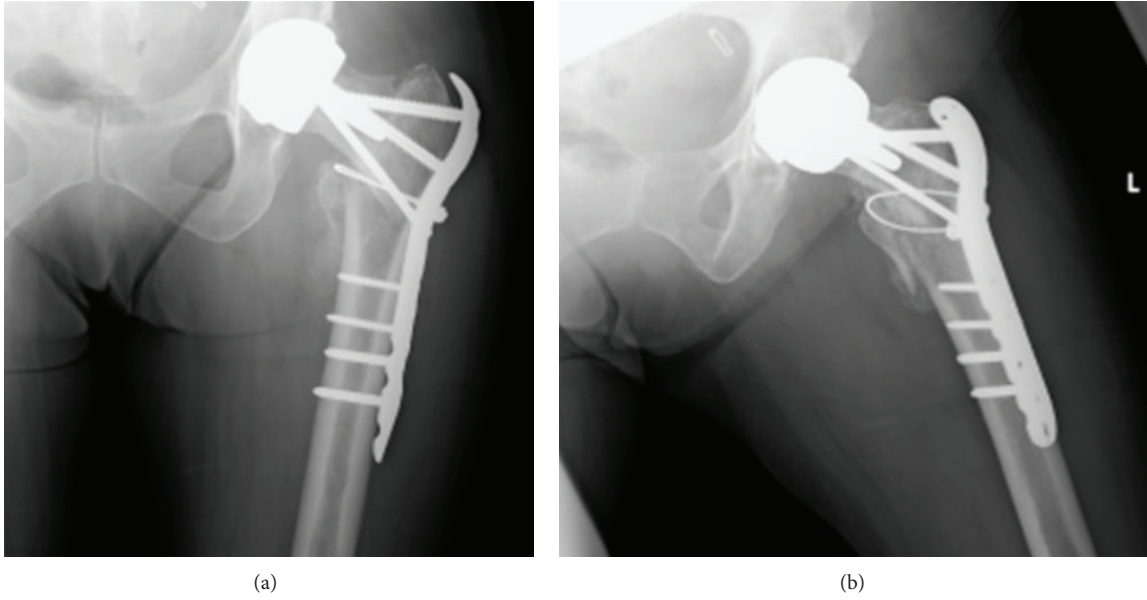
FIGURE 5: (a)-(b) Images taken at 6-week postoperation review.

Mrs. X was reviewed six weeks post-operatively and it was noted that her fracture had collapsed slightly and the hip had slipped into a more varus position (see Figure 5). At this stage light partial weight bearing was continued and a review was arranged for a further six weeks.

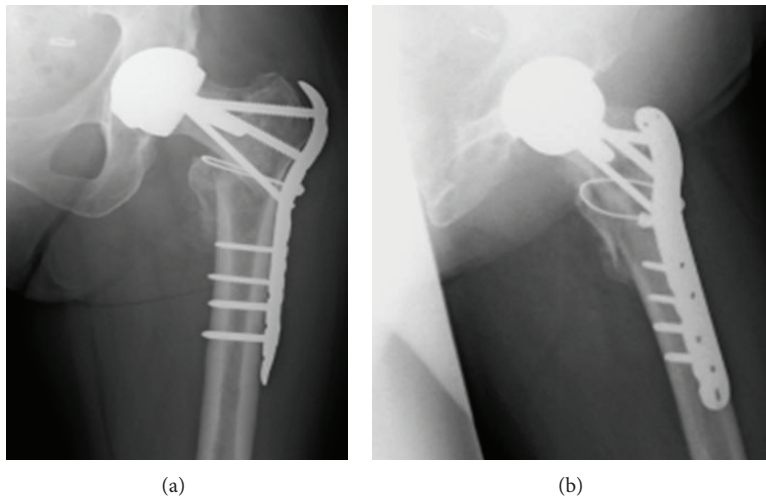
FIGURE 6: (a)-(b) Radiographs from 12 weeks after operation.

At 12 weeks post-operatively, it was noted that there was good callus formation at the fracture site and that the fracture appeared to have stabilised, with no evidence of metalwork failure (see Figure 6). Mrs X was advised to wean herself off crutches and was referred for physiotherapy.

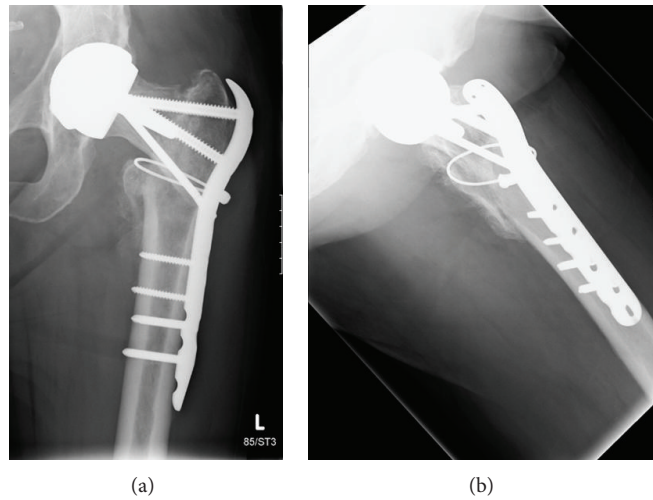
FIGURE 7: Showing an AP and a lateral view 4 months from surgery.

At a further review 4 months post-operatively, X-rays demonstrated ongoing healing; however there continued to be a small area in the superior neck which was not fully consolidated (see Figure 7). Mrs X was fully weight bearing and allowed to return to aquarobics.

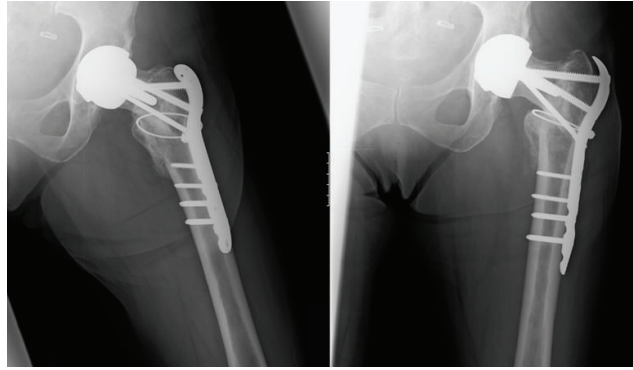
FIGURE 8: AP views, 8 months from surgery.

At a review eight months from surgery it was noted that whilst the fracture had slipped into varus soon after surgery, subsequent comparison X-rays showed there was no further slip with good callus formation (see Figure 8). Mrs X was able to walk with no pain and used a stick for stability. She complained of some tenderness over the lateral wound with the metal work underlying. At this stage it was thought there was good fixation and stability.

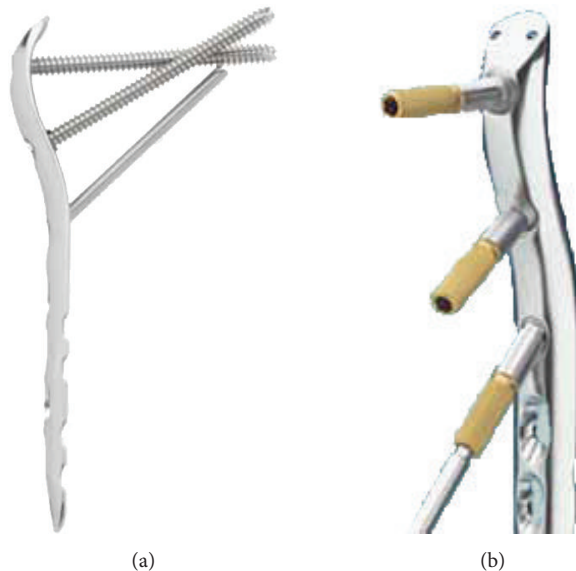
FIGURE 9: Positions of the screw holes with drill guides.

The main concern with using the internal fixation device was the placement of the screws and the stem of the current hip prosthesis. A decision was made to utilise a Synthes LCP proximal femoral plate [8]. This plate was selected to allow anatomical reduction and fixation with screws at angles that would not disrupt the pre-existing prosthesis. The plate design makes it possible to pass the screws both anterior and posterior to the stem, with the first and third screws passing posterior and the second screw passing anterior (Figure 9).
