# Mechanical Failure of SIGMA Total Condylar-III Revision Total Knee System Modular Femoral Component Due to Bolt Screw Breakage – Our Experience in Overcoming Broken Component Incarceration

**Case Report:** We present a rare case of modular femoral component mechanical failure in a 69-year-old male, manifesting as left knee instability and acute pain while walking 4 years following revision of total knee replacement due to infection. Radiographs revealed mechanical failure of the Sigma Total Condylar-III Revision prosthesis bolt, with intra-operative extraction efforts complicated by a lodged broken bolt. Despite initial challenges, successful extraction was achieved using mosquito forceps and a universal nail extractor.

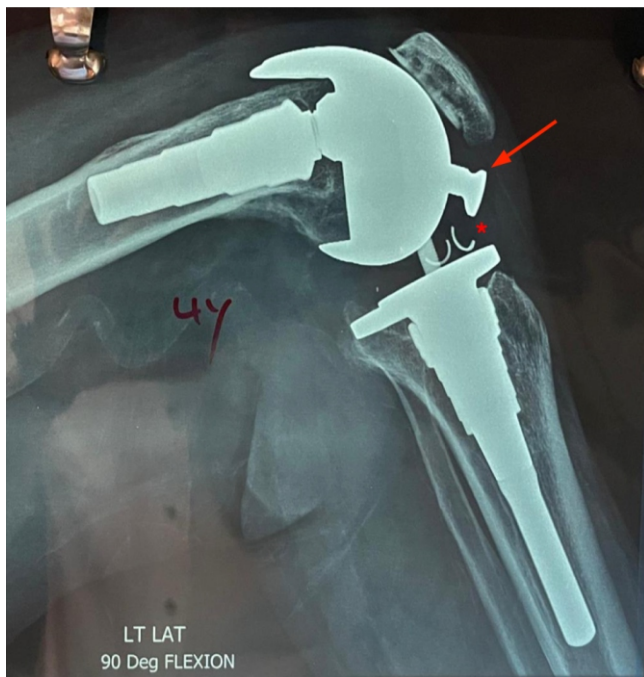
**Figure 1:** Preoperative radiographs showing prominent bolt head extrusion from the femoral component (arrow) and 2 semicircular rings floating in the knee joint (asterix).

Radiographs showed a bolt head extruding from the femoral component and two semicircular radio-opaque structures in the knee joint, suggesting a mechanical failure of the SIGMA® TC3 Revision Knee System Femoral Component's bolt (Fig. 1). A diagnosis of mechanical implant failure was made after a thorough work-up to rule out an infection or any periprosthetic fracture and subsequently the patient was scheduled for implant removal and revision arthroplasty.

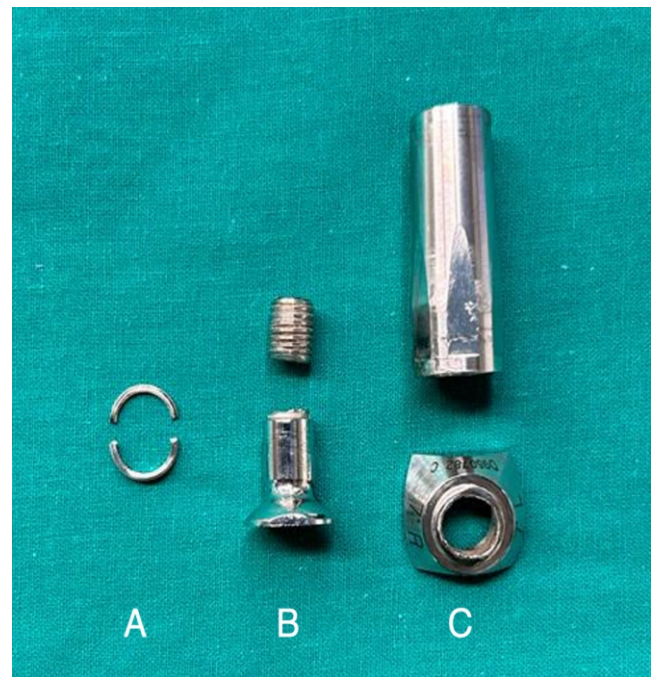
**Figure 2:** Intraoperative picture showing (a) 2 semicircular sleeve threads (b) broken bolt and (c) broken adapter.

Intraoperatively, thickened black synovium suggesting metallosis was noted. The joint fluid appeared normal further ruling out an active infection. The tibial base plate was well fixed to the bone. The broken bolt and adapter at the femoral component-sleeve junction were visualized. Two semicircular screw threads from the adapter were seen floating in the joint space.

The broken bolt head and the adapter end engaging it were readily extracted along with the two semicircular sleeve threads. The remaining part of the broken bolt was incarcerated to the remaining part of the broken adapter and attempts to remove it with bone nibblers or by drilling proved to be futile. Finally, the broken part was removed using mosquito forceps – slowly rotating the broken bolt out of the sleeve threads of the adapter (Fig. 2). The distal portion of the broken femoral

The TC3 Revision Total Knee System (DePuy, Warsaw) is one of the most used revision implants worldwide. The femoral component in the TC3 is connected to the femoral sleeve or stem through a femoral adapter and corresponding femoral adapter locking bolt. In this paper, we present a case of mechanical failure of the femoral component of this system with breakage of both the femoral adapter and the locking bolt, both of which proved difficult to extract.

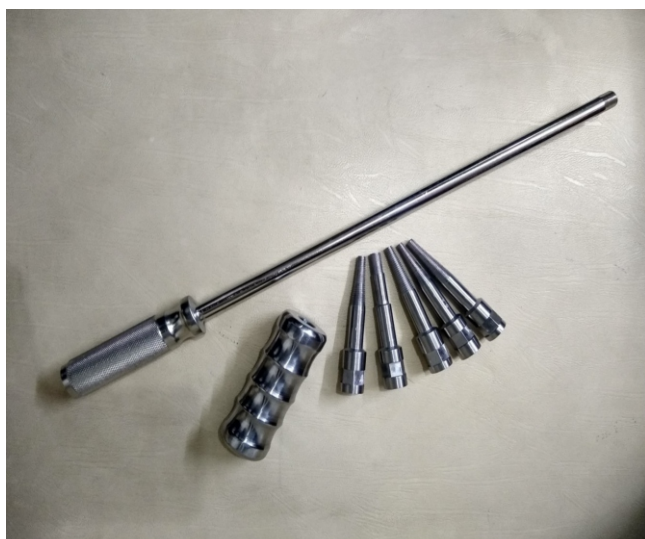
**Figure 3:** Universal nail extractor.

adapter was rigidly fixed to the femoral sleeve and all attempts to remove it using the dedicated implant extraction instruments failed. The universal nail extractor unexpectedly proved to be the key to successful extraction. It was carefully introduced into the femoral canal, and with gentle yet firm back-hammering, the adapter was successfully extracted (Fig. 3).

In this report, we describe our experience in removing incarcerated broken components during the extraction of broken bolts and adapters. The universal nail extractor serves as a great tool for difficult implant removal and should be kept on standby for all revision cases.

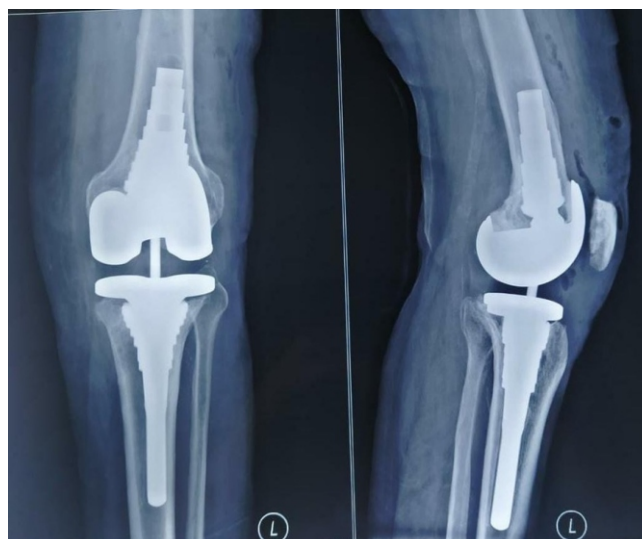
Post-surgery the patient was mobilized with full weight bearing from the next day and a range of motion (ROM) of 0–120° was achieved. Post-operative radiographs showed good alignment of the implants (Fig. 4).

**Figure 4:** Post-operative radiograph showing well-aligned revision total knee replacement implants.

The tibial base plate and femoral sleeve were well fixed to the bone and thus were retained. The femoral component was fixed to the femoral sleeve with a new bolt and adapter. The insert was changed.
