## Case report

## Adverse Soft-Tissue Reaction After Ceramic-On-Ceramic Bearing Fracture Mimicking a Periprosthetic Joint Infection

Ruben Tresgallo-Parés, MD<sup>a</sup>, Norberto J. Torres-Lugo, MD<sup>a,\*</sup>,  
Edwin Rosado-Hernández, MD<sup>a</sup>, Gerardo Olivella, MD, MPH<sup>a</sup>, Norman Ramírez, MD<sup>b</sup>,  
Antonio Otero-López, MD<sup>a</sup>

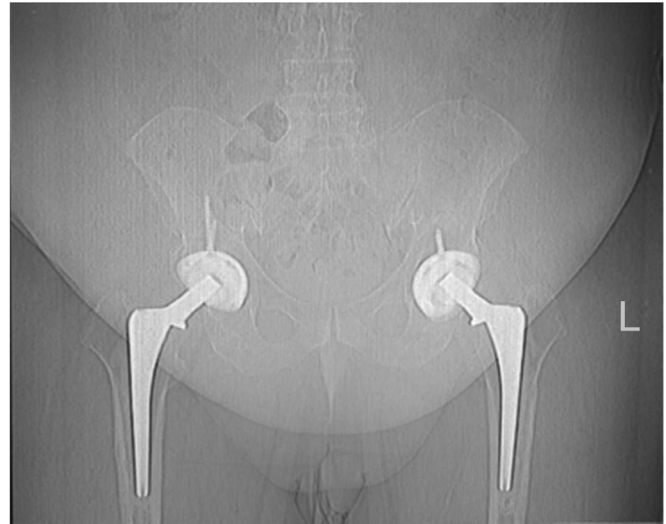
**Figure 1.** Anteroposterior pelvis radiograph showing eccentric femoral head component and osteolysis around bone screws.

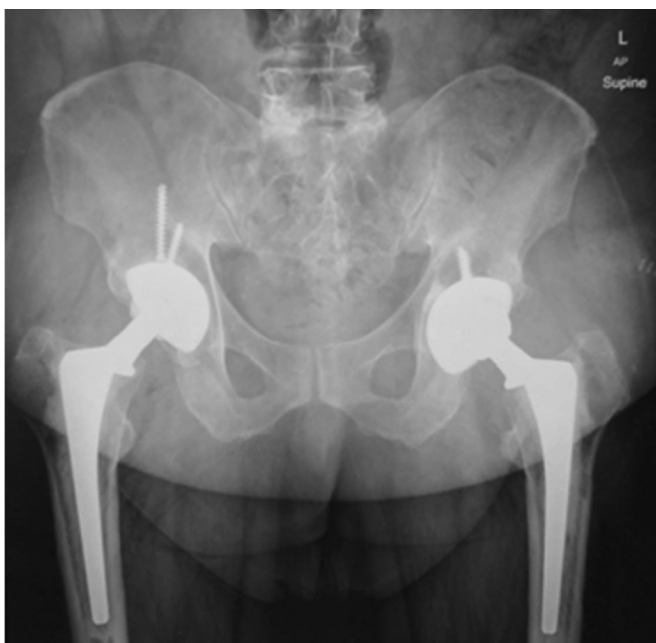
The patient showed complete resolution of the initial symptoms and felt well at the first follow-up visit (Fig. 5). He was ambulating without assistance and tolerating full weight-bearing. Fever, chills, malaise, or any other symptom suggestive of an ongoing infectious process were denied. After 2 years of scheduled follow-up, the patient remained completely functional and without any complication.

**Figure 5.** Two-week postoperative pelvis anteroposterior radiograph.
