Two- and Three-Dimensional Echocardiography in the Evaluation of the Paravalvular Regurgitation of the Mitral Valve Annuloplasty Ring

J Teh Univ Heart Ctr 2018;13(4):191-192

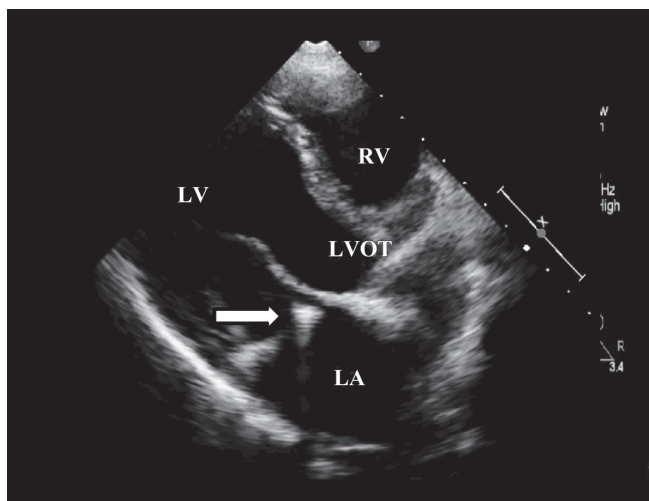
Figure 1. Parasternal long-axis view of the echocardiogram, showing gross dehiscence in the mitral ring (arrow).

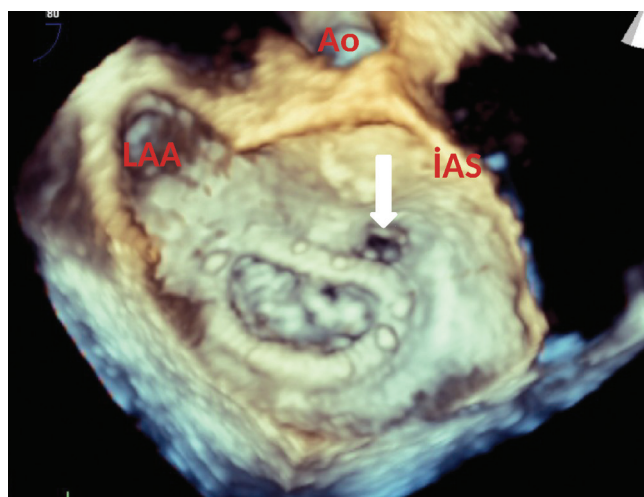
Figure 4. Three-dimensional transesophageal echocardiography, showing the anterior mitral annulus para-ring hole in the anteromedial segment (arrow).

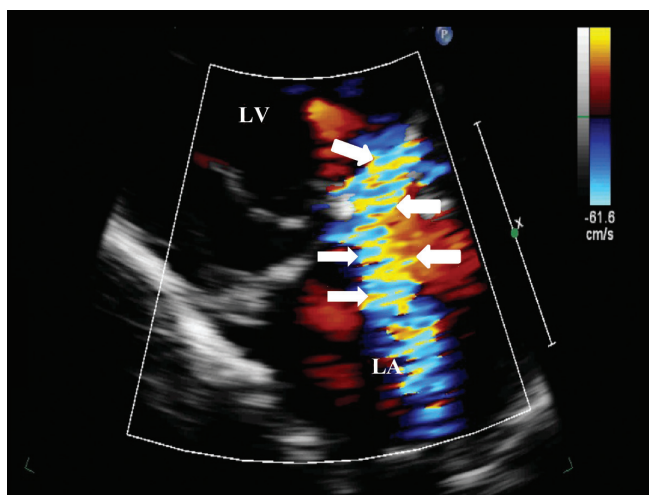
Figure 2. Trans thoracic echocardiography view of the centrally directed mitral regurgitation jet by color Doppler (arrows).

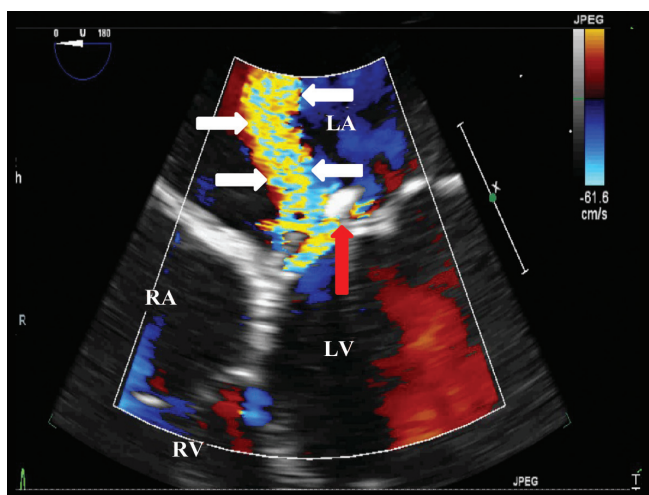
Figure 3. Transesophageal echocardiogram (4-chamber view), showing severe mitral regurgitation (white arrows) and another jet slightly toward the posterior wall of the left atrium (red arrow).
