Femoral prosthesis fracture after hip arthroplasty revision

A Case Report and Review of Literature

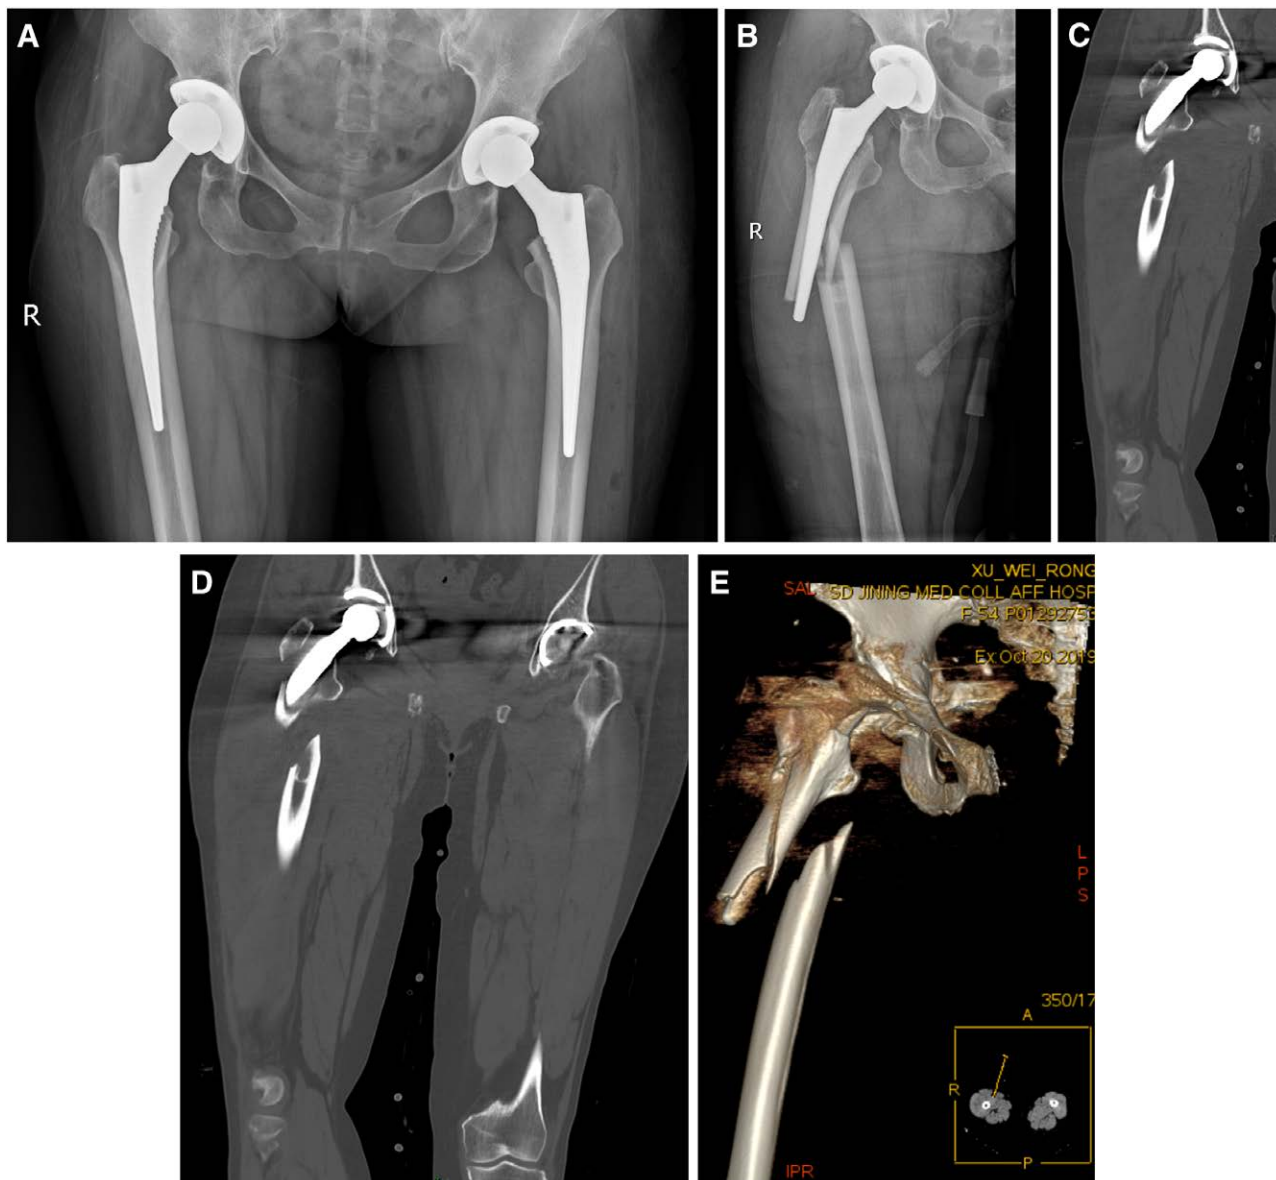
Figure 1. Imaging examination after bilateral THA and trauma. A: Radiography after bilateral THA; B: Radiography of the superior part of the right femur; C, D: Computed tomography (CT) scan of the right upper femur fracture after bilateral THA; E: 3 D CT reconstruction of the femoral fracture after right THA.

was performed in our hospital more than 3 years ago, and right hip arthroplasty was done more than 2 years ago. She underwent revision of the hip joint prosthesis (right) and steel wire internal fixation of the femoral fracture in our hospital because of a car accident (Figs. 1, 2A–C). She has a history of blood transfusion, cephalosporin allergies, and mussel food allergies.

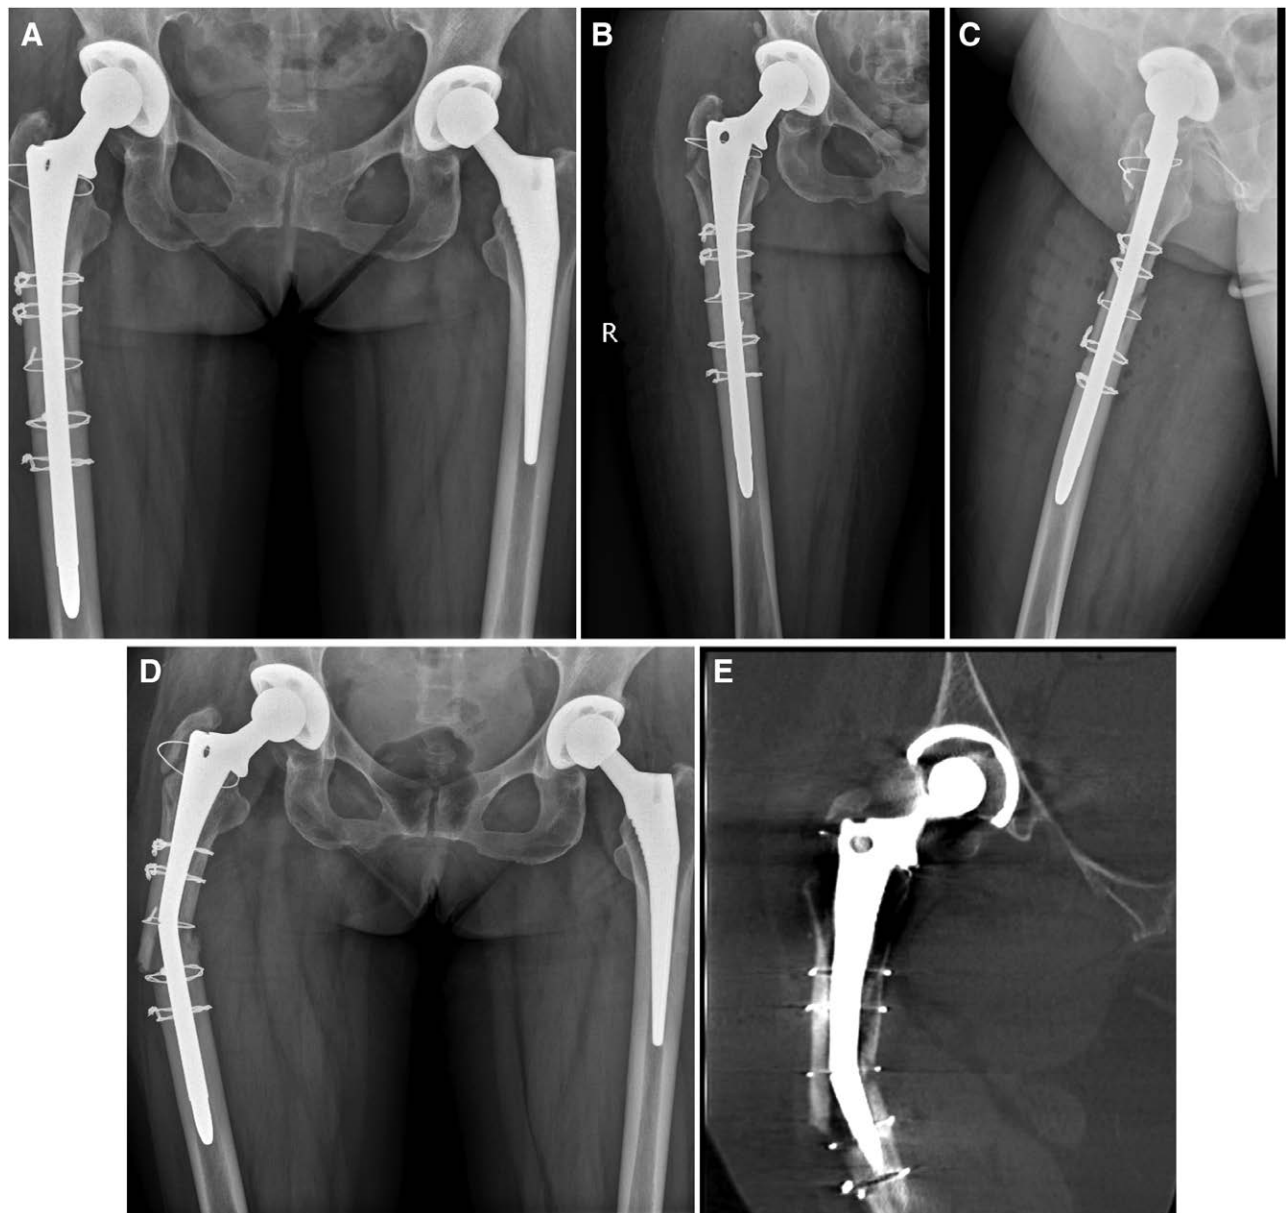
Radiographic examination revealed a fracture of the right upper femur and a fracture of the artificial joint—changes after bilateral hip arthroplasty (Fig. 2D, E).

Figure 2. Radiographic analysis after the first revision of hip joint and entering the hospital this time. A–C: Orthostatic radiography of both hips after the revision of the right hip joint; anterior lateral radiography of the right hip; D, E: Orthostatic radiography and CT of the right upper femur fracture after the revision of the right hip joint.

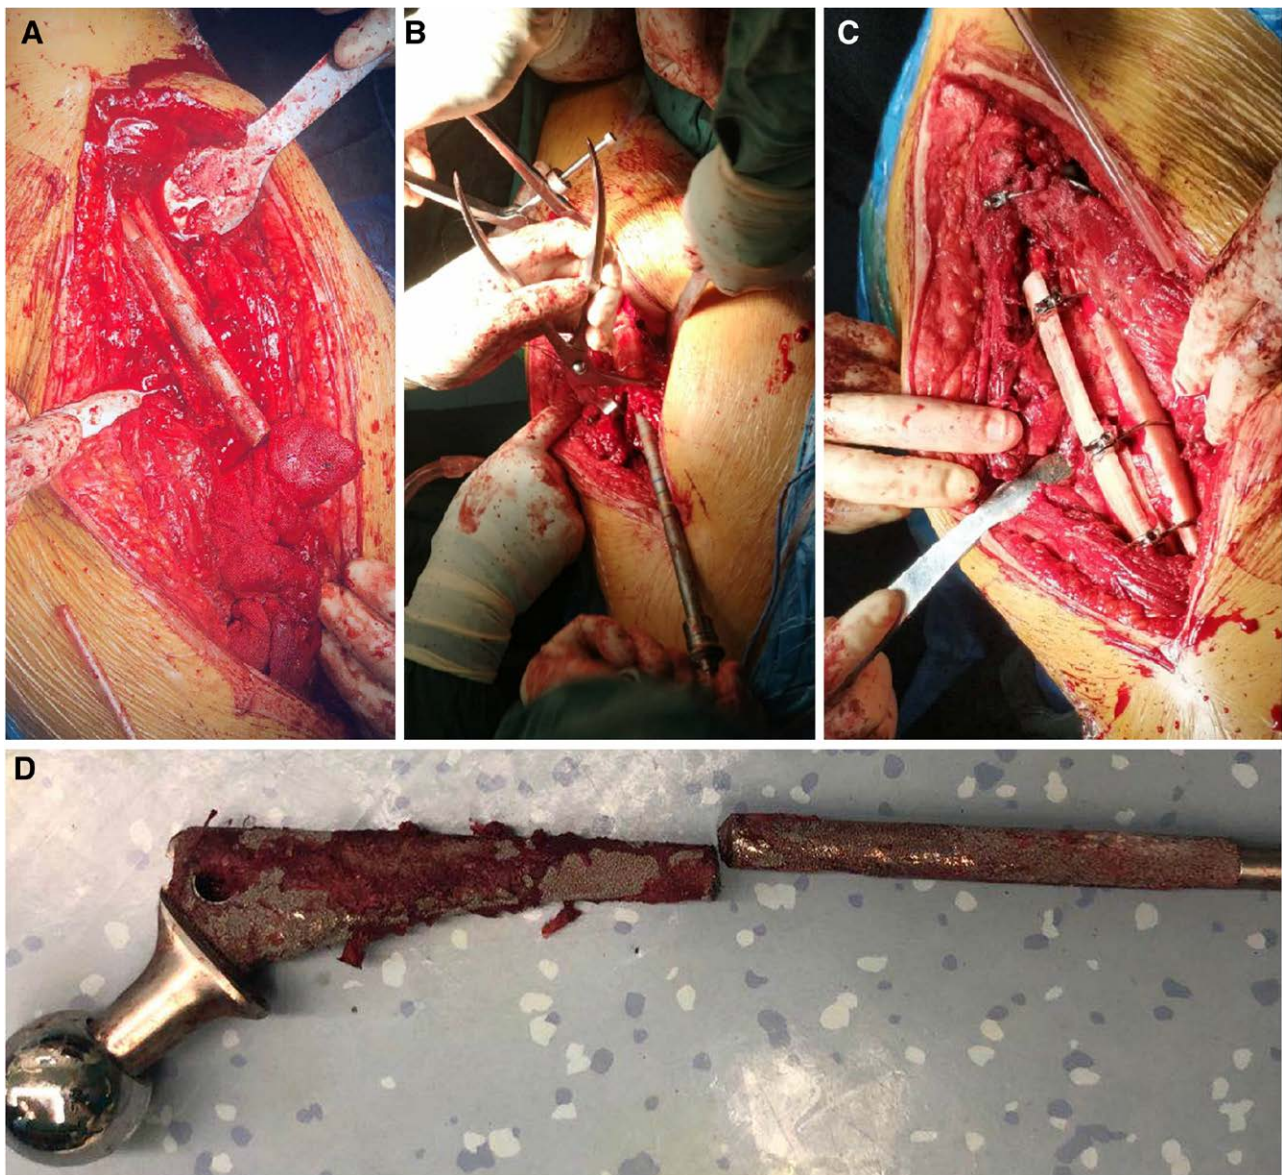
We decided to perform revision of the hip prosthesis and fix it with an allogeneic bone plate. During the operation, the acetabulum was fixed reliably without obvious wear; the fibrous connection at the greater trochanter of the femur had good continuity; the fractured end of the femoral shaft was hardened; and the femoral prosthesis was fractured at the fracture site. Therefore, it was necessary to open windows on both sides of the femur to remove the broken femoral stem prosthesis. The bone on the surface of the femoral stem grew well. First, the fracture was temporarily reduced and fixed with a steel wire, and then the medullary cavity was reamed with a medullary cavity file. Due to the narrow medullary cavity of the patient's femur, we decided it was better to use a Solution handle medullary cavity file to enlarge the medullary cavity than the matched handle medullary cavity file. Next, the contents of the cavity were washed clean; the 13.5-mm Solution bowed femoral stem was inserted; and then a +8-mm metal head was placed, which

Figure 3. Pictures during surgery. A: The fracture ends at the femoral shaft are hardened, and the femoral prosthesis is broken at the fracture site; B: Temporary reduction and fixation of fracture, prebinding of steel wires, pulp cavity file and reaming; C: 2 allograft plates were placed on both sides of the broken end of the femur and fixed with 3 steel wires; D: A broken prosthesis was removed during surgery.

could be reset without dislocation. After that, 2 allogeneic bone plates were placed on both sides of the femur fracture end; they were fixed with 3 steel wires, and 1 was fixed at the greater trochanter and femoral calcar (Fig. 3). The iliac bone was cut into strips and placed at the broken end of the femur. Fluoroscopy examination showed that the prosthesis was placed in a good position. Finally, a drainage tube was placed for flushing, and the wound was sutured owing to the satisfactory fracture reduction results. During the operation, the patient was given 300 mL of autologous blood, 4 units of allogeneic red blood suspension, and 400 mL of plasma. The patient recovered well after the operation (Figs. 4 and 5).

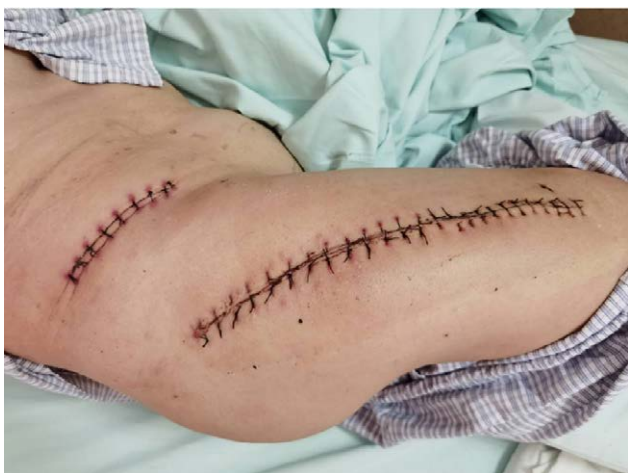
Figure 4. The incision healed well after the operation.

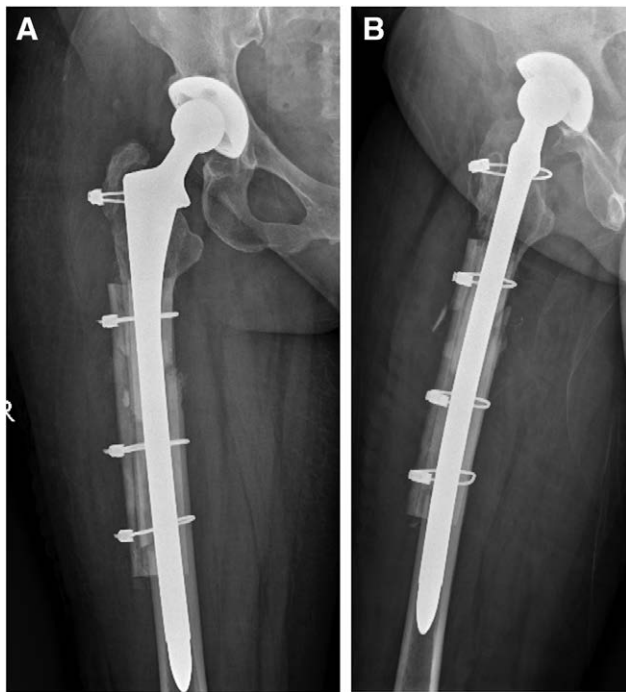
Figure 5. Radiographic analysis after the second revision of the right hip joint. A, B: Anterior and lateral radiographic positions after the second revision.

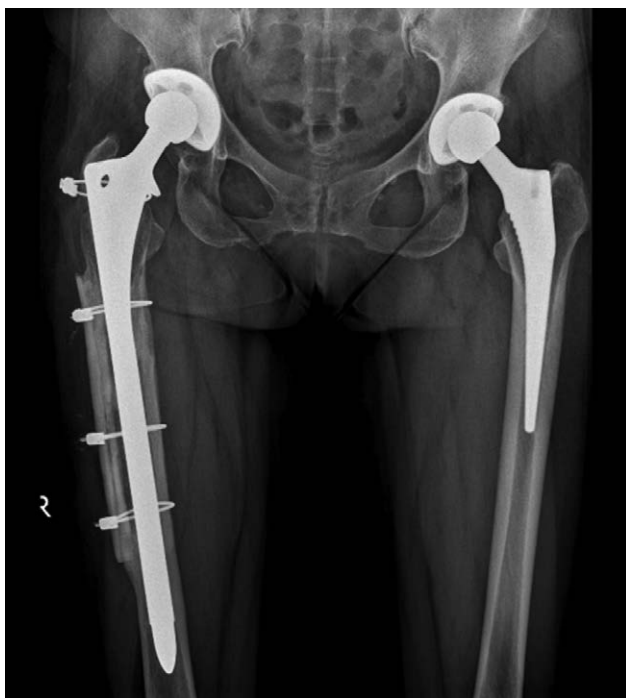
Reexamination was performed 1 year after the operation. Radiographic examination showed that the fracture healed well without obvious abnormalities (Fig. 6), and the hip joint activity

Figure 6. Radiographic analysis 1 year after the second revision of the right hip joint.
