# Concrete Tank Failure as the Result of Implementing Wrong Boundary Conditions for Wall Support—Case Study

**Abstract:** Damage to large reinforced concrete structures is rarely due to design errors. Sometimes, however, a small error can lead to major damage and costly repairs. The article describes the damage, the results of non-destructive and destructive tests, the results of numerical calculations, and the method of repairing a reinforced concrete tank in a sewage treatment plant. The failure was caused by applying the wrong boundary conditions to the reinforced concrete wall support inside an existing biological reactor. During leak testing, one of the new walls cracked and was displaced, which resulted in the tank leaking. An inspection of wall damage and displacement was carried out on termination of the leak testing and while the tank was draining. The causes of the failure were determined based on the inventory information and numerical simulations. Both non-destructive tests of reinforcement and concrete and destructive tests of concrete were carried out. The concrete class of the foundation slab was determined based on a compression test of sample cores obtained from d

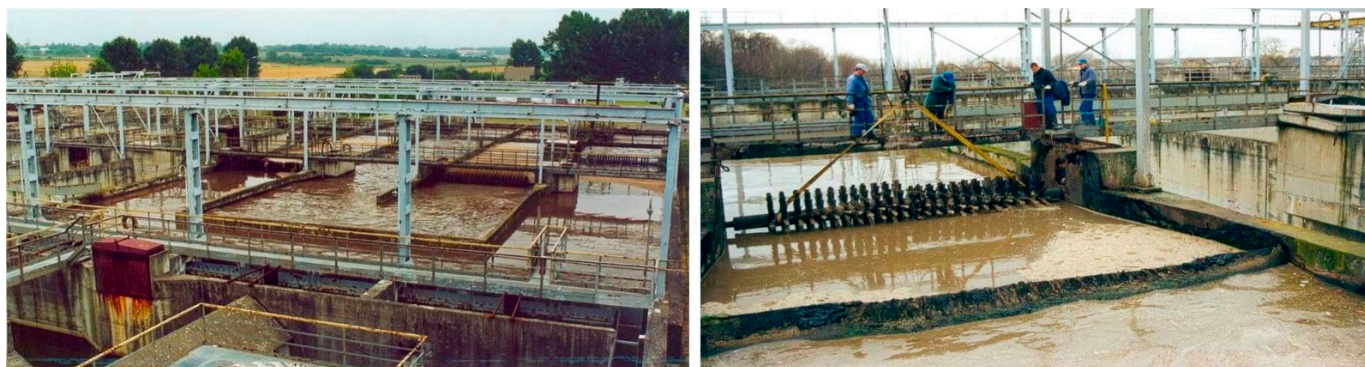
Figure 1. Archival photographs of the biological reactor in the 1990s.

The biological reactor was brought into operation in 1989 (Figure 1). However, the innovation of the applied technology required a reduction in the surface area and in the capacity of the existing tank. In the second half of 2018, renovation works and technological upgrades of the biological reactor in the waste treatment plant began. It was decided to infill the remaining unused space to the level of the existing terrain with building materials (Figure 2).

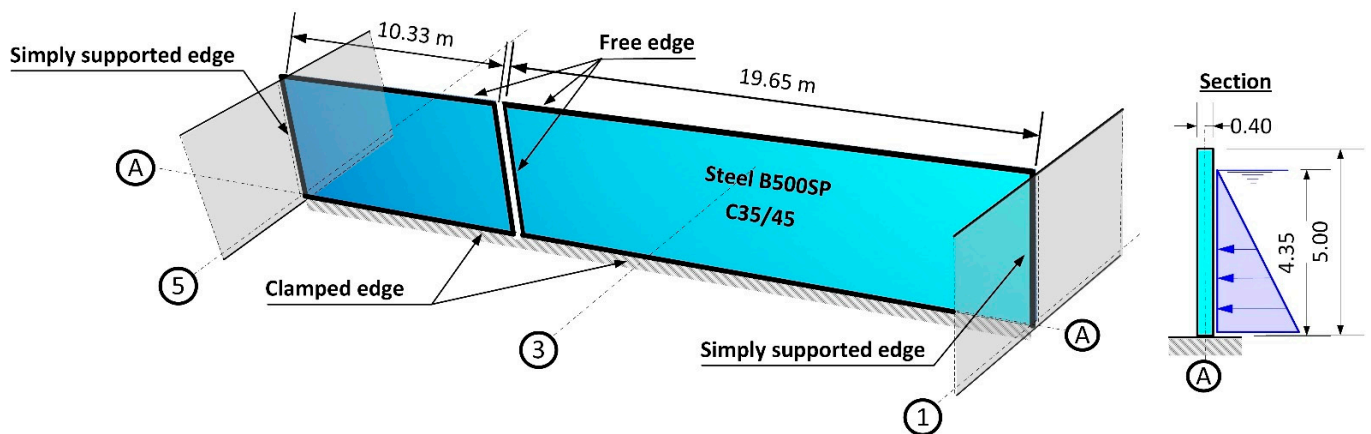
Figure 4. Static scheme adopted in the project design for walls on the A axis for the leak testing of the biological reactor.

The project design engineer did not calculate the length required for the anchoring in the foundation slab, which must have been taken into consideration when fixing rebars with adhesive. The design engineer adopted a nominal depth without verifying whether it was sufficient in relation to the possible failure of the rebar. Based on the catalogue of the anchor manufacturer [19], the engineer adopted a depth for fixing of the rebars as equal to 25 cm for  $\phi 20$  (B500SP) rebars and did not apply any calculations for verification purposes. The rebars for attaching the edges of the vertical wall in the place of the old walls were selected in a similar way. A static scheme with loadings adopted by the design engineer for the leak test is presented in Figure 4.

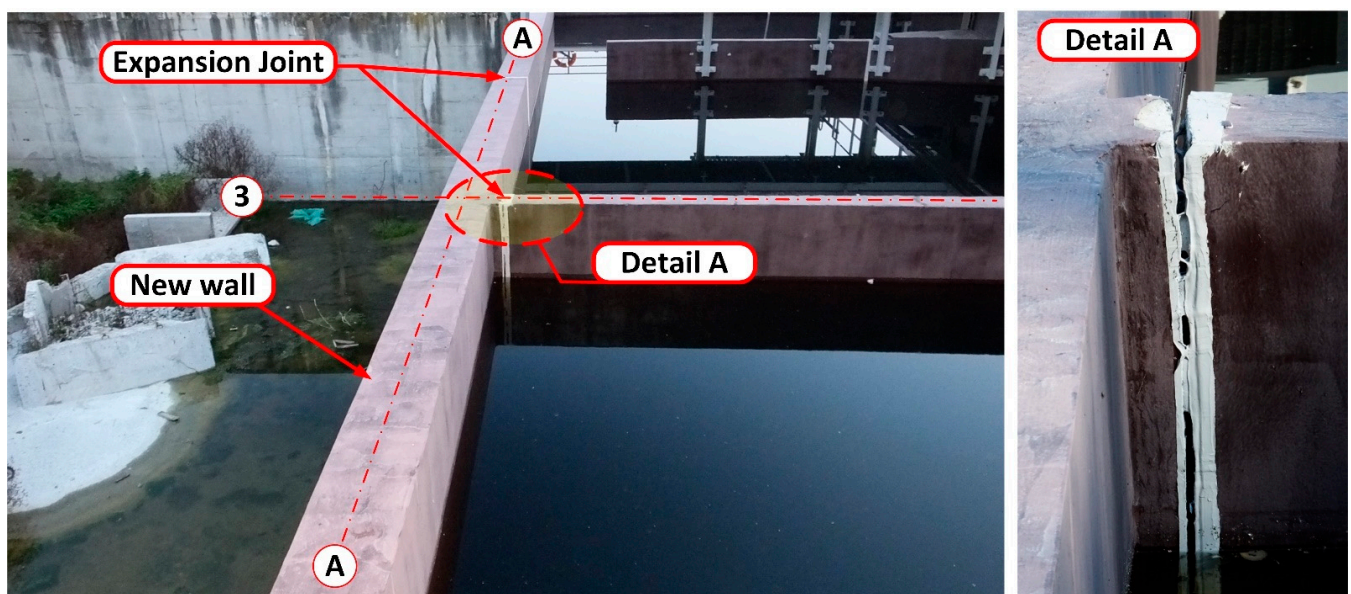
Figure 5. Leak testing of the biological reactor. View of the wall on the A/1–5 axis. Failure of the expansion joint at the interface between the vertical wall on axis 3 is visible. The first 12 h of leak testing.

During the leak testing, leaks appeared showing the location of shrinkage cracks [17]. Shrinkage cracks appeared in 8 places along the whole length of the wall. The cracks started at the base of the wall and reached a height of no more than 2.50 m. A progressive wall displacement was also noted, as well as a small deformation, which alerted the building inspectors to the danger of the wall collapsing along its whole length. Wall deformation was especially visible where the leakage was occurring at the interface with the expansion joint between the wall on the A axis, and the wall perpendicular to it on the 3 axes. After 24 h, further displacement of the new wall was observed and the crack at the interface of the vertical wall had increased to a value of about 7 cm. At this point, the deflection and deformation of the wall from the plane were clearly visible to the naked eye—Figure 6. For this reason, it was decided to immediately terminate the leak testing, and to drain the reactor to a level of 1.0 m above the tank bottom.

Completion of the building work on reactor 2 was planned for mid-September 2018. As part of this process, the reactor vessel was filled with water to a level of 4.35 m above the bottom and leak testing was initiated—Figure 5.

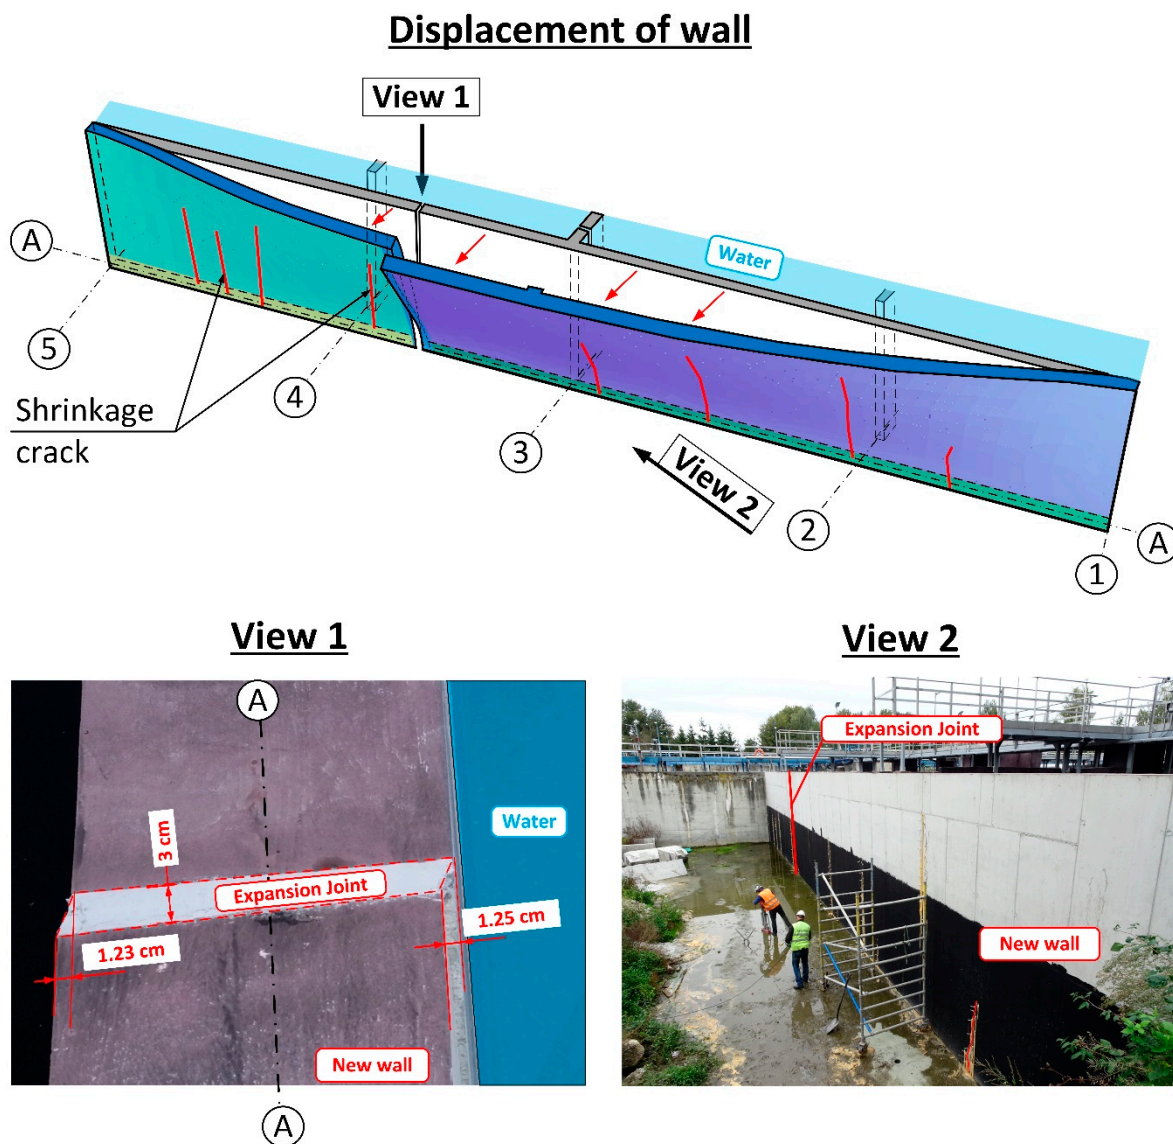
Once the tank was completely drained, it was determined that the wall deflection was partly reduced to an average about 1.0–2.5 cm. On the inside of the tank, a crack was observed at the base of the wall at the interface between the old and new concrete of ~0.7 cm indicates that joining the wall with the foundation slab of the existing biological reactor was not completed.

**Figure 6.** Wall displacement on Axis A following termination of leak testing. Destruction of the seals of the expansion joint (dilation) of the wall on the 3 axes.

shrinkage, in accordance with [31,35,36]. These indicated that the amount of horizontal strengthening provided was adequate. For this reason, the diagonal cracks which appeared (Figure 6) were most likely the result of negligence in curing the concrete.

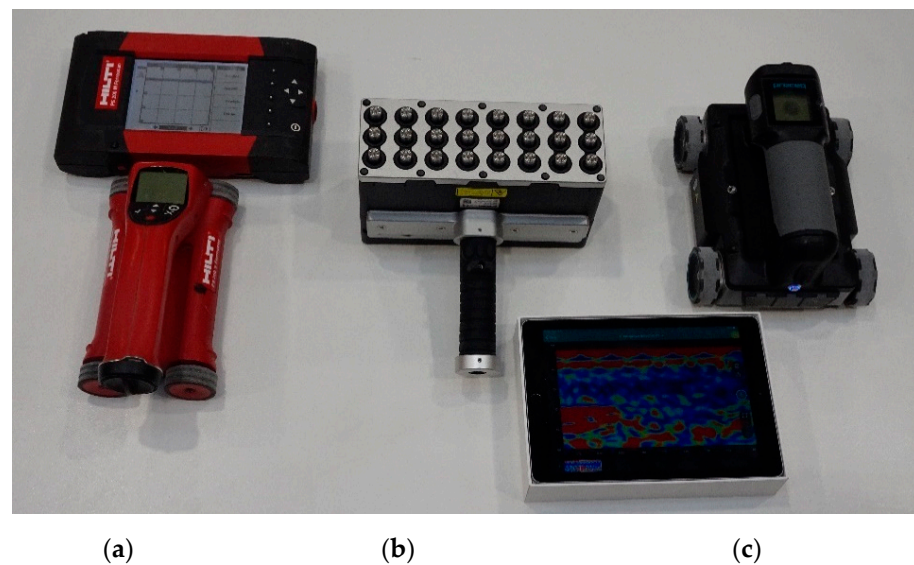
**Figure 7.** Instruments used in the tests, (a) electromagnetic scanner, (b) ultrasonic tomography, (c) radar scanner.

The PS 200 electromagnetic scanner was used to determine the location and diameter of reinforcement (Figure 7a). The sensor area was equipped with a circumferential transmitting coil and seven receiving coils. The electric current induced in the receiving coils was analysed. The detection range of the device is up to 10 cm. Five scans of reinforcement of  $0.36 \text{ m}^2$  area each were made on the tested wall. The location of the tested areas is shown in Figure 8.

The Pundit 250 Array ultrasonic tomography for concrete was also used during tests (Figure 7b). The instrument contains 3 rows of 8 transducers operating on a frequency 50 kHz. Each pulse-echo transducer transmitted an ultrasonic signal and echoes were received by the remaining transducers. Each transducer transmitted its own signal one by one with a delay of 8–200 ms. Complete measurement in one row consisted of 28 scans. The instrument was used to locate the reinforcement and detect internal defects in the concrete structure. Five, 80 cm long linear scans were made in the middle of the tested area of the PS 200 scanner (Hilti, Schaan, Liechtenstein).

For radar tests, we used the GPR Live System with antennas generating measurement signal of stepwise variable frequency within the range of 0.2–4.0 GHz (Figure 7c). In

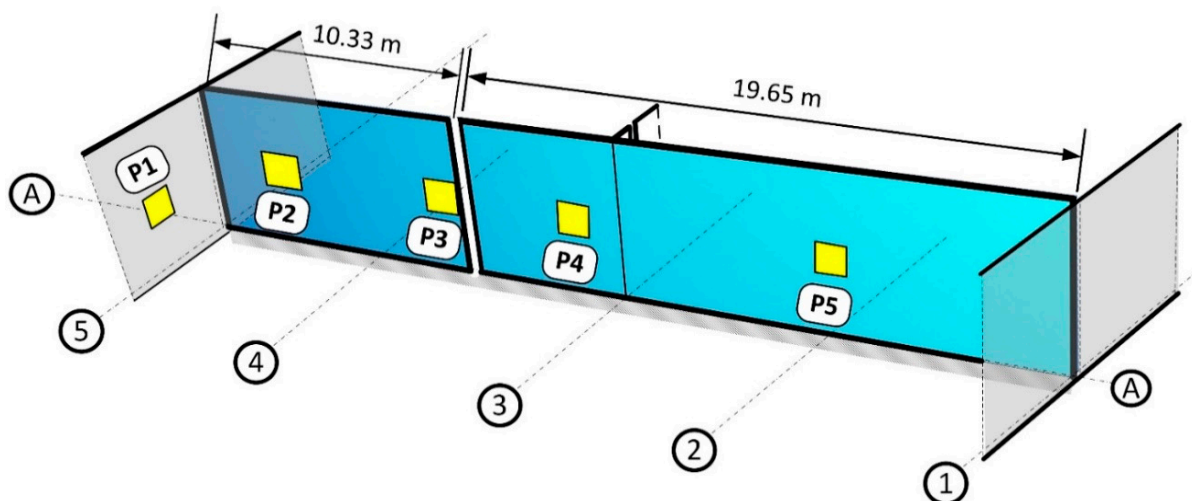
**Figure 8.** Places where electromagnetic, radar and ultrasonic tests were performed.

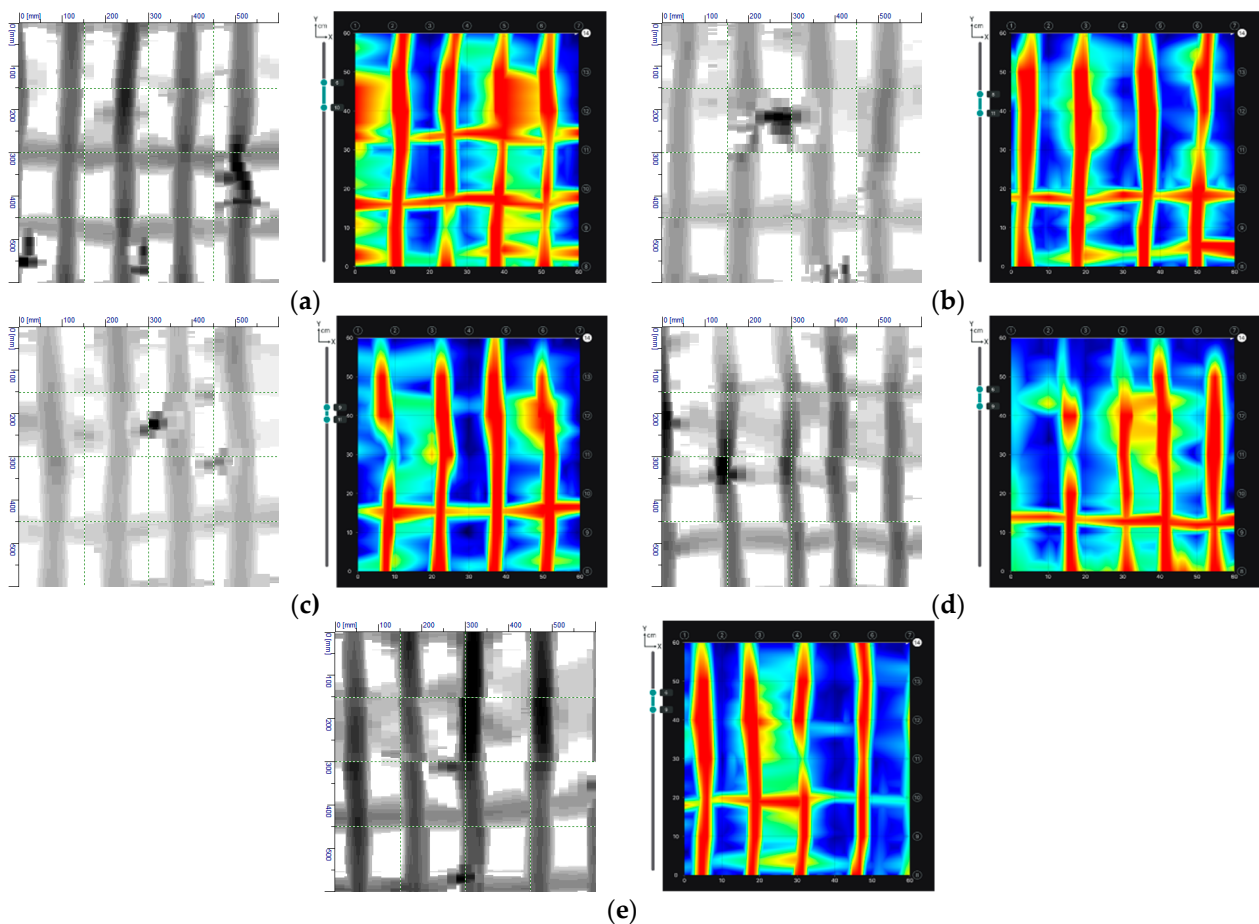
The conducted NDT showed the compliance of the reinforcement with the project in terms of quantity and location of rebars. However, the concrete cover of the bars was found to be slightly larger than the designed one. The reinforcement was at an average depth of 55 mm, with a standard deviation of 6 mm. This fact was considered in the design by taking the average concrete cover. A comparison of the results of the reinforcement detection using electromagnetic and radar methods is presented in Figure 9. It was found that the diameters and position of the reinforcing bars are in accordance with the design.

**Figure 9.** A comparison of the results of the reinforcement detection using electromagnetic and radar methods: (a) P1, (b) P2, (c) P3, (d) P4, (e) P5.

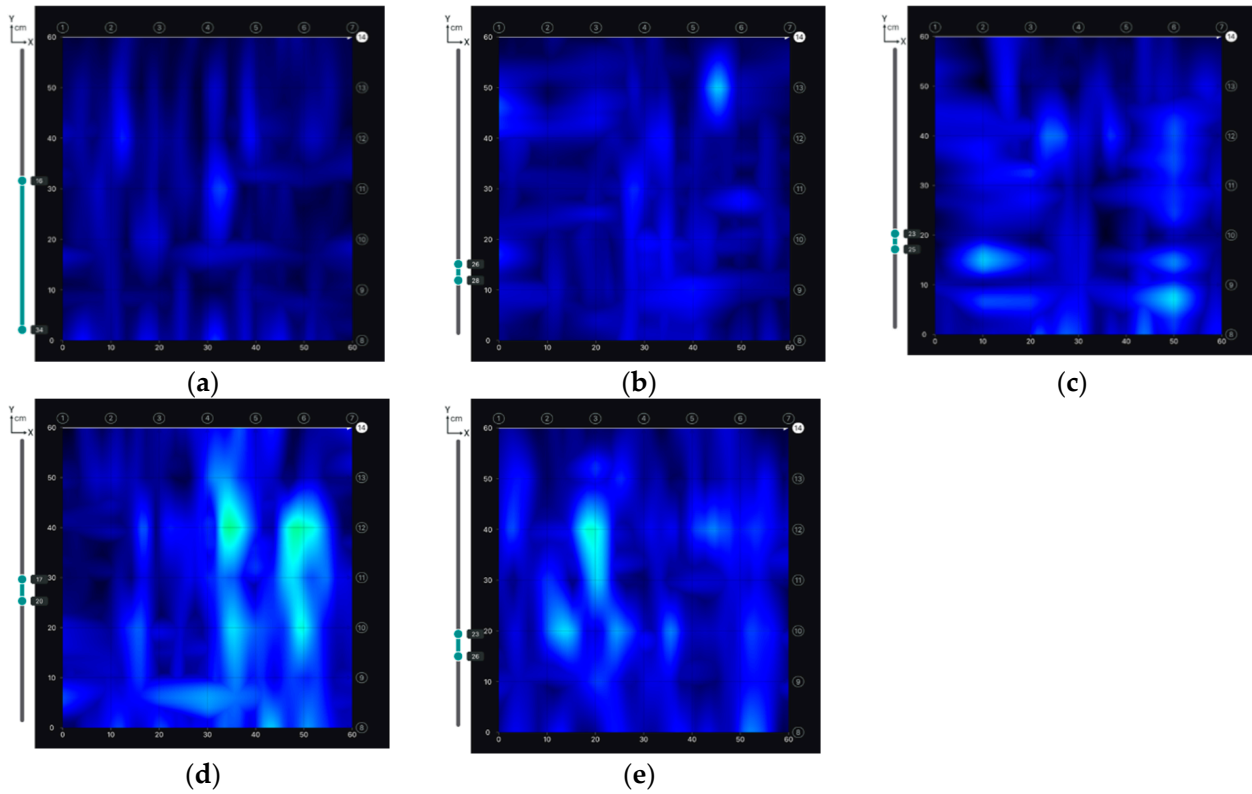
Based on the scans made using the radar method, it was also possible to determine the occurrence of internal defects in the concrete. Images of radar scans at depths behind the reinforcement zone are shown in Figure 10. Internal defects of the concrete are light blue in colour. Only in the first scan, no internal defects were found (Figure 10a). The scans made in P2 and P3 have small defects, while in the P4 and P5 scans larger defects of about 30 × 30 mm were diagnosed. Similar results were obtained using the ultrasound method (Figure 11). The first scan shows only the reinforcement in cross-section (Figure 11a). In the scans taken in subsequent places, there are already areas of discontinuity in the concrete structure. The experience of the authors [21,22] shows that the applied ultrasound device

Figure 10. Testing of the location of internal defects in concrete using the radar method in measuring points: (a) P1, (b) P2, (c) P3, (d) P4, (e) P5.

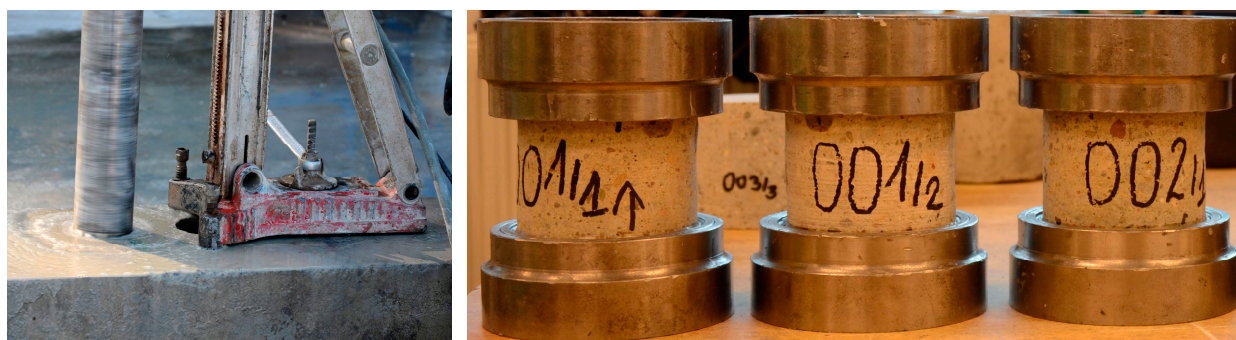
The effectiveness in anchoring the rebars is directly related to the quality of the concrete bases, in which they are to be embedded. For this reason, compression tests were carried out for the concrete making up the existing foundation slab to determine the concrete class. The concrete class of the foundation slab was determined on the basis of a compression test of sample cores with a diameter of  $\phi$  100 mm and a height of 100 mm obtained from drilling (Figure 12), in accordance with the methodology presented in [23–26]. The results of these tests are presented in Table 1. When determining the strength of concrete, the Neville formula [27] was taken into account, according to which the strength of a cube sample with a side of 150 mm equals 98% of the strength of a cylindrical sample with a height and diameter of 100 mm.

Figure 12. Testing for strength: core drilling and concrete specimens prepared for testing.

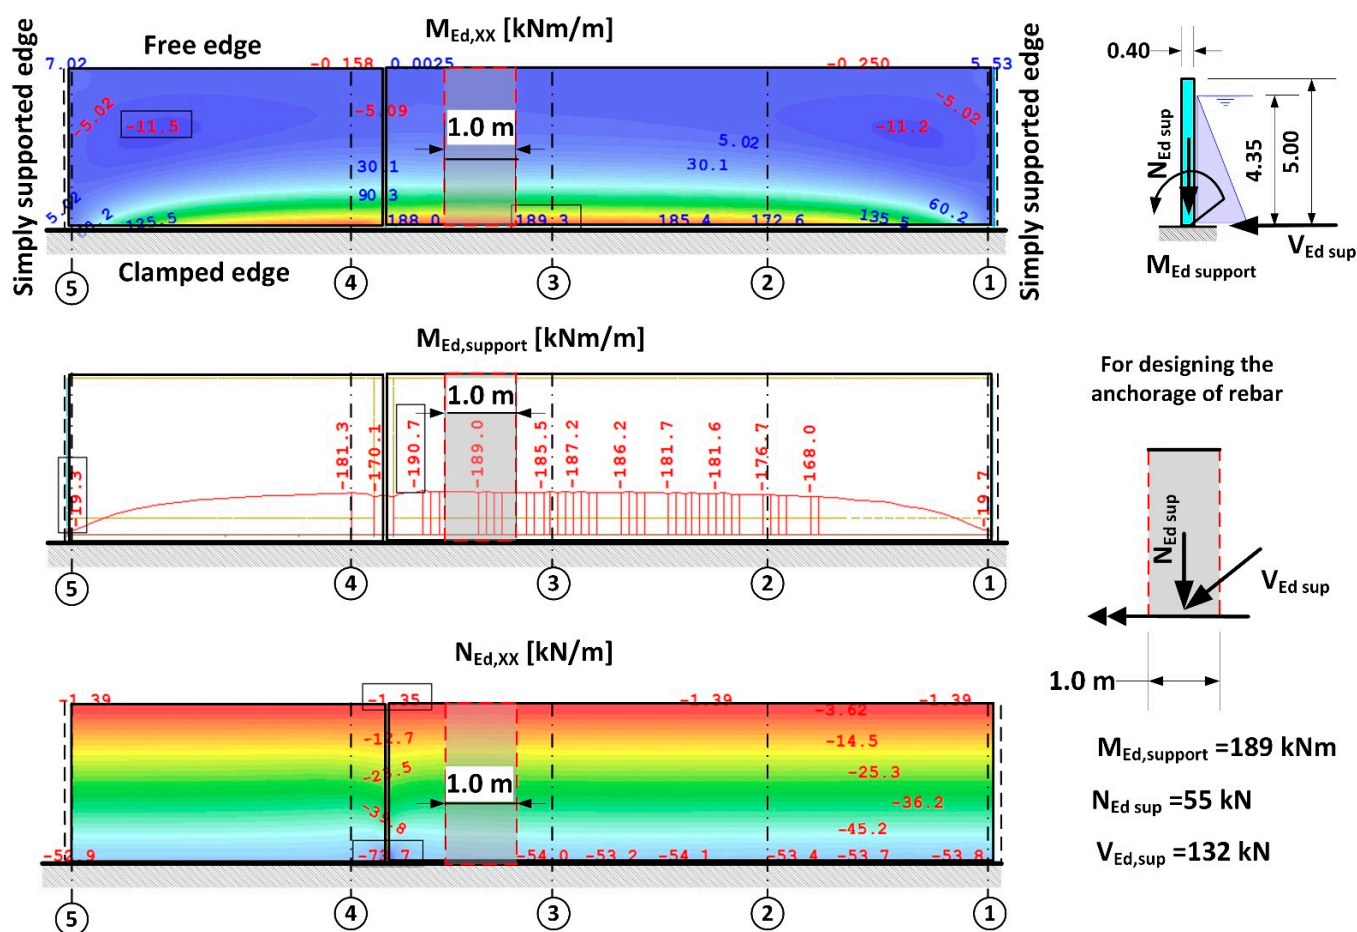
#### Load Case for ULS -> 1.15 G (Dead load)+1.5 Q (Hydrostatic water pressure)

**Figure 13.** Static scheme of the wall for determining the reactions of the supports for verifying the load bearing capacity of the rebars in the foundation slab.

As a first step, according to [31–33], the design correctness of the strengthening of the reinforced concrete wall assuming a rigid fix to the foundation slab was analysed. It was determined that the design strength was correct in relation to the flexural behaviour, and the wall did not indicate any excessive deformation. Obtained support reactions were used for verifying the load-bearing capacity of the anchorage of the wall connecting rebars on the A axis with the existing foundation slab. The static scheme and the values of the internal forces assumed for calibrating anchorage in the foundation slab are presented in Figure 13.

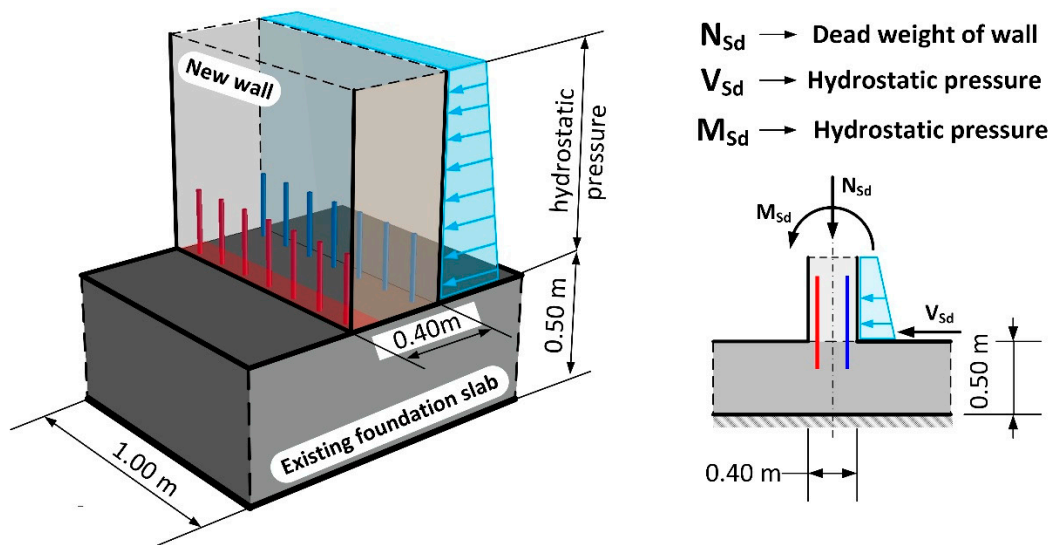
Local failure mechanisms of reinforcing bar anchorage				
Steel failure tension	Steel failure shear loads	Combined pull-out and concrete cone failure	Concrete cone failure	Concrete pry-out failure
$\gamma_{Ms} = 1.40$	$\gamma_{Ms} = 1.50$	$\gamma_{Mp} = 1.50$	$\gamma_{Mc} = 1.50$	$\gamma_{Mc} = 1.50$
$N_{Rd,s} = N_{RK,s} / \gamma_{Ms}$	$V_{Rd,s} = V_{RK,s} / \gamma_{Ms}$	$N_{Rd,p} = N_{RK,p} / \gamma_{Mp}$	$N_{Rd,c} = N_{RK,c} / \gamma_{Mc}$	$V_{Rd,cp} = V_{RK,cp} / \gamma_{Ms}$
Global failure mechanisms of reinforcing slab foundation

Figure 14. Static diagram of anchoring the wall in the foundation slab of the existing tank. Local failure mechanisms and global failure mechanism considered in the analysis.

Strengthening the structure with inappropriate boundary conditions is a very common mistake. According to the foundation slab, a typical problem is to verify the wall anchorage only by checking the local failure mechanisms (Figure 14).

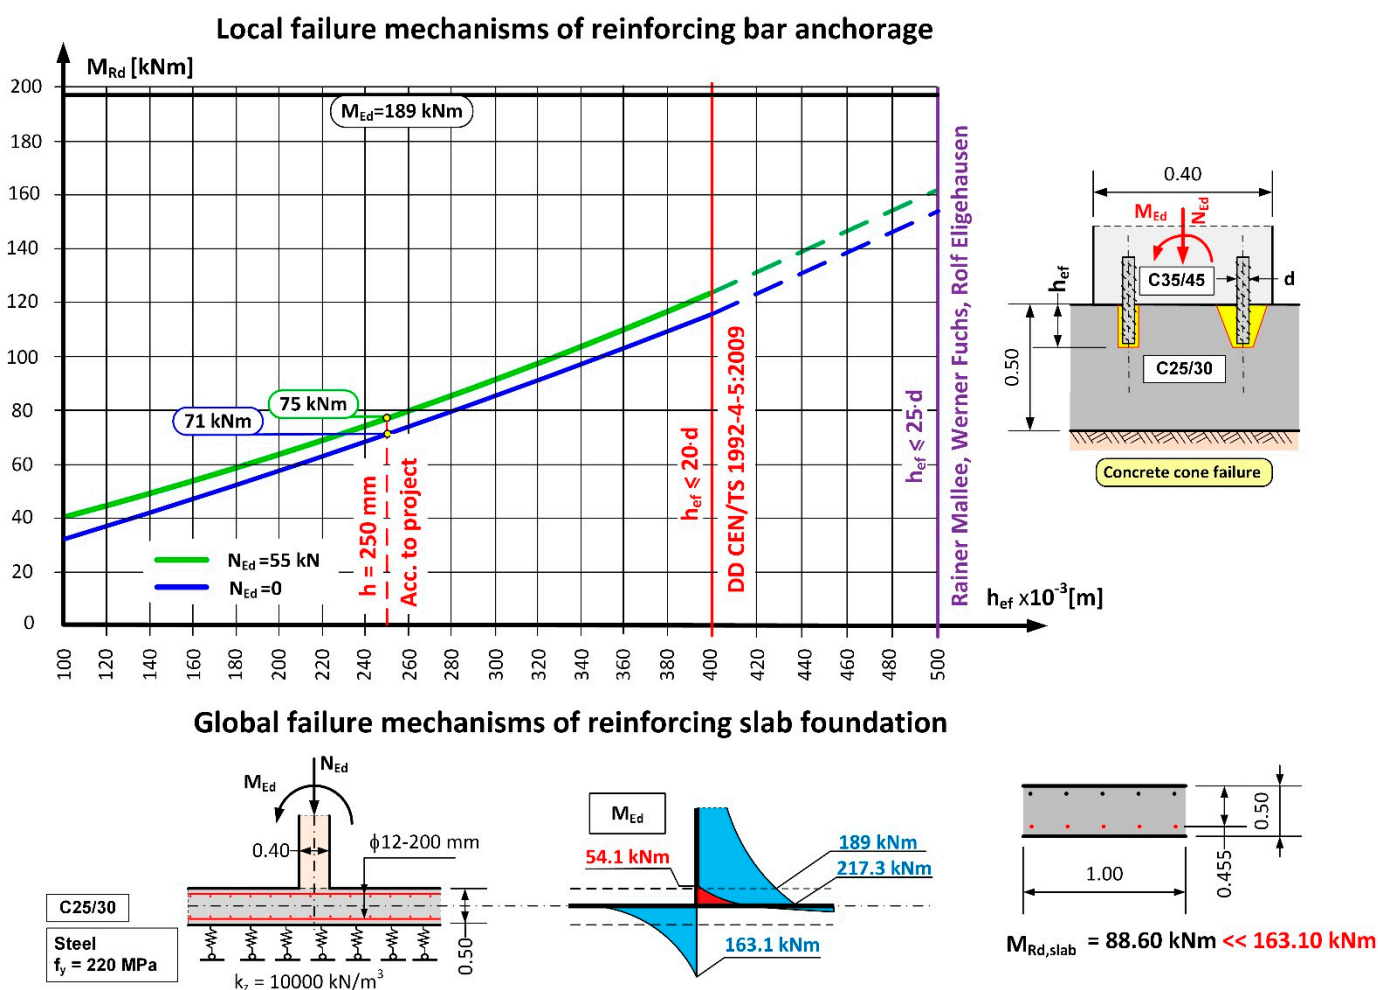
To answer the question posed earlier, the value for the anchoring moment in the foundation slab was set as a function of the anchorage depth for a  $\phi$  20 mm rebar in accordance with [18,34]. In the calculations, the two most significant failure mechanisms were considered: concrete cone failure and combined pull-out of the rebar with concrete cone failure. The results of the calculations are presented in the form of a graph in Figure 15. Analysis of the calculation results in relation to the value of the calculated anchorage moments, which were measured during the leak test, indicates that there was no possibility of achieving a complete anchorage of the wall in a slab which is 50 cm thick. For the anchorage depth adopted in the project design (25 cm), the maximum possible anchorage moment, taking into account a favourable impact of the compression force from the self-weight of the wall ( $N_{Ed} = 24 \text{ kN/m}^3 \times 0.40 \text{ m} \times 5.00 \text{ m} \times 1.00 \text{ m} \times 1.15 = 55 \text{ kN}$ ) amounts to 75 kNm. On the other hand, the calculated anchorage moment for the wall in the foundation plate obtained from the static calculations (Figure 13) amounts to 189 kNm, which is equivalent to loading in the order of  $\sim 255\%$ . It should be noted that the maximum anchorage length of rebars according to [18] is  $20d$ , which makes it impossible to achieve the required bending resistance  $M_{Rd}$ . The key to solving this problem is to use deep anchorage and check the connection with the strut and Tie (S-T) method for reinforced concrete structures. The second important criterion is sufficient bearing capacity of the foundation slab due to bending and cracking. In the case under consideration, the bearing capacity of the foundation slab is twice as low.

Figure 15. Anchorage capacity of the wall and foundation slab connection from the condition of the anchorage length of the bars [17,18] and the bending resistance of the foundation.

Therefore, the design concept adopted as a basis for realising the wall was destined for failure from the start as there was no possibility of achieving a completely effective anchorage in the foundation.

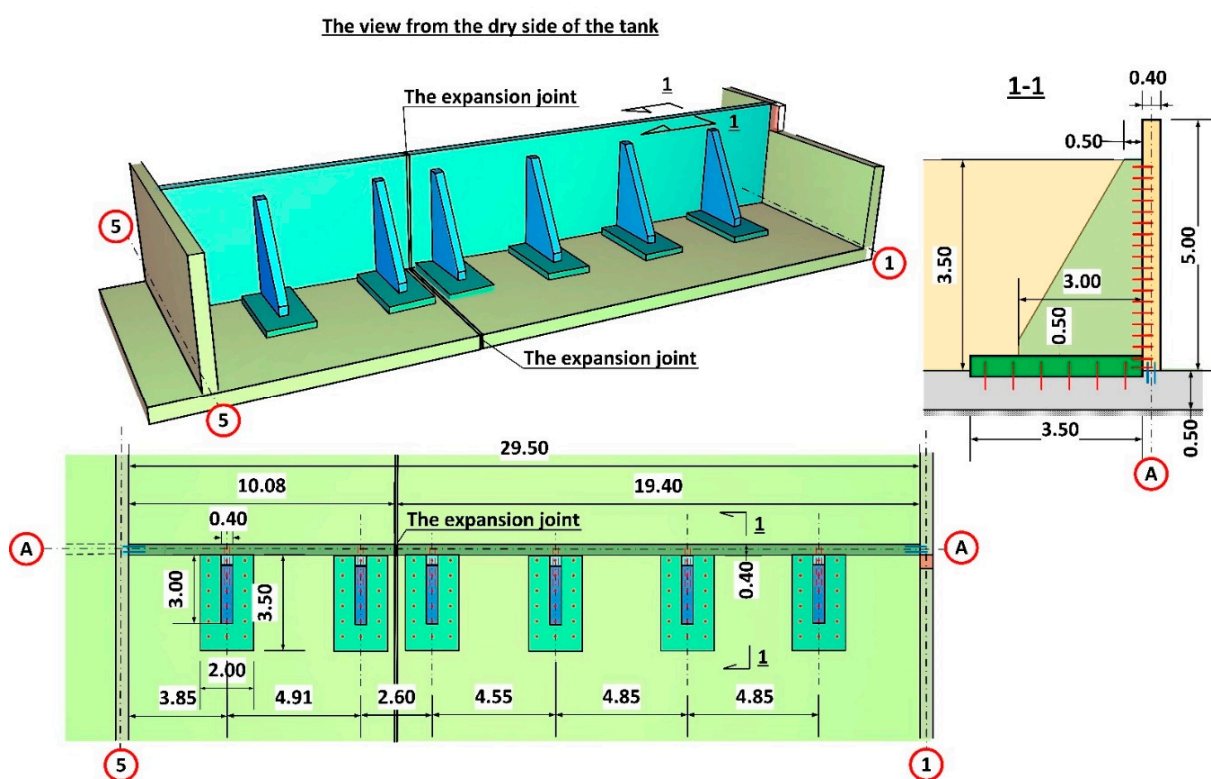
**Figure 16.** Support concept for the damaged wall in reactor no. 2.

Both numerical analyses carried out in SOFiSTiK [29] and inspection of the construction site indicated that the designed solution should be changed to enable strengthening without removal of the damaged wall. The new solution has been applied in reactor no 1 on the A/5–9 axis in order to avoid a similar failure. It was decided that buttresses, in the form of reinforced concrete pilasters, would be used to provide direct stiffening and support for the damaged wall, especially with consideration of the loading on the damaged anchor's reduction. The final design concept for strengthening, which was approved by the investor and the design engineer, is presented in Figure 16.

The ribs supporting the walls were designed as 40 cm thick reinforced concrete pilasters from C35/45 concrete. Due to considerable forces being transferred by the ribs to the foundation plate, additional support was planned in the form of a reinforced concrete base of 2.00 m  $\times$  3.50 m in the area and 0.50 m in height. The need to extend the base of the ribs resulted from insufficient flexural load-bearing of the existing foundation slab. While pressing on the slab, the rib generates flexural moments on the slab from ground resistance. Extending the base of the ribs allowed to distribute the loading over a larger area. What is more, the inclusion of a larger area of the slab secures additionally a twofold increase in height of the transverse cross-section for flexural and punching shear forces (50 cm + 50 cm = 100 cm). The basis for rib design was provided by several numerical models (FEM) which replicated the boundary conditions on the edges of the wall support. The numerical model was developed using quadrilateral mesh on surfaces (Figure 17). Additionally, rigid and non-linear elastic bonds were used. Articulated joints were used at the interface where the ribs connect to the wall. The external edges of the wall, which had been subjected to loading, were remodelled as articulated joints transferring only transverse forces. The analysis of the concrete wall according to the third-order theory, which contains non-linear analysis together with the analysis according to the second-order theory and the effects of the geometrical system modification, e.g., length modification for big deformations, was performed in SOFiSTiK [29]. The analysis of non-linear effects in SOFiSTiK was carried out by iterations using a modified Newton method with a constant stiffness matrix. The non-linear material behaviour of reinforced concrete in the shell elements was modelled by means a layer model with the arrangement of the crosswise reinforcement layers in their correct positions near the surfaces. The non-linear behaviour of the components of reinforced concrete was defined by non-linear uniaxial stress-strain laws of concrete (an increase of strength due to biaxial compressive behaviour is considered), consideration of tension softening of concrete after cracking dependent on fracture energy, trilinear stress-strain laws of reinforcing steel. Properties of the concrete material for a new structure were assumed as: a unit weight of 25 kN/m<sup>3</sup>, the Young's Modulus of 34,077 N/mm<sup>2</sup> (C35/45) and the Poisson's ratio of 0.2, nominal strength 35 N/mm<sup>2</sup>, tensile strength 3.21 N/mm<sup>2</sup>. Properties of the concrete material for the old, existing structure were assumed as: a unit weight of 24 kN/m<sup>3</sup>, the Young's Modulus of 31,476 N/mm<sup>2</sup> (C25/30) and the Poisson's ratio of 0.2, nominal strength 25 N/mm<sup>2</sup>, tensile strength 2.56 N/mm<sup>2</sup>. Properties of the reinforcing steel material properties were assumed as: the yield strength of N/mm<sup>2</sup> and the Young's Modulus of 200,000 N/mm<sup>2</sup>.

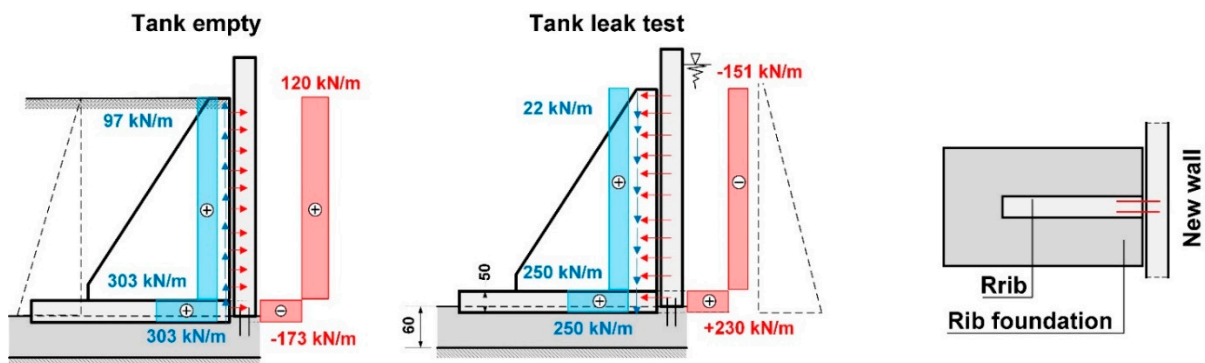
**Connection of reinforced concrete rib to the wall**

Figure 18. Design values for determining the wall-rib connection based on FEM calculations.

The first stage of numerical calculation involved calculating the external forces in the ribs. The next step was to determine the transverse forces including the interactions at the interface of the rib–wall, side walls–wall, wall–foundation slab, and rib base–foundation slab. Determination of the forces provided the basis for designing the connection in the form of post-installed rebars using chemical adhesives (Figures 18 and 19).

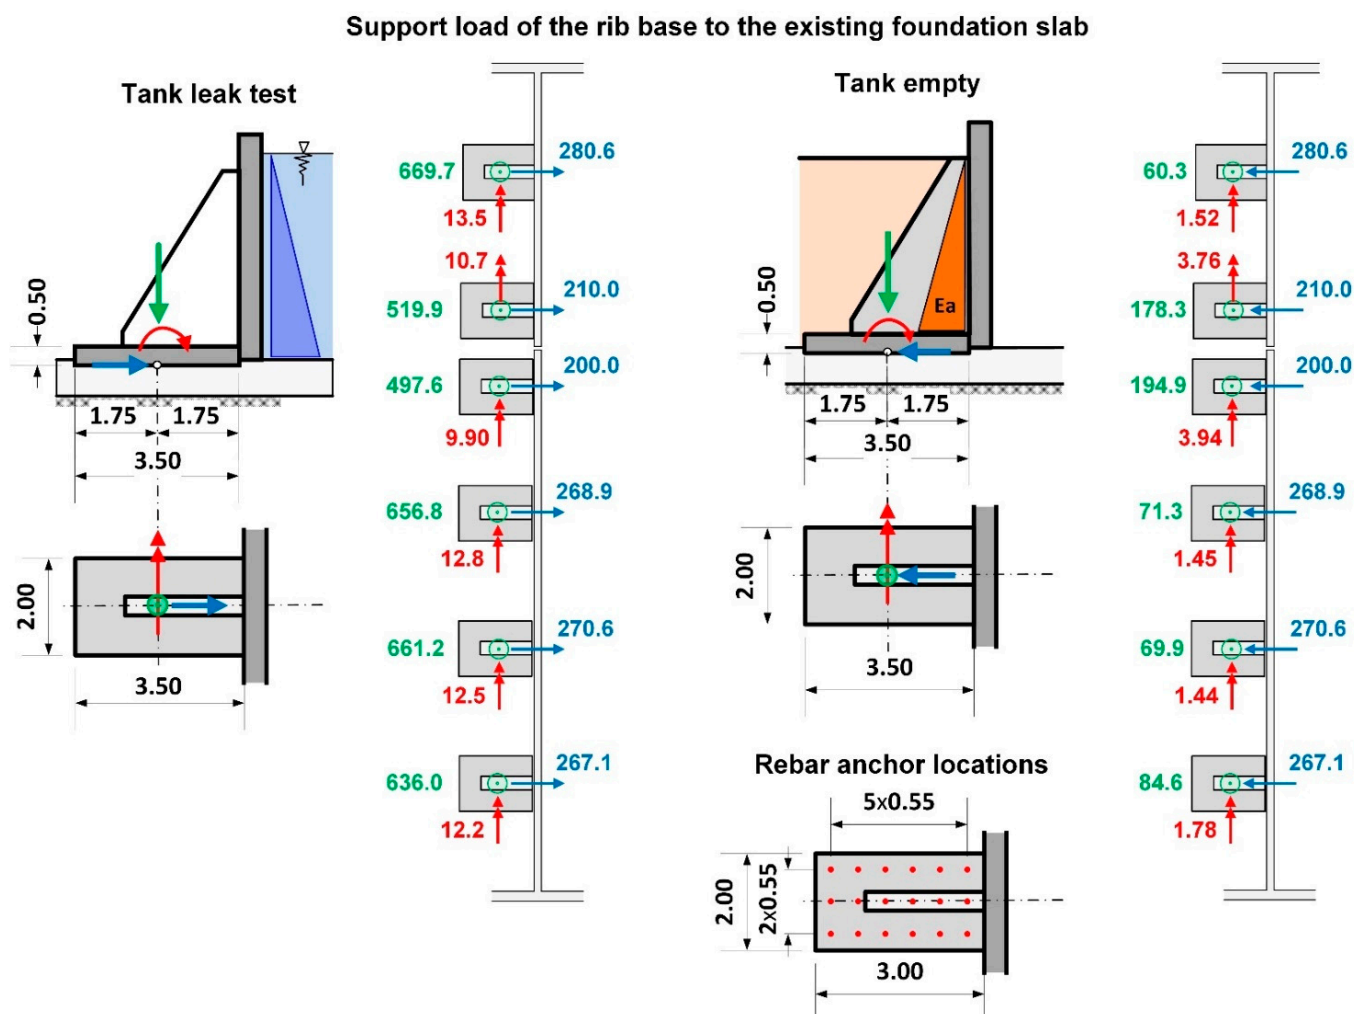
**Figure 19.** Reactions transferred to the anchor system based on FEM calculations.

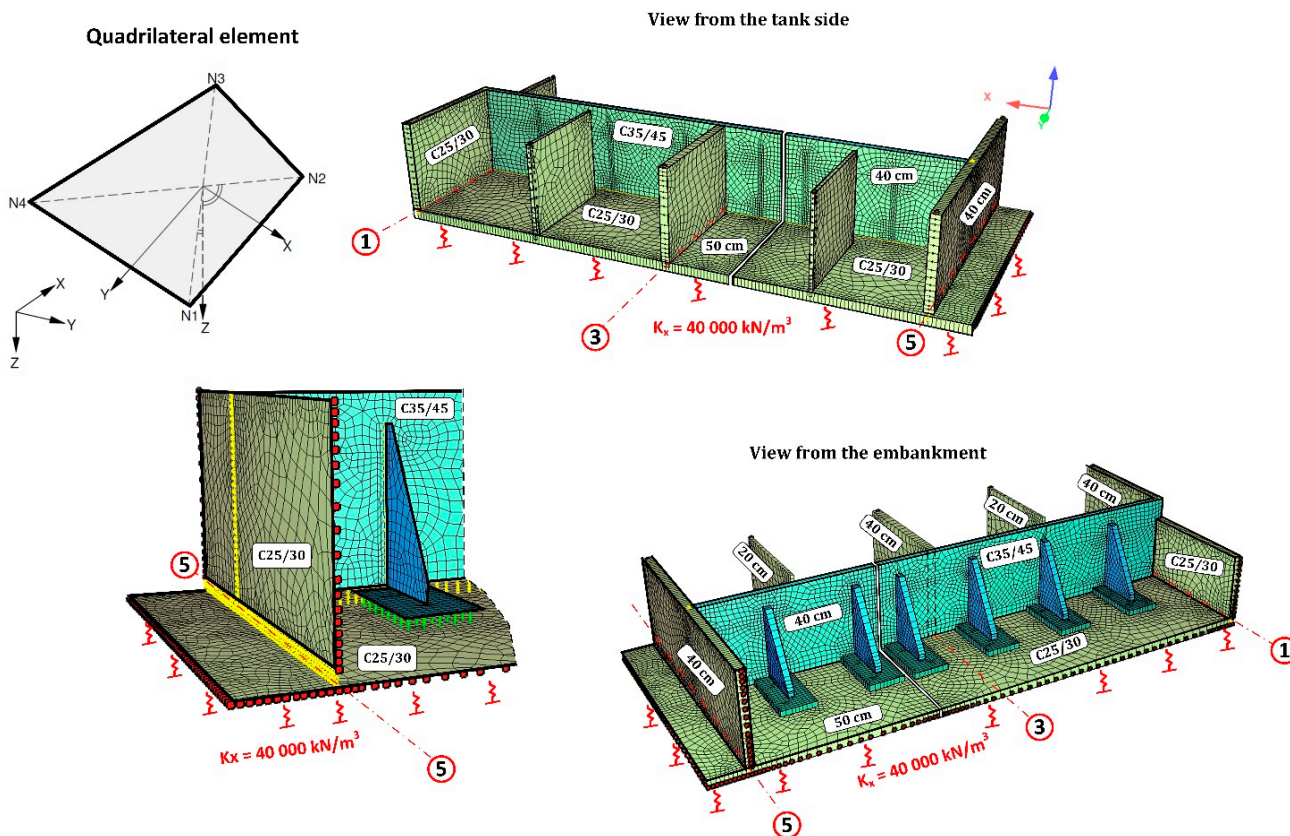
Figure 20. Sketch of the numerical model for verification of the flexural loading of the existing foundation slab.

The last stage of the calculations was aimed at verifying the foundation slab in relation to reactions transferred by the base of the ribs to the underlying substrate. A corrected numerical model, based on the previous one, was developed for this purpose. The numerical model was extended to include the existing tank in order to approximate as closely as possible the existing field conditions, for instance: the Winkler model of the soil, the elastic half-space model, and the non-linear behaviour of cracked concrete. Meeting this goal required using the rigid linear connections to take into account the connections at the interface between the bottom of the rib base and the existing foundation slab. A sketch of the most important elements of the numerical model is presented in Figure 20, whereas the calculated values of the flexural moments in the foundation slab are presented in Figure 21.

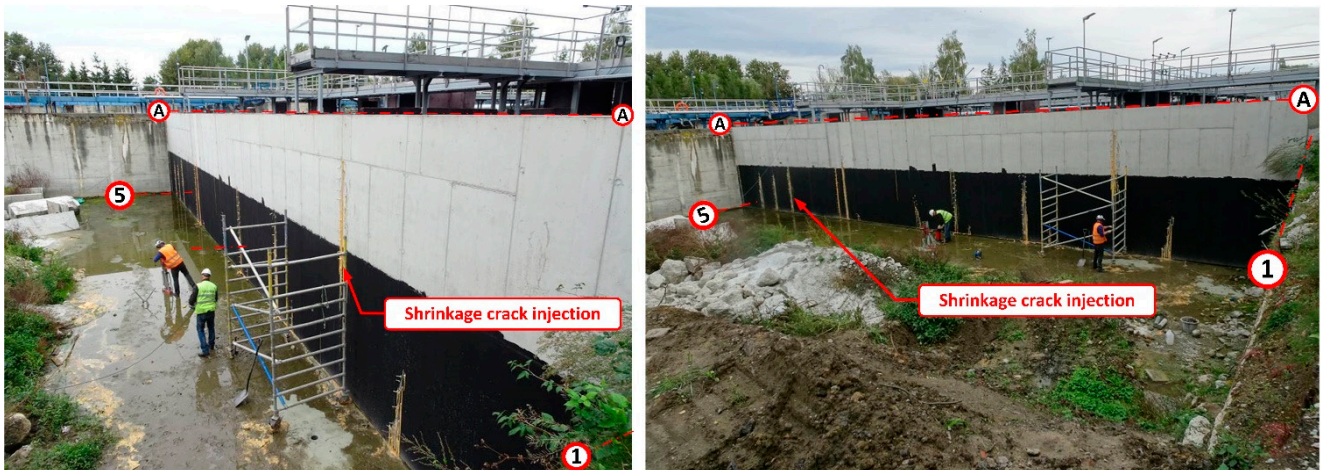
Figure 22. Injection in vertical cracks resulting from concrete shrinkage.

Numerical analysis and static calculations carried out by the authors provided the basis for the preparation of a repair design. Prior to applying the pilasters, all of the shrinkage cracks, which appeared during the leak test, were sealed. The sealing was carried out by means of injection (Figure 22). The next step involved the renovation of the coatings of the tank interior and the installation of the bases for the pilasters. Finally, the reinforced concrete pilasters were installed and the insulation on the covering of the walls and supports from the ground side was restored (Figure 23). After completing all the construction works, a leak test was carried out again (Figure 24). It was successful. After the repair and leak test, the tank was covered with soil (Figure 25).

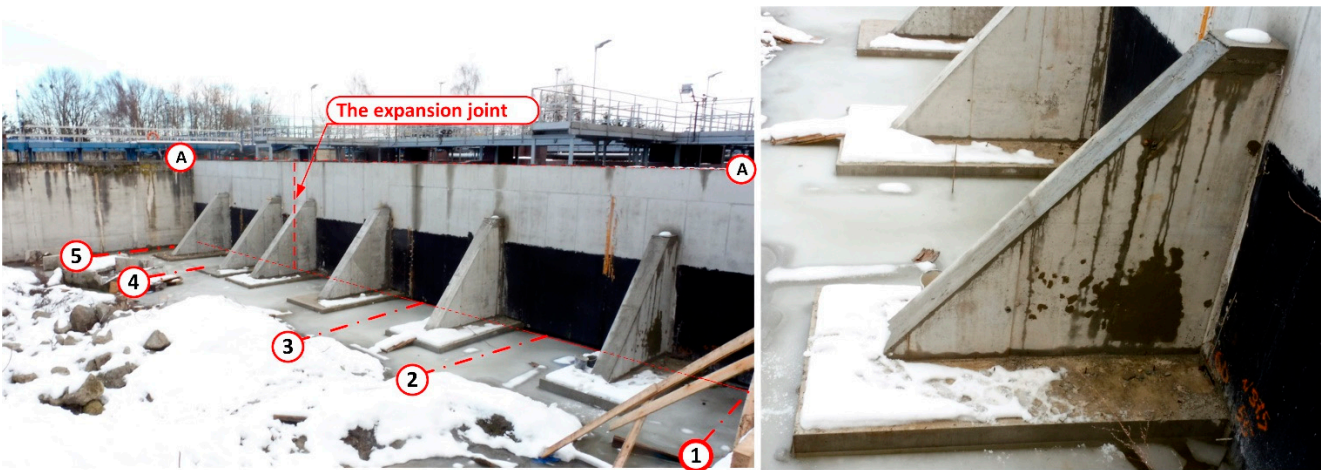
Figure 23. Strengthening of the wall of the biological reactor on the A axis with reinforced concrete supports.

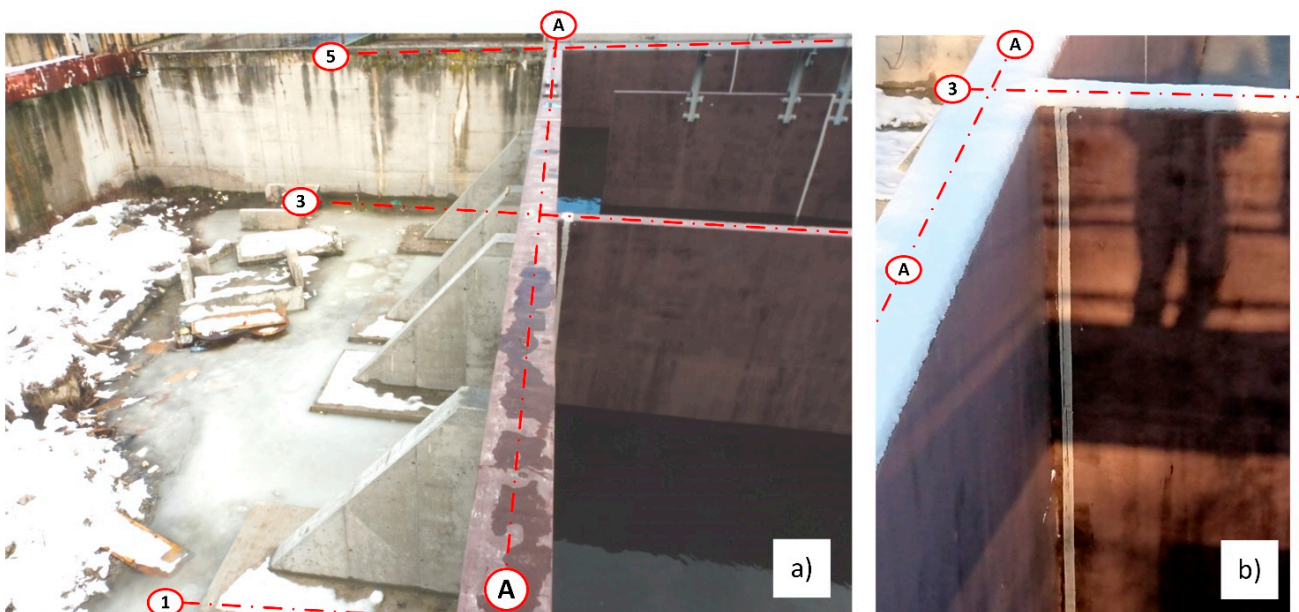
Figure 24. View of the strengthened wall of the bioreactor on axis A after the leak test, (a) view from the side of the supports; (b) view of the repaired expansion joint (dilatation) of the perpendicular wall in axis 3.

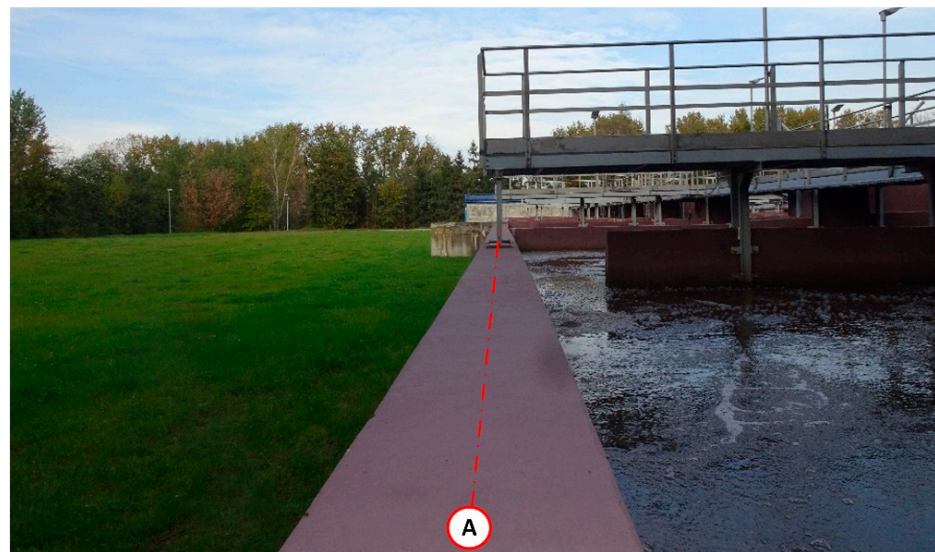
Figure 25. Wall view after repair.
