Case report

Traumatic fracture of the polyethylene tibial post and cone in a posterior-stabilized total knee arthroplasty: A case report

Case presentation: A 70 year-old female developed a fracture involving both the tibial insert post and cone after a minor trauma after undergoing posterior-stabilized total knee replacement 4 years prior.

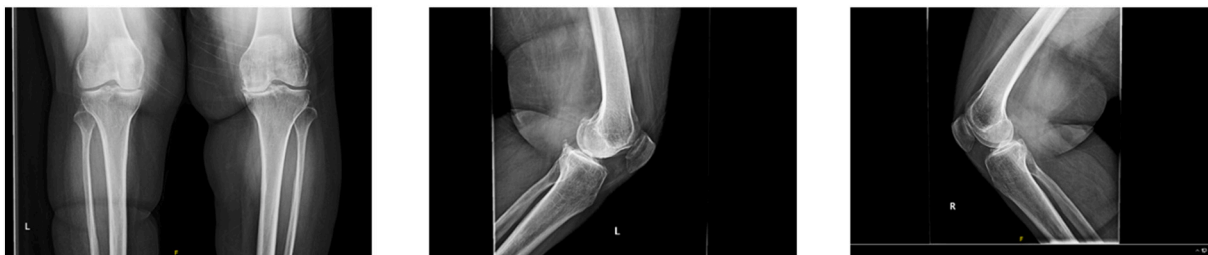
An obese (BMI 32) 70 year-old female has been following in our orthopedic clinic in King Saud University Medical City since 2015 for left knee osteoarthritis (Image 1). A trial of conservative management failed therefore, she underwent TKA in February 2015 through a medial parapatellar approach and using the Persona PS-TKA system (Zimmer

Image 1. Bilateral knees standing AP and lateral radiographs during first visit in clinic.

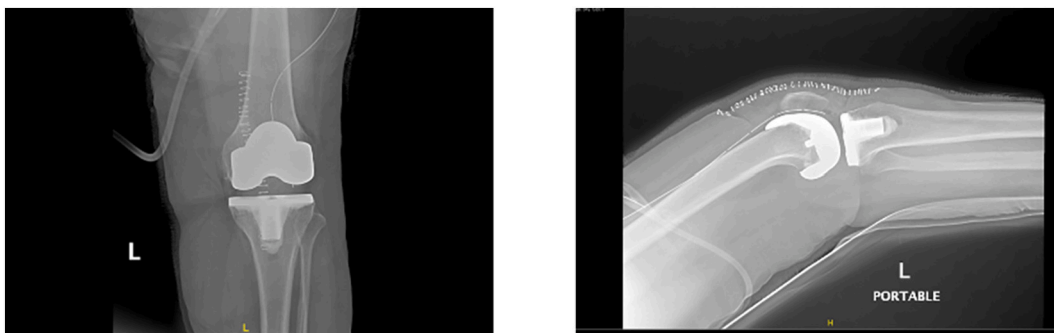
biomet, USA). The sizes used were femur size 5, tibia size D, and the insert thickness was 12 mm which was sterilized using ethylene oxide (Image 2). Post-operatively, she was mobilizing and compliant with physical therapy.

Image 2. AP and lateral radiographs post Left total knee arthroplasty.

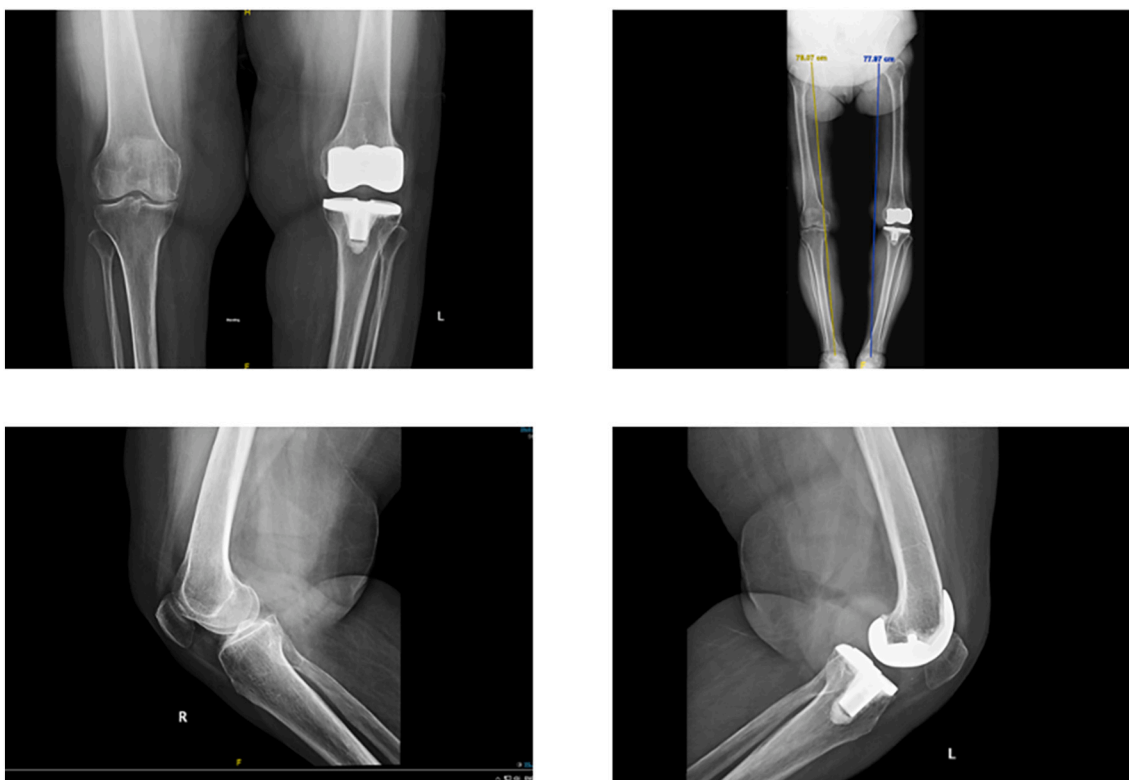
In March 2021, she presented to the clinic complaining of left knee pain and inability to bear weight following a fall on a flexed knee. Her drug, family, and psychosocial history were unremarkable. Examination and imaging AP and lateral standing both knees X-rays were unremarkable, therefore, she was given analgesia and follow-up. She presented 3 months later complaining of pain and instability with weight bearing. Her examination showed varus laxity and recurvatum. Standing AP, lateral and full length lower limbs standing radiographs showed a varus deformity and no loosening (Image 3). She was placed in a knee brace and booked for revision TKA. The patient and relatives were in agreement with our treatment plan.

Image 3. Bilateral knees standing AP and lateral and full-length standing radiographs 16 months post left total knee arthroplasty.

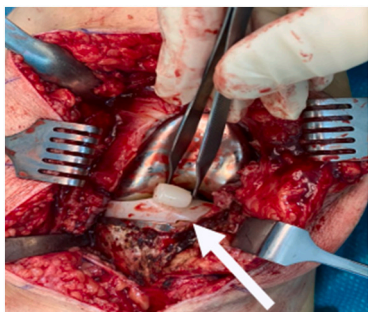
She underwent left revision TKA in July 2021, which was done by the senior author. Intraoperatively, she was found to have a broken polyethylene tibial post and cone (Image 4), as well as a stretched but intact lateral cruciate ligament. The polyethylene liner was initially exchanged, but since instability with varus laxity persisted on examination, both femur and tibia components were revised using the Persona revision system (Zimmer biomet, USA). The sizes used were tibia size D, 10 mm stem, 10 mm augment used both medial and lateral, femur size

Image 4. Intraoperative photograph showing broken tibial post.

Contrary to the available literature, our case describes a rare complication of a tibial post and polyethylene cone fracture after a minor trauma several years after undergoing PS-TKA. It shows an obese female with a history of minor trauma 3 years after her primary TKA. In our case, two implant fractures were encountered, which up to our knowledge, has yet to be reported in the literature. Furthermore, this is the first case that has been described with fractures occurring using the Zimmer Persona PS-TKA system. In addition, most of the published reports showed good outcomes by only changing the polyethylene insert. However, in our case, the initial hardware was well-positioned but our patient remained to have laxity when we changed the insert, which required an exchange of the entire hardware into a constrained implant (Zimmer Biomet, USA). We believe that this remaining laxity is due to the long duration of having the fractured implant in place (4 months), which may have led to stretching of the lateral collateral ligament.

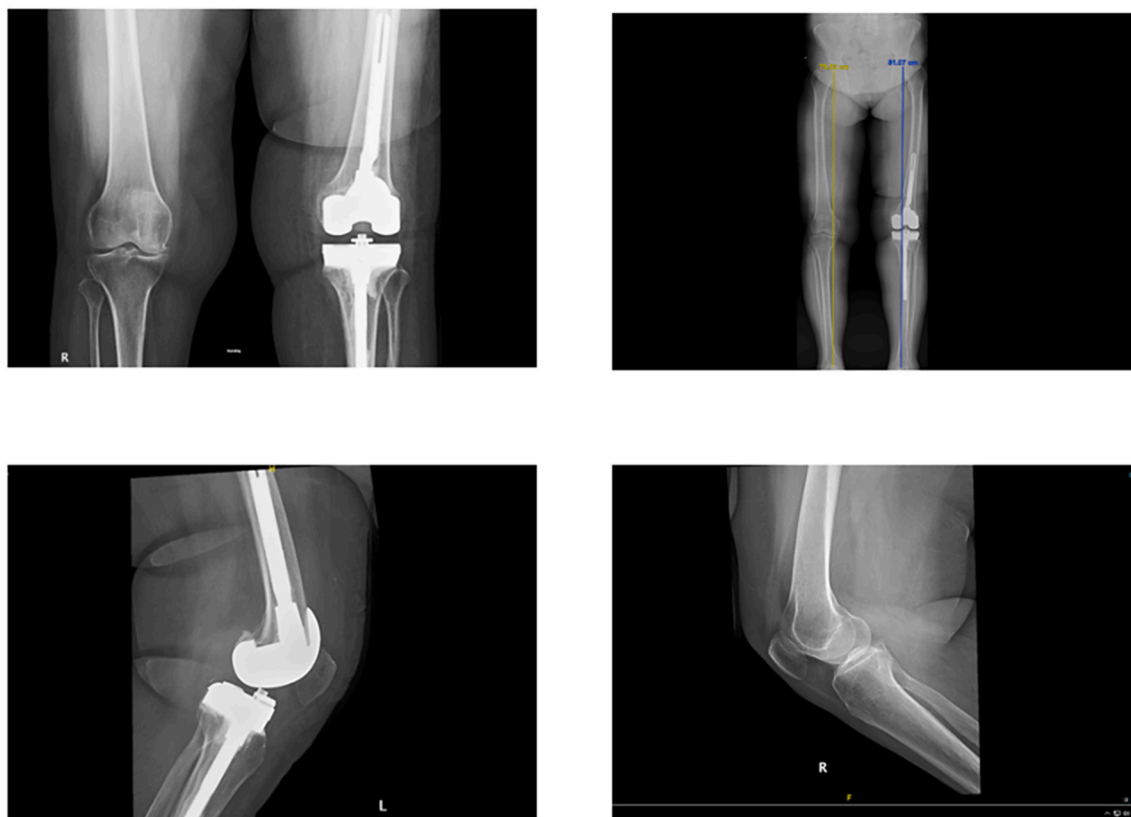
her next visit. During her latest follow up at 1 month post-operatively (August 2021), she was doing well and compliant with the physical therapy protocol. The hinged knee brace was removed and her examination showed a stable knee and ROM from 0 to 90 degrees. Her radiographs showed good alignment (Image 5). We initiated weight bearing as tolerated and ROM without the brace. She is still being seen in

Image 5. Bilateral knees standing AP and lateral and full-length standing radiographs 1 month post left knee revision arthroplasty.

5+, 13 mm stem with 9 offset, posterior augment medial condyle 5 mm, and a 14 mm Insert. Examination afterwards revealed a stable knee.
