Check Central Venous Catheter Set thoroughly or Bite the Bullet!

Indian Journal of Critical Care Medicine (2021); 10.5005/jp-journals-10071-23891

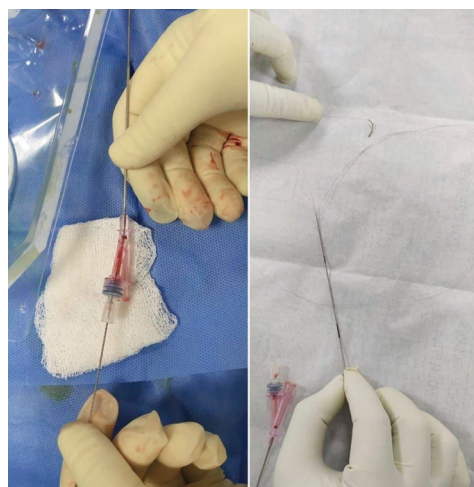
A 55-year-old man, known case of chronic liver disease with portal hypertension, hepatic encephalopathy grade 2 and ascites, and COVID-19 (RT-PCR positive), was admitted to COVID-19 intensive care unit (ICU) with two episodes of hematemesis from the ward. On admission, he was drowsy with a pulse rate of 130 beats/minute, a blood pressure 96/56 mm Hg on noradrenaline infusion at the rate of 0.1 μ /kg/min, and oxygen saturation of 90% at room air. He was intubated in view of threatened airway. His basic lab parameters were as follows: Hb—5.6; TLC—6600; platelet count—80,000; INR—4.6; serum bilirubin—8.2; SGOT/SGPT—163/216; urea—76; creatinine—5.2; serum Na—127; and serum K—4.7. The management was started according to the standard hospital protocol. In view of vasopressor support, ultrasound-guided right internal jugular vein (IJV) cannulation was planned keeping in mind the risk of bleeding due to deranged coagulation and thrombocytopenia. After proper positioning and complete aseptic precaution, the right IJV was identified with the help of a high-frequency linear probe of ultrasound. After local anesthetic infiltration, under real-time ultrasound, right IJV was punctured and guidewire insertion tried through Y-connector of the needle. There was some resistance in insertion and only 5 cm of the guidewire could be negotiated. After a while of unsuccessful negotiation, we decided to remove the guidewire but it was stuck inside the needle. We removed needle–guidewire assembly as a whole and pressed the insertion site to avoid bleeding. After removal of whole conduit, we tried to pull out the guidewire but could not as it was stuck somewhere around the valve part (Fig. 1). We manually straightened the J-part of guidewire and tried to negotiate, but we failed. Then we pulled a little harder, and it opened like a spring (Fig. 1) and came out. Thereafter, we opened the new catheter set and could cannulate IJV easily in one go.

the introducer needle. In our case, the guidewire was stuck similarly and we tried to remove the guidewire by maneuver described by Arya et al.² We could not retrieve even by rotating the guidewire or needle by 90 to 180° mainly because in our case, the guidewire was stuck at the hub of Y-piece and not at the tip. Similarly, the technique described by Henderson³ did not work because the needle could not be retrieved over the guidewire.

Fig. 1: Guidewire stuck at hub (L), and after applying some force, it opened like spring (R)

embolization, multiple punctures leading to pneumothorax, and large hematoma. We would like to emphasize on revising the simplified preprocedural checklist described by Gandhi et al.⁴, highlighting the last point that says about the ability to negotiate the guidewire through introducer needle using a dispenser. So an ounce of prevention is worth a pound of cure; this way we can further minimize procedure-related complications, especially in cases with deranged coagulation.
