# Aneurysm Perforation Due to Advancement of the Coil Delivery Wire During Stent-Assisted Embolization

We report a case of intraprocedural aneurysm rupture during coil embolization caused by a coil delivery wire. A 68-year-old woman underwent stent-assisted coil embolization for an unruptured aneurysm in the internal carotid artery (ICA). A low profile visible intraluminal support device was deployed at the aneurysm neck. Coil embolization was performed with a jailing technique. After deflection of the jailed microcatheter was released, a coil was placed in the aneurysm against resistance to coil insertion. The movement of the microcatheter tip was restricted with the stent. A coil delivery wire that was advanced after coil detachment perforated the aneurysm. Hemostasis was achieved, and coil embolization was finished with a slight neck remnant. Complete occlusion of the aneurysm was confirmed on angiography six months later. Advancement of a coil alignment marker after coil detachment may cause aneurysm perforation due to coil delivery wire advancement. In stent-assisted coil embolization, when the movement of the microcatheter tip in the aneurysm is restricted by the stent and t

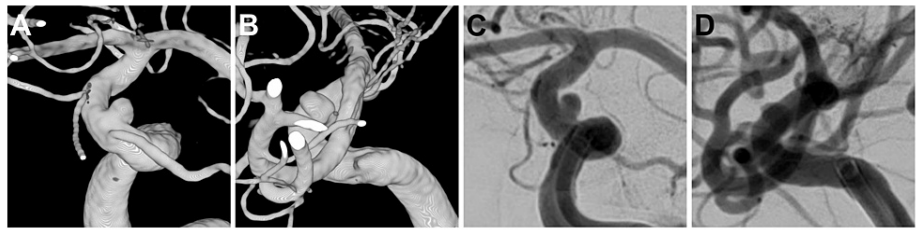
**FIGURE 1: Working projection angiography before endovascular surgery.**

3D reconstructed angiography (A, B) and angiography (C, D) of the left internal carotid artery. The angle was set so that the aneurysm neck and the parent vessel were separated (A, C), and the internal carotid artery in which the stent was to be placed was depicted long enough (B, D).

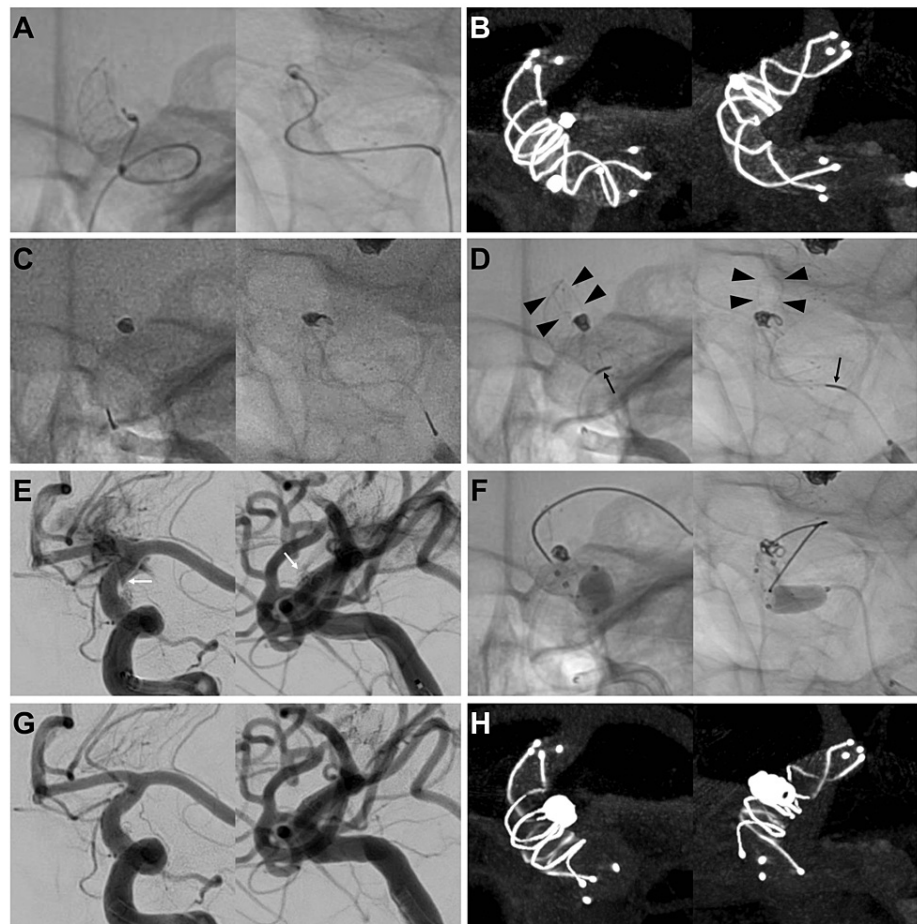
### FIGURE 2: Imaging findings during endovascular surgery.

The left side of each panel was the frontal working projection, and the right side of the lateral working projection. (A) Native imaging. A microcatheter was advanced into the aneurysm. One loop of a coil was inserted, and a stent was placed. (B) Cone beam CT with five-fold diluted contrast media shows an increased metal coverage of the aneurysm neck. (C) Native imaging. The coil was placed in the aneurysm, and the rear end of the coil alignment marker and the second microcatheter marker were matched. (D) Native imaging after coil detachment shows 9-mm advancement of the coil alignment marker (black arrows) compared to its position before detachment and advancement of the coil delivery wire (arrowheads) through the aneurysm wall. (E) Left internal carotid angiography after retrieving the perforated coil delivery wire showing extravasation of contrast media from the aneurysm (white arrow). (F) Native imaging. The balloon catheter was expanded at the proximal portion of the aneurysm. (G) Left internal carotid angiography after temporary balloon expansion shows no extravasation of contrast media from the aneurysm, and the aneurysm was occluded with a slight neck remnant. (H) Cone beam CT with five-fold diluted contrast media at the end of the surgery shows an increased metal coverage by shortening the proximal portion of the stent.

The patient received endovascular surgery under general anesthesia. We kept activated clotting time over 250 s during the surgery. An 8-Fr guiding catheter was inserted into the left femoral artery and was advanced to the cervical portion of the left ICA. Via this catheter, a 6-Fr Cerulean (Medikit, Tokyo, Japan) was advanced to the cavernous portion of the left ICA, and a microcatheter for stent deployment (Headway 21; Terumo, Tokyo, Japan) was placed at the superior trunk of the left middle cerebral artery. A microcatheter for coil embolization (Headway 17; Terumo, Tokyo, Japan), which was shaped with steam in accordance with the form of the aneurysm and the left ICA, was advanced into the aneurysm. After one loop of Target 360 Nano 2.5 mm × 4 cm detachable coil (Stryker Neurovascular; Fremont, CA, USA) was placed into the aneurysm through the microcatheter, a low-profile visible intraluminal support device (LVIS) Blue 3.5 mm × 22 mm (Terumo, Tokyo, Japan) was deployed from the C1 portion to the C4 portion of the left ICA with increased metal coverage at the aneurysm neck (Figure 2A). The Target 360 Nano 2.5 mm × 4 cm was removed, and cone beam CT with five-fold diluted contrast media showed good attachment of the stent to the vessel wall (Figure 2B). Insertion of the Target 360 Nano 2.5 mm × 4 cm into the aneurysm via the Headway 17 that was jailed with the stent was attempted, but it was retrieved because the resistance increased during the coil insertion. A smaller coil was chosen, and a Target 360 Nano 2.0 mm × 3 cm was placed in the aneurysm. The longer the coil was placed into the aneurysm, the greater the resistance became, but the coil was entirely placed in the aneurysm after deflection of the Headway 17 was gradually released (Figure 2C). Once the rear end of the coil alignment marker was overlapped to the second microcatheter marker, the coil delivery wire was fixed at the proximal part of the microcatheter, and the coil was detached. The coil alignment marker advanced 9 mm immediately after coil detachment, and a coil delivery wire perforated through the aneurysm wall (Figure 2D). Angiography after retrieving the coil delivery wire showed extravasation of contrast media from the aneurysm (Figure 2E). A Scepter XC balloon catheter 4 mm × 11 cm (Terumo, Tokyo, Japan) was advanced from the guiding catheter and expanded in the left ICA proximal to the aneurysm after antihypertensive therapy, manual common carotid artery compression, and reversal of heparin with protamine were implemented (Figure 2F). The Headway 17 came out from the aneurysm because the expansion of the Scepter balloon shortened the proximal side of the LVIS. Angiography 5 min after blocking the proximal ICA revealed the disappearance of extravasation of contrast media and a slight neck remnant of the aneurysm (Figure 2G). Coil insertion with a trans-cell approach was difficult because of an increased metal coverage of the aneurysm neck with the LVIS. Cone beam CT with five-fold diluted contrast media showed an increased metal coverage at the proximal portion of the aneurysm neck by the shortened LVIS. Angiography 10 min later revealed no extravasation of contrast media, and the surgery was finished.

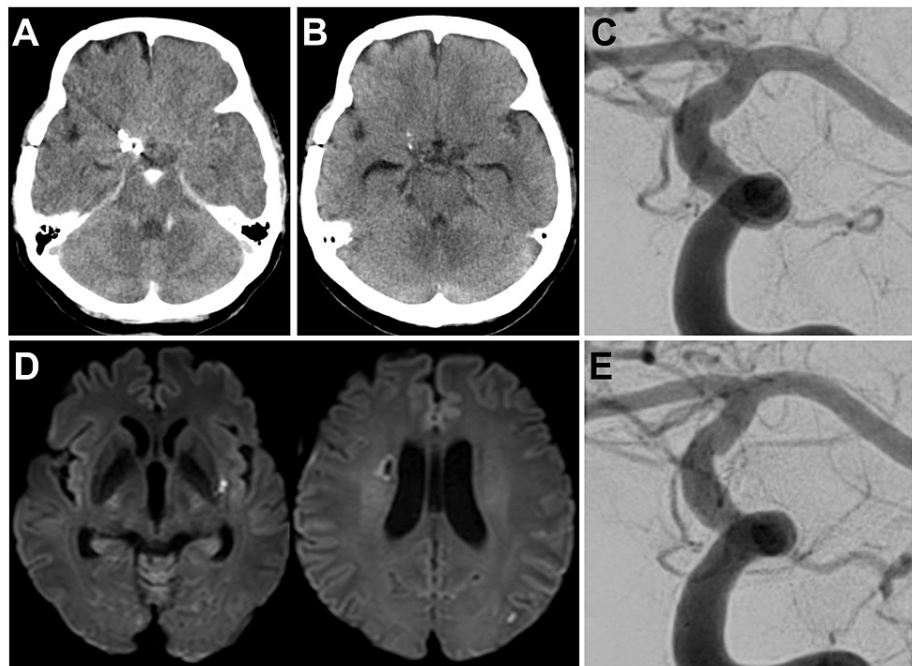
**FIGURE 3: Imaging findings after endovascular surgery.**

(A) CT immediately after surgery shows a high-density area in the interpeduncular cistern. (B) CT the day after surgery revealed that the high-density area in the subarachnoid space has almost disappeared. (C) Left internal carotid angiography of working projection the day after surgery shows no extravasation of contrast media and a slight neck remnant of the aneurysm. (D) Diffusion-weighted MRI of the head the day after surgery shows a small high intensity spot outside the left putamen and in the left occipital lobe. (E) Left internal carotid angiography of working projection six months after surgery showing complete occlusion of the aneurysm.

The CT immediately after surgery showed a high-density area in the interpeduncular cistern (Figure 3A). The patient was kept under general anesthesia, and CT the day after surgery revealed the disappearance of most of the high-density area (Figure 3B). Angiography the day after surgery showed no extravasation of contrast media and a slight neck remnant of the aneurysm. There was no neurological deficit after emergence from general anesthesia. MRI revealed diffuse and spotted cerebral infarction in the left cerebral hemisphere (Figure 3D). The VerifyNow system showed an aspirin resistance unit of 418 and a P2Y12 reaction unit of 256, and oral administration of aspirin 100 mg/day and clopidogrel 75 mg/day were continued while cilostazol was discontinued because of the perforation. The postoperative course was uneventful, and the patient was discharged home 10 days after surgery. Angiography six months after surgery revealed complete occlusion of the aneurysm (Figure 3E).

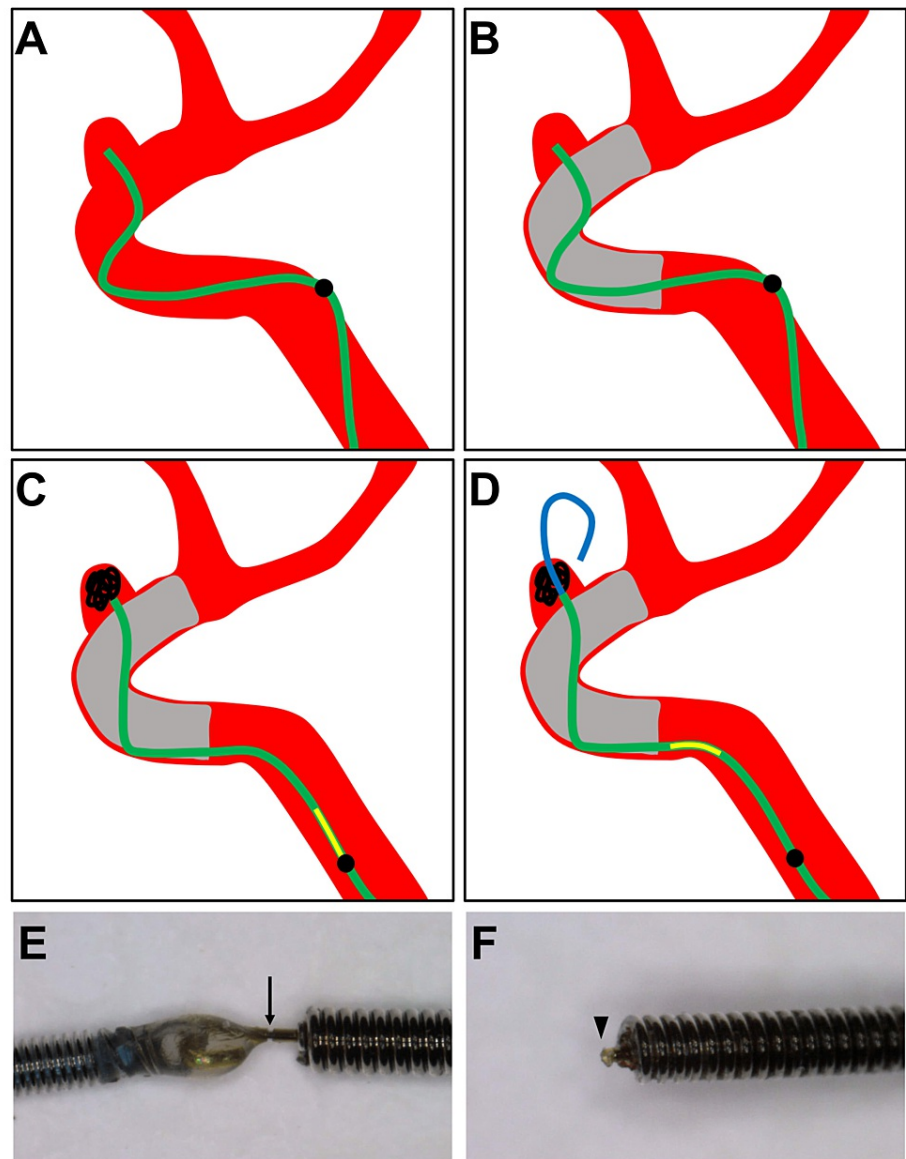
**FIGURE 4: The process of aneurysm perforation.**

In this case, first of all, a microcatheter for coil embolization was advanced into the aneurysm (Figure 4A). The microcatheter movement was restricted because it was jailed due to LVIS deployment (Figure 4B). Since there was resistance when placing a coil, the coil was inserted into the aneurysm while pulling the microcatheter (Figure 4C). The movement of the microcatheter tip was restricted because of an increased metal coverage of the aneurysm neck with the LVIS. On the other hand, the proximal portion of the microcatheter was flexible and straightened. There was resistance when placing the coil, and the coil delivery wire wound inside the microcatheter. During coil detachment, deflection of the coil delivery wire was released, and the wire was advanced and perforated the aneurysm (Figure 4D). Since the tip of the coil delivery wire became sharp after coil detachment, there was a high possibility of its causing perforation once being advanced toward the aneurysm wall (Figure 4E,F).

(A-D) The process of aneurysm perforation due to coil delivery wire advancement. Green line: the microcatheter for coil embolization, Black line: the coil, Yellow line: the coil alignment marker, Blue line: the perforated coil delivery wire, Black point: the second microcatheter marker, Grey area: the low-profile visible intraluminal support device (LVIS). (A) A microcatheter was inserted into the aneurysm, conforming to the shape of the blood vessel. (B) An LVIS was placed at the aneurysm neck. (C) The movement of the microcatheter tip was restricted by the LVIS. Deflection of the proximal portion of the microcatheter was released, and the microcatheter was straightened. A coil was inserted into the aneurysm against resistance. (D) After coil detachment, deflection of the coil delivery wire was released, and the aneurysm was perforated. (E-F) Photographs of the Target coil detachment zone. (E) The coil (0.010 inch) and the coil delivery wire (0.014 inch) are connected in the detachment zone (arrow). (F) The sharp tip (arrowhead) of the coil delivery wire after coil detachment.

In this case, we used a jailing technique [12], which may have caused the advancement of the coil delivery wire during coil detachment because the microcatheter was jailed by the stent, and its movement was restricted. When using a semi-jailing technique [13] and a trans-cell approach [14], the microcatheter movement is not restricted by the stent, and the microcatheter moves backward when there is resistance to coil insertion. During coil detachment, the coil delivery wire does not advance, but the microcatheter does. Accordingly, among techniques for stent-assisted coil embolization, only the jailing technique is associated with perforation caused by coil delivery wire advancement.

In this case, a smaller coil with different shapes should have been chosen because resistance to coil insertion increases due to the situation in which the movement of the microcatheter tip is restricted. Alternatively, removing the jailed microcatheter without the coil insertion in anticipation of the flow diverter effect may be an option. Using tactile and visual feedback to anticipate problems would have saved the complication in this case. During surgery, the advancement of a coil alignment marker was confirmed after coil detachment, but aneurysm perforation due to the coil delivery wire was not recognized. Angiography was performed to clarify the situation after the coil delivery wire was retrieved, and aneurysm perforation was recognized. When aneurysm perforation occurs, the device that caused the perforation should be left on site [15]. The coil delivery wire that perforated the aneurysm must be removed; however, additional coil insertion, blocking of the ICA, preparation of heparin reverse, and hypotensive management should have been performed before removal of the coil delivery wire. In this case, the high-density area in the subarachnoid space on postoperative CT was mostly due to leakage of contrast media, as it was washed away on CT the following day. Angiography immediately after removal of the coil delivery wire indicated that the contrast agent leaked from the perforation site, and if the situation had been recognized, angiography should not have been performed at the normal injection pressure.
