## Case Report

# Guidewire-Related Complications during Central Venous Catheter Placement: A Case Report and Review of the Literature

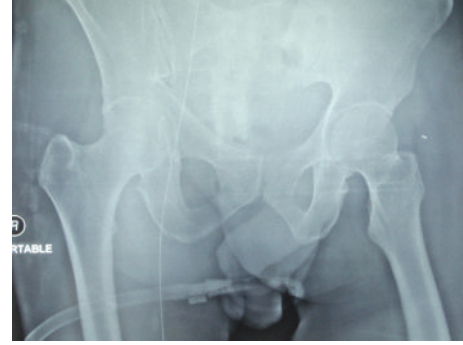
FIGURE 3: Pelvic X-ray showing the guidewire extending into the femoral vein in the right thigh.

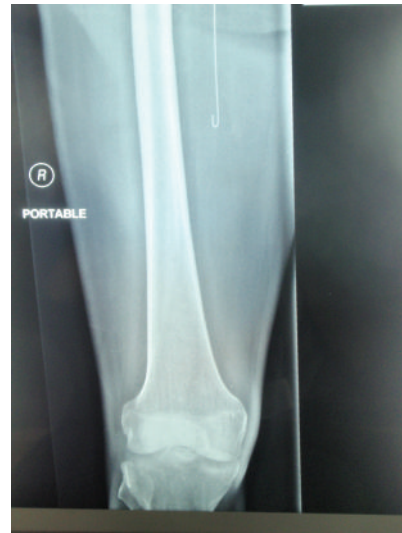
FIGURE 4: Right thigh X-ray showing the J-tip of the lost guidewire medial to the femur.
