Article

Plasticity of Bead-on-Plate Welds Made with the Use of Stored Flux-Cored Wires for Offshore Applications

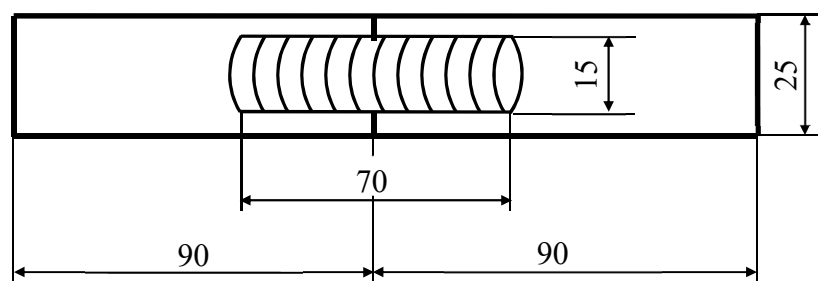
Figure 1. Scheme of test specimen and dimensions in millimeters.

Bead-on-plate welds were made on S355J2 steel specimens with thicknesses of 10 mm. Dimensions of specimens are given in Figure 1, chemical composition of base material and weld metal made with the use of wires is given in Table 1. Basic mechanical properties of weld metal made with the use of wires are given in Table 2.

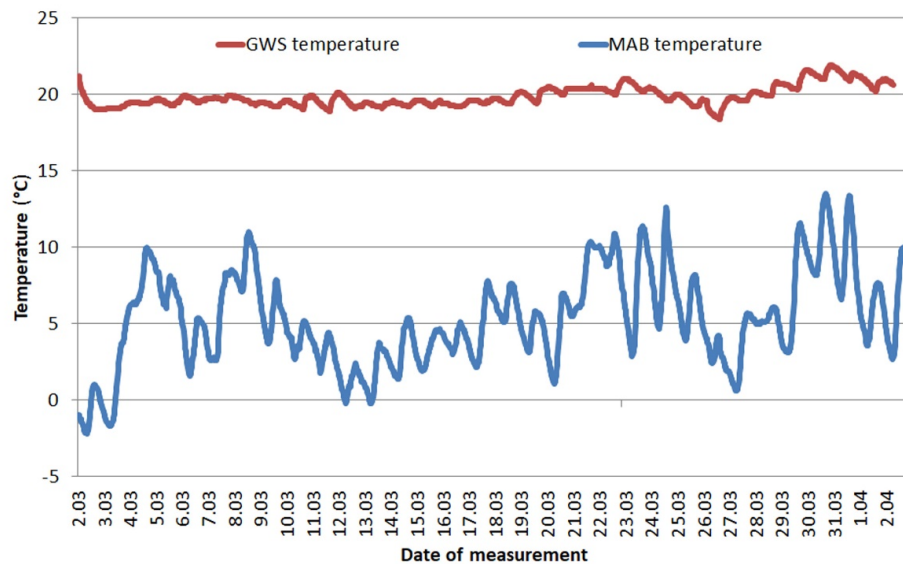
Figure 2. Ambient temperature changes during wires storage—Gdańsk welding site (GWS) and Mońki agricultural building (MAB)—1 month.

A clear difference is visible between the temperatures in MAB and GWS. For MAB, the temperature curve is always below the temperature curve measured in GWS. Storage conditions in GWS were stable in terms of temperature, temperature shocks are not visible.

A comparison of temperature changes in GWS and in MAB is shown in the Figure 2. In addition, the Table 3 presents values of statistical measures and coefficients describing the temperature changes at each location in a given time period.

The differences in recorded temperatures for studied areas result from both geographical and anthropogenic factors. The north-eastern part of Poland is an area where the continental climate with a higher temperature gradient begins to dominate. It results in clearly lower temperatures compared to Gdańsk, which is a port city, with a predominance of maritime climate. The second factor results from the degree of urbanization of both locations—Mońki is a small city and Gdańsk is a main city of a metropolitan area in northern Poland. The more specifically analyzed conditions in which the wires were stored may lead to the reason for differences in recorded relative humidity. The welding side is usually a drier place, there are not many sources of moisture. In contrast, unheated MAB may be exposed to increased air flow and water vapor supply from the environment. This analysis of the storage conditions is visible in Figures 2 and 3.

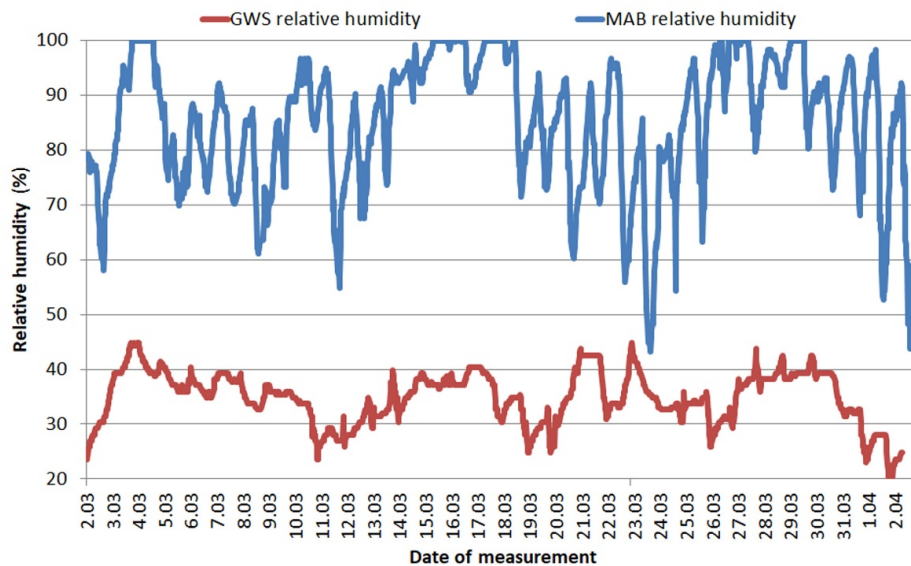
For MAB, the registered humidity is very high, reaching up to 100%, which means that in the place where the wires were stored, the air was saturated with water vapor. The humidity was clearly lower in GWS. It did not exceed 50% at any time. Differences in the waveforms of temperature and relative humidity result, among others, from the fact that the GWS was heated.

Figure 3. Ambient humidity changes during wires storage—Gdańsk welding site (GWS) and Mońki agricultural building (MAB)—1 month.

The Figure 3 shows a comparison of changes in relative humidity at the same time and for the same places. Coefficient values describing the change in this property are also given in Table 3.

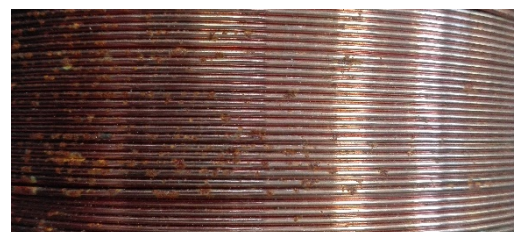
Differences can also be seen between the degradation that occurred in A wire and B wire. Both wires stored in the GWS have a shiny, smooth surface with no corrosion areas and no visible signs of degradation or environmental impact. In the MAB environment, A wire began to undergo surface corrosion—numerous corrosion areas of a small range are visible. The boundaries between the individual coils are clear, the non-corroded areas are still shiny and smooth. The B wire stored in the same environment was significantly more degraded. The entire surface is covered with corrosion products, which in some places have a significant thickness. Areas without a thick layer of rust were covered with a thin layer of corrosion products and there were no shiny areas.

Figure 4. The surface layer of wire after storage: (a) A wire stored in Gdańsk welding site (GWS); (b) A wire stored in Mońki agricultural building (MAB); (c) B wire stored in Gdańsk welding site (GWS); (d) B wire stored in Mońki agricultural building (MAB).

Wires in delivery condition and wires stored for 1 month have been subjected to visual examinations. Photographs of the surface layer of those wires in delivery condition were already presented in the previous publication [20]. Pictures of the surface of the stored wires are shown in Figure 4. It can be clearly seen that the surface of wires stored in MAB has greater degradation than the surface of wires stored in GWS.

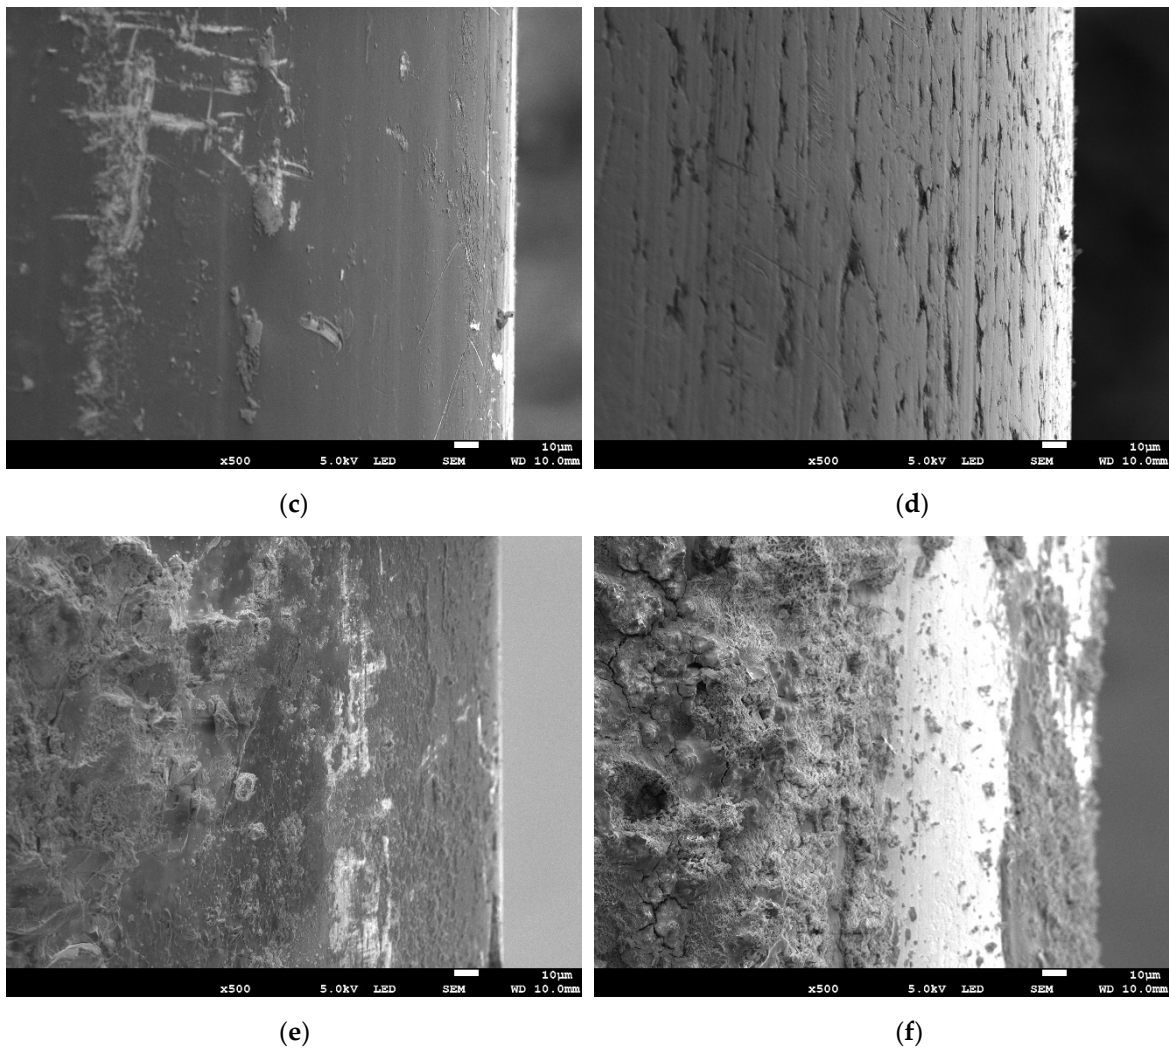
SEM images show that the surfaces of both wires in delivery condition significantly differ (Figure 5a,b). The A wire is smooth, has a homogeneous surface without gaps in the continuity of the copper coating. On the contrary, B wire shows longitudinal grooves on the surface, located parallel to the axis of the wire and the direction of material forming. After storing the wires in GWS, A wire still has a smooth surface; only small precipitations can be observed on it (Figure 5c). The EDS analysis (Figure 6a) shows that these products mainly contain copper. B wire behaved similarly—in the grooves visible in Figure 5d, copper compounds accumulated (Figure 6c). Both wires from the MAB location are characterized by a high degree of degradation (Figure 5e,f). On their surface, precipitations of iron oxides were found, which was confirmed by the EDS analysis (Figure 6b,d). The differences between these wires can be seen in the SEM photos at higher magnification—A wire is only locally covered with a thicker layer of corrosion products, but a thin, brittle layer of iron oxides has formed on its surface (Figure 6b). A much thicker layer of corrosion products has accumulated on B wire. Figure 5e,f show the most degraded parts of the wires. Figure 5c–f also show the edge of the wires, which in each case shows no signs of corrosion other than atmospheric corrosion.

Figure 5. Surfaces of flux-cored wires: (a) A wire in delivery condition; (b) B wire in delivery condition; (c) A wire stored in GWS; (d) B wire stored in GWS; (e) A wire stored in MAB; (f) B wire stored in MAB.

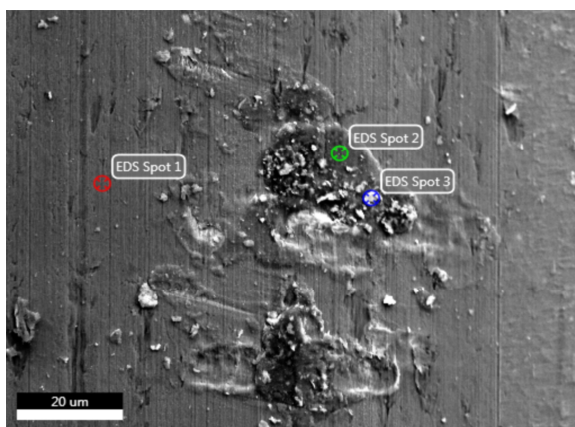
Zone	Fe	Cu	O	S
EDS Spot 1	5.01	91.44	3.55	-
EDS Spot 2	4.64	86.83	7.46	1.07
EDS Spot 3	4.19	90.68	4.48	0.65

Zone	Fe	Cu	O	S
EDS Spot 1	5.57	92.18	1.49	0.76
EDS Spot 2	43.53	53.44	2.45	0.58
EDS Spot 3	76.09	13.70	7.74	2.48

Zone	Fe	Cu	O	S
EDS Spot 1	22.38	65.55	9.43	2.68
EDS Spot 2	47.97	52.03	-	-
EDS Spot 3	22.37	58.85	19.48	4.30

Zone	Fe	Cu	O	S
EDS Spot 1	60.51	5.43	33.58	0.48
EDS Spot 2	66.30	33.70	-	-
EDS Spot 3	71.56	6.04	21.74	0.66
EDS Spot 4	60.68	6.26	32.61	0.45

Figure 6. SEM image and spot EDS analysis of flux-cored wires: (a) A wire stored in GWS; (b) A wire stored in MAB; (c) B wire stored in GWS; (d) B wire stored in MAB.

2. The wires stored in the welding site had a less degraded surface and after storage the copper compounds appeared in grooves. After being stored in an agricultural building, the surface of the wires was covered with iron compounds—for the B wire the amount of corrosion products is greater.

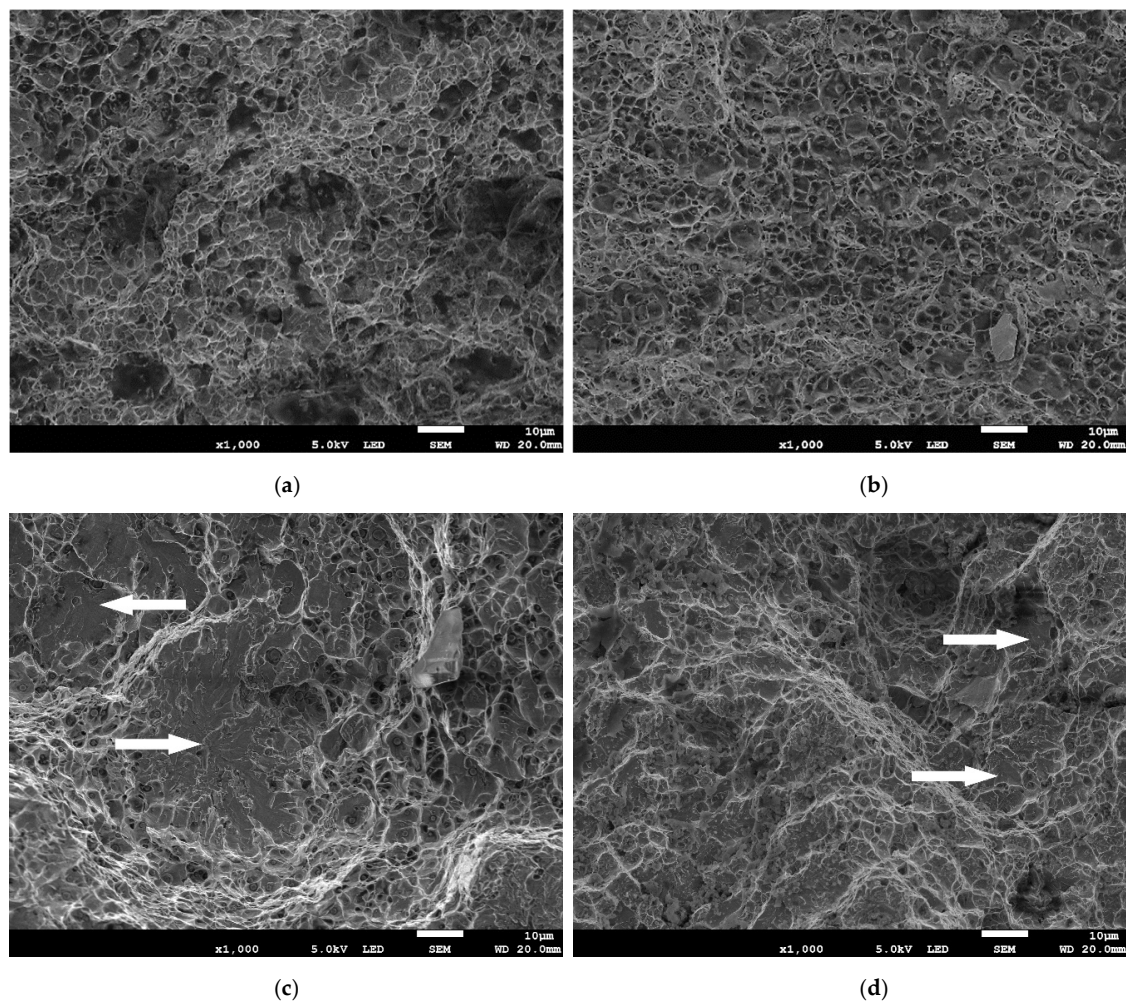
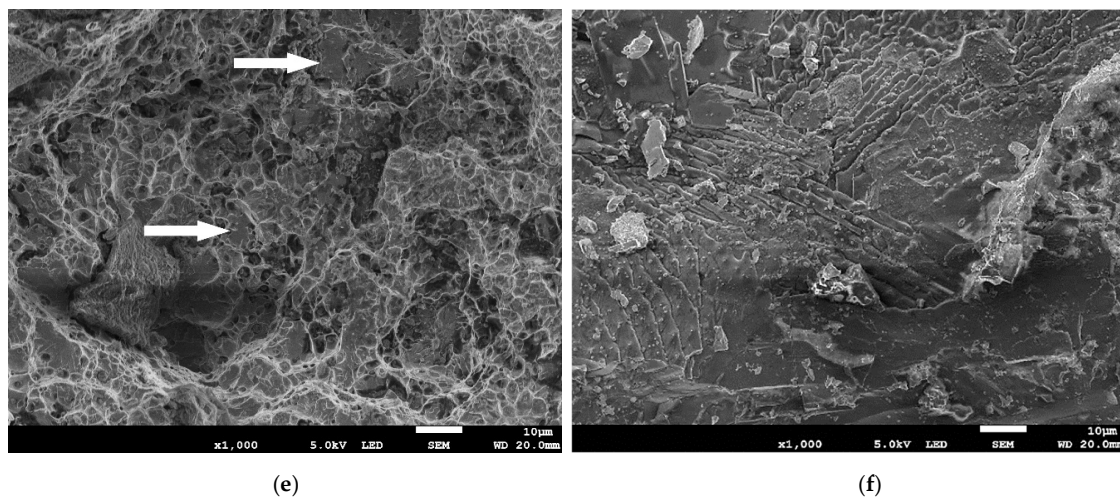
Figure 10 shows SEM images of fractures after tensile test. In Figure 10a,b, dimples, characteristic of the ductile microvoid coalescence fracture, are clearly visible. Such a fracture mode predominated in specimens made with wires in delivery condition. An increased share of the brittle fracture (marked with white arrows) was observed in specimens made of wire from the GWS and in the specimen made of A wire from MAB (Figure 10c–e). In this case, the quasi cleavage fracture was found. Three zones can be observed—at the face the fracture was more ductile, dimples appeared larger, in the middle zone between dimples flat cleavage areas appeared and at the root there were dimple clusters and larger areas of cleavage, with large steps. Figure 10f shows the fracture surface of a specimen made using B wire stored in MAB. In this specimen, cleavage fracture dominates. At 1000× magnification, only single dimples are visible, situated between large cleavage areas.

Figure 10. Fracture surfaces of specimens after tensile tests: (a) specimen made using A wire in delivery condition; (b) specimen made using B wire in delivery condition; (c) specimen made using A wire stored in GWS; (d) specimen made using B wire stored in GWS; (e) specimen made using A wire stored in MAB; (f) specimen made using B wire stored in MAB.

A change in plasticity can also be observed by comparing the mode of fracture of the tensile tested specimens (Figure 10). The most characteristic is the transition from the ductile microvoid coalescence fracture to the almost complete cleavage fracture for the specimen made using B wire stored in MAB. Such a great change is directly related to the results of plasticity indexes (Table 5), which also indicate a very intense degradation of bead-on-plate weld plasticity for this wire and location. In all fracture surfaces, at least some dimples were found and they were all equiaxed, which confirms that tensile loading was the main loading type responsible for breaking of specimens.

4. The mode of the fracture in tensile specimens varied depending on the storage conditions and grade of wire. Under the influence of monthly storage, there was a change from the ductile microvoid coalescence fracture to the almost complete cleavage fracture.
