CASE REPORT: CLINICAL CASE

Valve Cracking Before Valve-In-Valve Transcatheter Aortic Valve Implantation to Treat Severe Paravalvular Leak

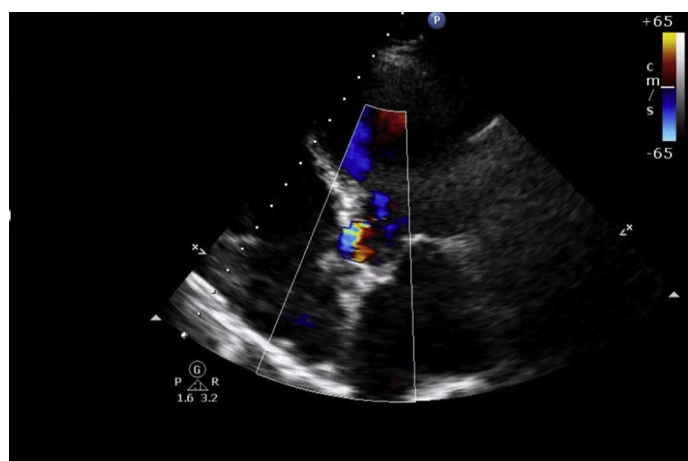
FIGURE 1 Transthoracic Echocardiography at Initial Presentation

Transthoracic echocardiography showing aortic paravalvular leak.

severe with deceleration time of 153 ms, and dense continuous wave Doppler signal (Figures 1 and 2, Video 1). Laboratory results showed elevated serum creatinine level of 264 $\mu\text{mol/l}$ and elevated blood urea level of 21.3 mmol/l. Computed tomography demonstrated low ostium of the right coronary artery (RCA) and confirmed the huge PVL (Figure 3). Sinus of Valsalva width and height were 33 mm and 12 mm, respectively, diameter of the aorta at the level of the sinotubular junction was 30 mm, and virtual valve to coronary distance was 5 mm. Pre-transcatheter aortic valve implantation (TAVI) cardiac catheterization and angiography showed no significant stenosis and severe PVL (Figure 4, Video 2).

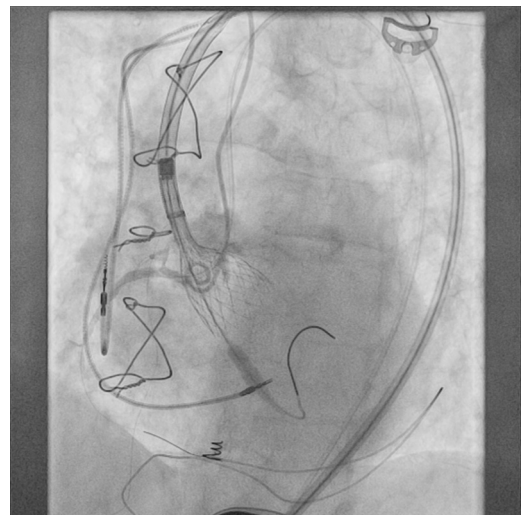
FIGURE 7 Transcatheter Heart Valve Positioning

Right coronary artery injection confirming its patency.

intentionally slightly deeper than the ideal position to secure the patency of the RCA ostium and to seal the paravalvular leak. After implantation there was only a slight residual aortic regurgitation (Figures 7, 8, and 9, Video 4). Echocardiography immediately after the procedure showed diminished regurgitation and preserved mitral valve function without conflict between the THV and the anterior mitral leaflet (Figures 10 and 11, Video 5). In the following days, the patient's symptoms subsided considerably, reclassifying her from NYHA functional class III to NYHA I with improvement in her kidney function too. Urea and creatinine levels reduced more than twice in the next 10 days.
