How is that? Knotting of a peripherally inserted central venous catheter

DOI: 10.4103/0019-5049.65367

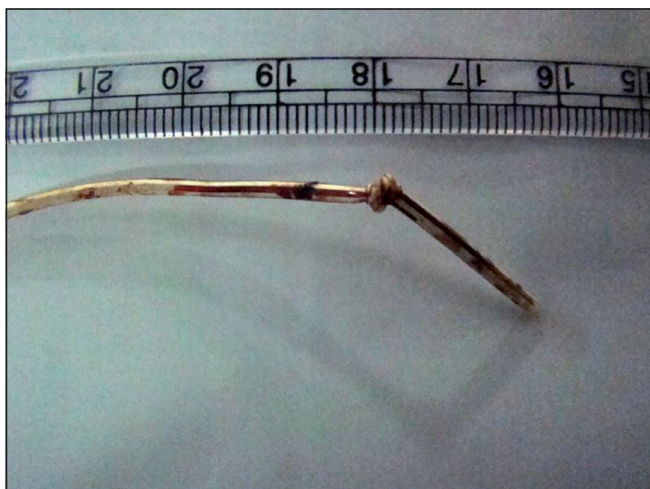
There was no resistance to the withdrawal till a distance of about 2.5 cm from the tip where it got impacted. Palpation just above the puncture site revealed a thickening in the catheter suggestive of a knot. With a venous tourniquet applied in the midarm to prevent a proximal migration of fragments in case of catheter fracture, steady traction was applied to the catheter to deliver it out. It revealed a well-formed knot about 2.0 cm from the tip [Figure 1]. Bleeding at the exit site was controlled with pressure. A

Figure 1: Peripherally inserted venous catheter with a knot about 2.0 cm from the tip

The exact reason for knot formation in our patient is uncertain. It could have happened due to a counterpuncture at the time of the difficult cannulation. Such mechanisms have been implicated even when there is no resistance during cannulation or catheter advancement.^[3]

Aggressive attempts at decannulation should be avoided to minimize damage to the vein or catheter fracture. Whenever possible, the knot should be brought to an area of easy surgical access and removed by venotomy. Using introducers to unravel the knot, a technique suggested for the stiffer catheters, is inappropriate for PICC since the knots here are tighter and the chances of breakage are higher.^[5] When a knot is stuck inside a major vessel or the heart, interventional radiological techniques or a major surgical procedure will be indicated.^[6]

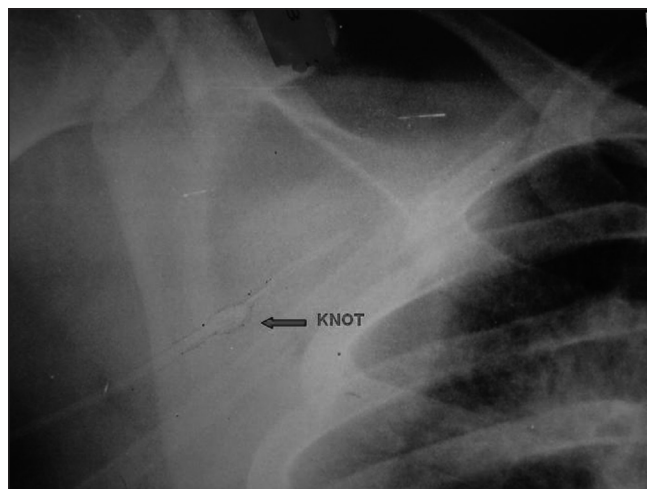
retrospective scrutiny of the immediate postoperative chest X-ray showed a suspicious shadow in the catheter [Figure 2].

Figure 2: Magnified view of the immediate postoperative chest X-ray suggestive of a knot in the catheter identified by retrospective scrutiny

We assert that knot formation should be suspected whenever flow through a PICC is compromised, after the commoner causes are ruled out, especially if there had been difficulty in cannulation, catheter advancement or stillet removal. This should be confirmed by fluoroscopy or a chest X-ray and decannulation planned immediately.
