## Suprascapular nerve injury secondary to cement extravasation in an anatomic total shoulder arthroplasty: a case report

Shoulder arthroplasty  
Nerve injury  
Suprascapular nerve  
Cement extravasation  
Anatomic total shoulder complication  
Arthroplasty revision

*Level of evidence:* Case Report

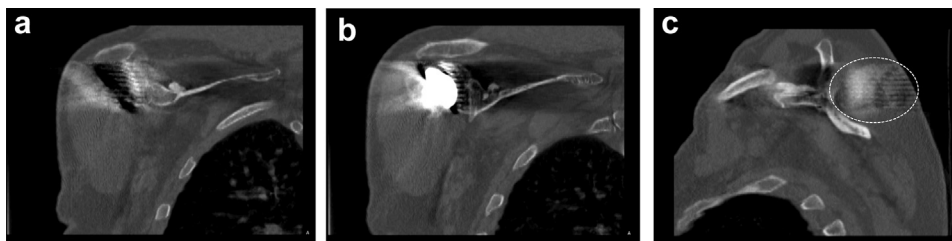
**Figure 1** (a) Coronal CT cut demonstrating cement extrusion into suprascapular notch. (b) Coronal CT scan revealing suprascapular nerve entrapment within cement extrusion. (c) Sagittal CT image demonstrating the expansive nature of the cement along the course of the suprascapular nerve. The area circled represents the cement on CT imaging. CT, computed tomography.

C5-6. A computed tomography of the shoulder demonstrated cement extravasation within the suprascapular notch (Fig. 1, a and b), as well as the expansive nature of the cement extravasation (Fig. 1, c). Upon recognition of the cement mass, the SSN was decompressed through an open trapezius splitting approach.<sup>19</sup> Fibrous tissue and a 4-cm maximum length cement fragment was noted in the area surrounding the area of the suprascapular notch surrounding the nerve (Fig. 2). It was cleared in a careful fashion and gently elevated with a Freer Elevator along its lateral margin near the glenoid surface. The fragment measured 4 cm × 1.5 cm × 1.0 cm (Fig. 3, a) and contained a clear course of the nerve within the inferior portion of the cement (Fig. 3, b). The nerve remained intact though there was some stenosis of the nerve through the area of the suprascapular notch. General neurolysis was performed and the suprascapular ligament was released. He was seen approximately 2 months after his cement removal surgical date and progressed well. His right shoulder range of motion improved to 135° forward flexion, 120° abduction, and 20° of external rotation with shoulder in 0° of abduction. His strength at that time was 4/5 for external rotation with 0° of shoulder abduction, 4+/5 with external rotation at 90° of shoulder abduction, 4+/5 with forward flexion, and 4+/5 for the subscapularis testing. At his last office visit, approximately 8 months from the date of surgery, his range of motion was 130° forward flexion, 120° abduction, 45° of external rotation with shoulder in 0° of abduction, 80° of external rotation with the shoulder abducted to 90°, and internal rotation to his back pocket. Strength of the right shoulder was 4+/5 for external rotation with 0° of shoulder abduction, 4+/5 with external rotation at 90° of shoulder abduction, 5–/5 with forward flexion, and 5–/5 for the subscapularis testing. Overall, the patient recovered well with decreased pain and improved functionality compared to preoperative measures. After the patient's 8-month follow-up, he did not have subsequent follow-up for long period due to geographical remoteness. The patient then followed up with outside institution at 14-year status post–right shoulder arthroplasty with complaints of progressive pain after pushing up from a seated position. Computed tomography scan at that time indicated superior anterior migration of humeral head consistent with rotator cuff tear arthropathy and a poorly visualized glenoid component with suggested loosening. Of greater concern at that time, the patient is in diminishing health and has been diagnosed with dementia. These factors ultimately lead to the family pursuing nonoperative measures for this patient.

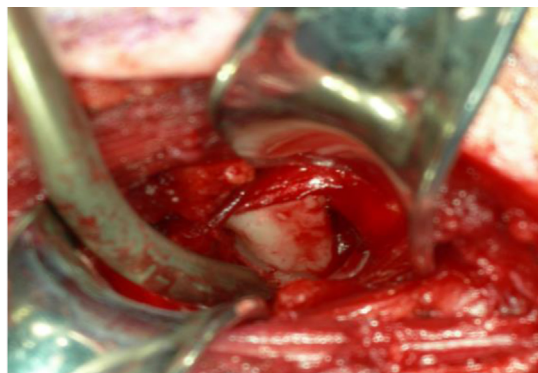
**Figure 2** Intraoperative image demonstrating the nerve entrapped within the cement.

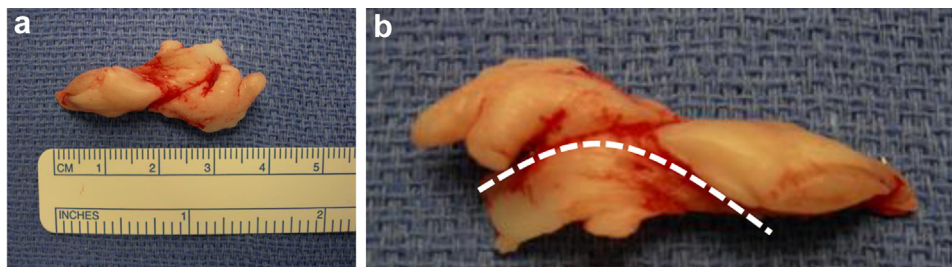
**Figure 3** (a) Extruded cement viewed from superior viewpoint. (b) Inferior view revealing course of suprascapular nerve (white dotted line) through the cement.

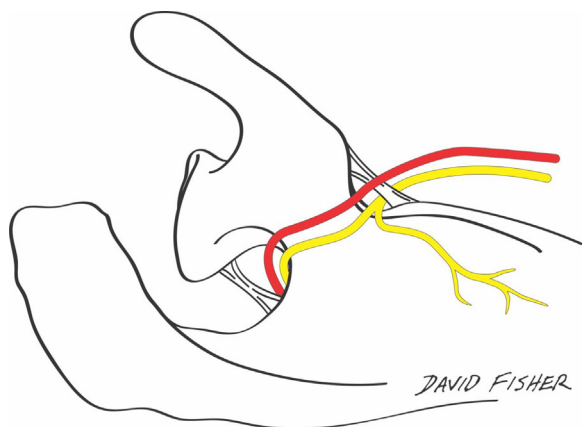
**Figure 4** Illustration demonstrating course of suprascapular nerve. (Illustration used with permission of David Fisher.)

The anatomical course of the SSN has been well defined.<sup>1,18</sup> The SSN ascends from the upper trunk of the brachial plexus involving roots from C5 and C6. The nerve passes downward to the superior border of the scapula and through the suprascapular notch, inferior to the superior transverse scapular ligament, where motor nerves to the supraspinatus muscle branch. From the suprascapular notch

the nerve tracks obliquely and laterally along the supraspinatus muscle in the supraspinatus fossa to the base of the scapular spine. The nerve begins to curve medially once it reaches the base of the scapular spine and passes under the inferior transverse scapular ligament through the spinoglenoid notch, terminating its course by giving off glenohumeral posterior capsule articular branches before innervating the infraspinatus muscle (Fig. 4). Given that the SSN is essentially in a fixed position throughout its course along the fossa, it is susceptible to intrinsic and extrinsic damage which could result in neural pathology.
