An Incognizant Glitch-pinnacle Polyliner Dissociation: A Case Report

Case Report: A 31-year-old male presented with failed femoral head fracture fixation for which total hip replacement was done. Postoperatively at 18 months, he was diagnosed with pinnacle liner dissociation and liner exchange was performed.

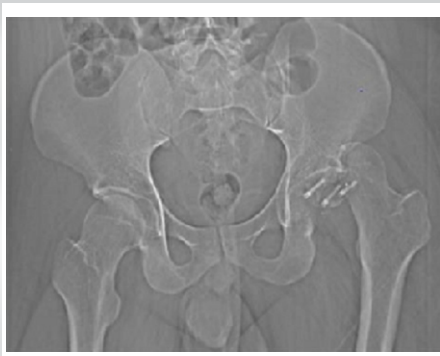
Figure 1: The primary X-ray with which the patient presented at our institute depicting a failed osteosynthesis of femoral head fracture fixation.

A 31-year-old male, BMI 30.61, met with a RTA 2 years back leading to trauma to the left hip. He was diagnosed with Pipkin type 2 femoral head fracture dislocation and underwent open reduction with multiple headless Herbert screw fixation at a peripheral hospital. He presented to us with failed osteosynthesis 1 month post-fixation (Fig. 1).

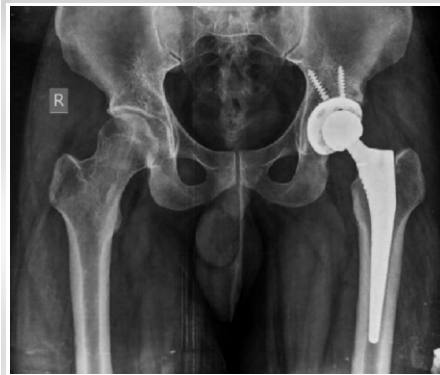
Figure 2: AP view after the primary total hip replacement.

able to resume active lifestyle. At routine 6 months follow-up, patient was doing well and the radiographs showed good integration of the acetabular shell and femoral stem (Fig. 2, 3).

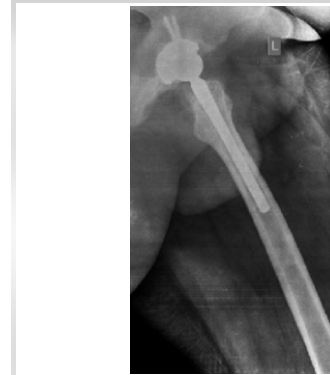
Figure 3: Lateral view after the primary total hip replacement.

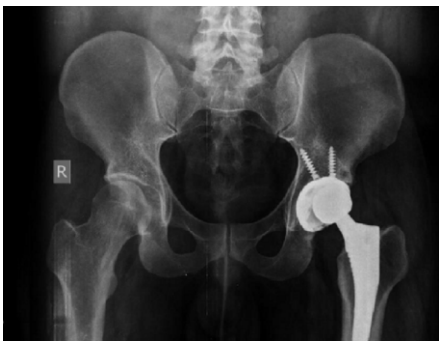
He continued to be asymptomatic till 18 months postoperatively when he noticed catching pain in the left groin followed by audible clunk while getting up from a chair. Radiographs revealed eccentric position of the femoral head in the cup while the cup and stem positioning looked acceptable (Fig. 4, 5).

Figure 4: AP view 18 months post primary THA. Eccentric positioning of the femoral head can be noted suggestive of liner dissociation.

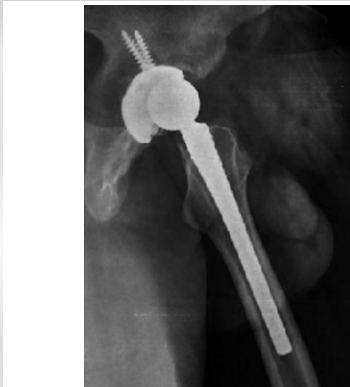
Figure 5: Lateral view 18 months post-primary THA. Eccentric positioning of the femoral head can be noted suggestive of liner dissociation.

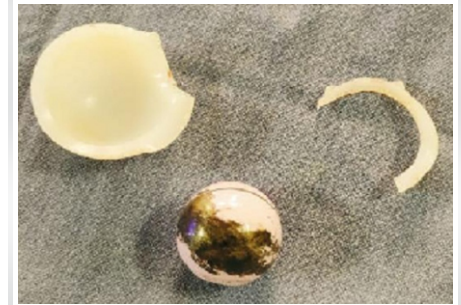
The hip was explored through routine posterior approach. Polyethylene liner dissociation was noted and the head was directly articulating with the acetabular shell. Posterior lip of the liner had fractured and the head had visible corrosive damage

Figure 6: Broken polyethylene liner extracted.

The acetabular cup was well integrated and an attempt was made to remove both the screws. One screw was removed easily and the other screw could not be removed and hence was left in situ. The liner was exchanged with marathon polyethylene 10° (32 mm ID and 50 mm OD) with the lip placed anteriorly to counteract the increased anteversion. The head was replaced with 32 mm ceramic head.

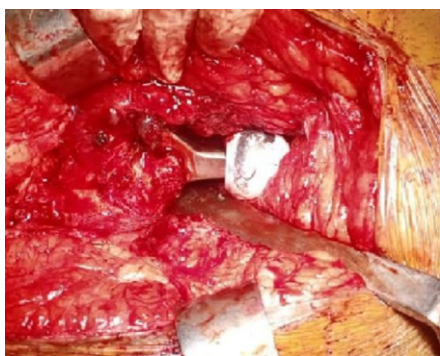
Figure 7: Femoral head showing evidence of corrosive damage.

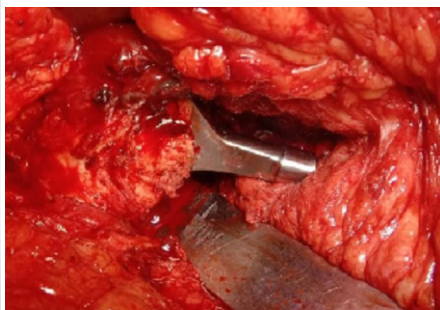
The trunnion looked clinically intact (Fig. 8). Acetabular screws were not protruding and were fully seated in the shell.

Figure 8: Trunnion showing no visible signs of corrosion.

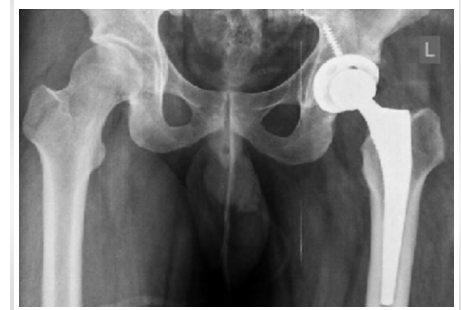
Postoperatively, he was able to resume active life by 3 weeks. At 1 year follow-up, patient is asymptomatic, had completely resumed all daily activities and radiograph revealed no

abnormalities (Fig.9).

Figure 9: Post-operative picture at 1 year follow-up following liner and head exchange.
