A double J stent misplaced in the inferior vena cava during Boari flap repair

A 30-year-old lady underwent a Boari flap repair for post-hysterectomy mid-ureteric stricture. The upper end of the double J stent inserted during the procedure was misplaced in the supra-renal inferior venal cava. Cystoscopic stent removal could be performed uneventfully, while the stricture was managed by endoureterotomy.

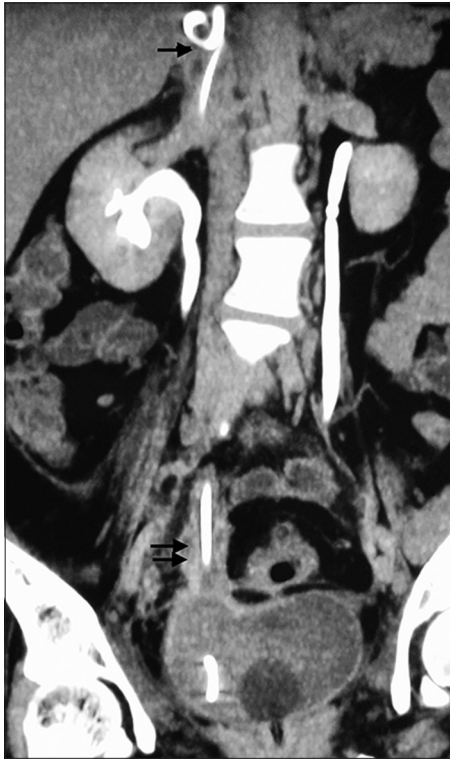
Figure 1: Stent has the upper coil in the inferior vena cava (single arrow) and lower coil in the bladder through the Boari flap (double arrow)

CT showed that the stent had traversed through the Boari flap and entered the IVC, with the upper coil of the stent in the supra-renal IVC [Figure 1]. The lower end of the stent was well placed in the bladder. There was no retroperitoneal hematoma. Further, the normal upper ureter was not connected to the Boari flap but was in continuation with the lower ureter [Figure 2]. The Boari flap, unconnected to the upper ureter, appeared like an out-pouching from the bladder.

The management of a ureteral stent that has migrated into the vascular system includes open surgical techniques,^[2] interventional radiological techniques^[1] and transurethral removal.^[5] In the present case, cystoscopy was selected for removing the migrated DJ stent as it had one accessible coil in the bladder and was placed for over 6 weeks without any urinary bleeding. There was no retroperitoneal hemorrhage or bleeding focus on abdominal CT.

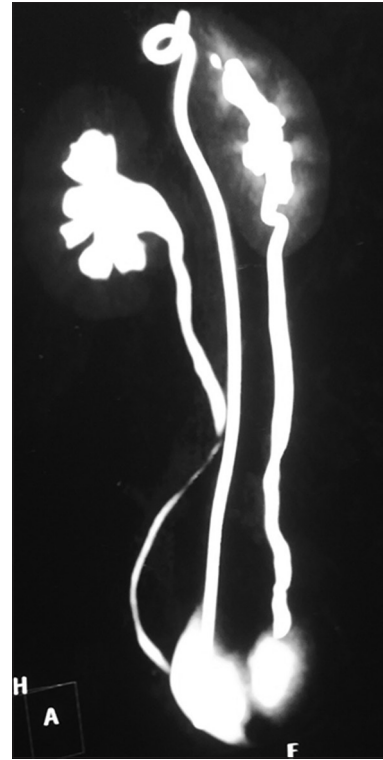
Figure 2: The right lower ureter is in continuity with the normal upper ureter while the Boari flap is not connected to the upper ureter. Stent exits through the Boari flap and has upper coil in the inferior vena cava

The present case is novel because endovascular positioning of the stent occurred during an elective Boari flap repair. We postulate that the surgeon mistook the gonadal vein as the upper ureter and anastomosed it to the Boari flap. The stent had a straight access to the IVC through the gonadal vein. This is further suggested by the fact that the proximal ureter was not connected to the Boari flap and it remained joined to the normal lower ureter. It is difficult to explain why the patient did not have bleeding from the gonadal vein or from the stent once the stent was placed in the IVC. It is possible that some degree of hematuria was ignored as a normal post-surgery consequence. Absence of prolonged post-operative bleeding could be due to intra-catheter blood clotting and gonadal vein
