## Case report

## Early failure with massive metallosis and posteromedial wear following atraumatic anterior cruciate ligament rupture after medial unicompartmental knee arthroplasty

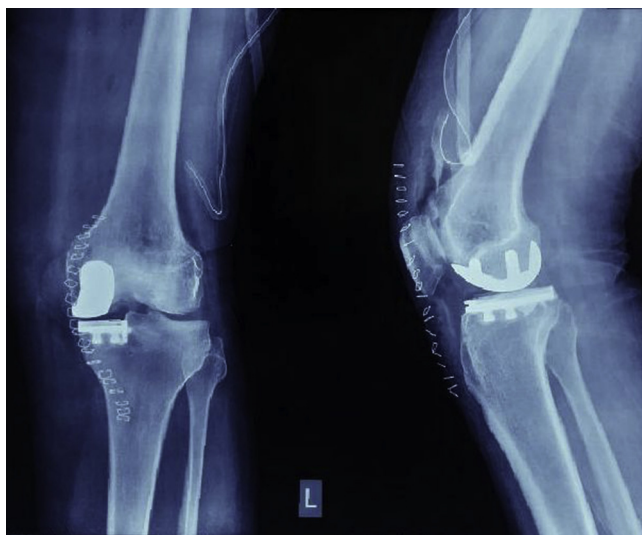
**Figure 1.** Immediate postoperative radiographs following index medial compartmental arthroplasty surgery showing well-fixed and well-aligned femoral and tibial components.

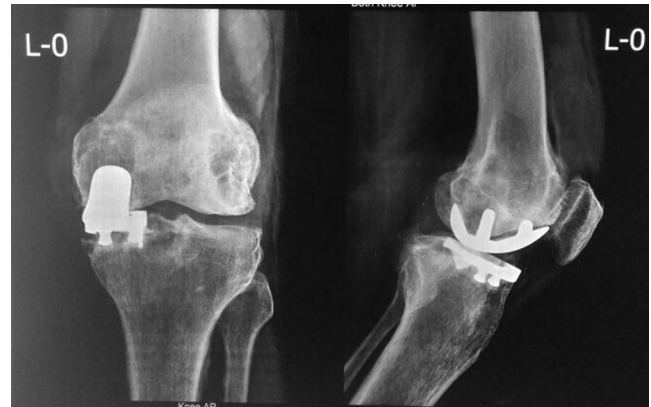
Knee radiographs revealed particulate densities behind the posterior femoral condyles. The medial joint space was completely diminished and the femoral component was in contact with the

**Figure 2.** At 2 years of follow-up, anteroposterior and lateral radiographs of medial UKA knee showing posterior displacement of femur, absent medial joint space, and increased femorotibial contact area.

posterior aspect of the metal backed tibial component (Fig. 2). Radiolucent lines and cystic changes were seen underneath the metallic tibial tray and also surrounding the 2 tibial studs with evidence of loosening of the femoral and tibial components.

This posterior shifting of femur (and eccentric point of contact) explains the abnormal posteromedial wear of the insert and the tibial component retrieved in our case, which is in contrast to the characteristic anteromedial wear seen in UKA with intact ACL reproducing the anteromedial osteoarthritis pattern seen in knees with intact ACL and medial compartment osteoarthritis [16].

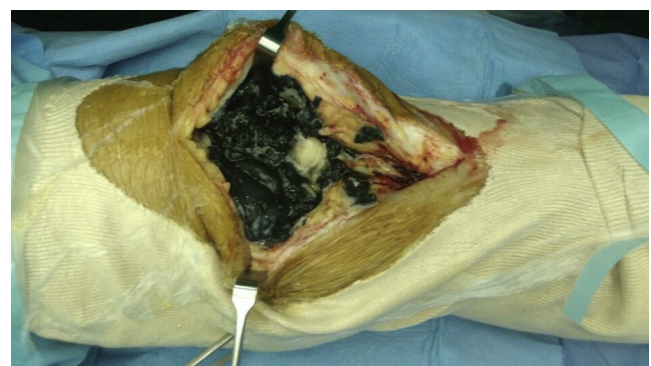
Intraoperatively, extensive blackish staining of the synovium, capsule, and the surrounding tissue was noted (Fig. 3). The synovium was rubbery in consistency and blackish staining of the synovial fluid was noted. Complete synovectomy was performed along with debridement of the surrounding tissue to debulk the metallic debris without compromising the integrity of the collateral ligaments. The ACL was found to be deficient which may have occurred due to an attritional rupture since there was no significant history of trauma or fall. There was full thickness wear of the posterior one-third and posteromedial aspect of the polyethylene component and the tibial tray (Fig. 4). The femoral component was loose but the anterior half of the tibial tray was well fixed. There was evidence of osteolysis underneath the femoral component and posterior aspect of tibial component with subsidence of the metallic tibial tray.

**Figure 3.** Intraoperative image showing black rubbery synovium due to massive metallosis.

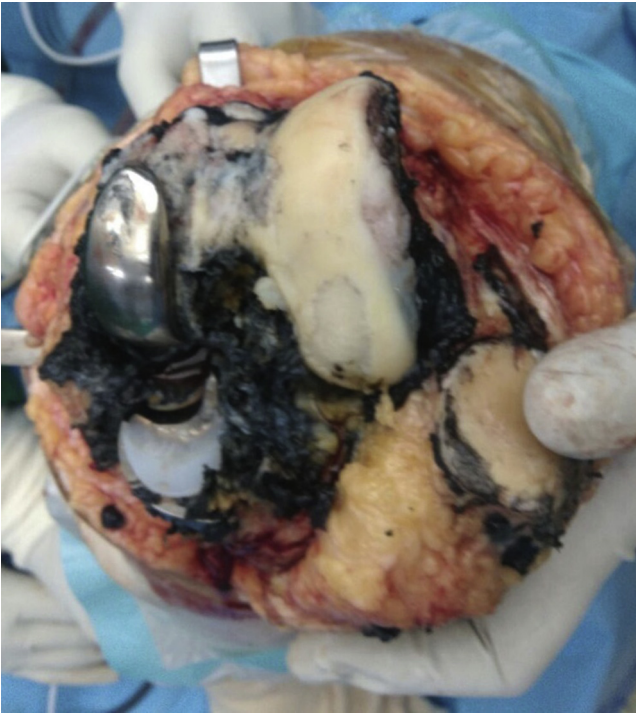
**Figure 4.** Full thickness wear of the tibial polyethylene insert and metallic tray.

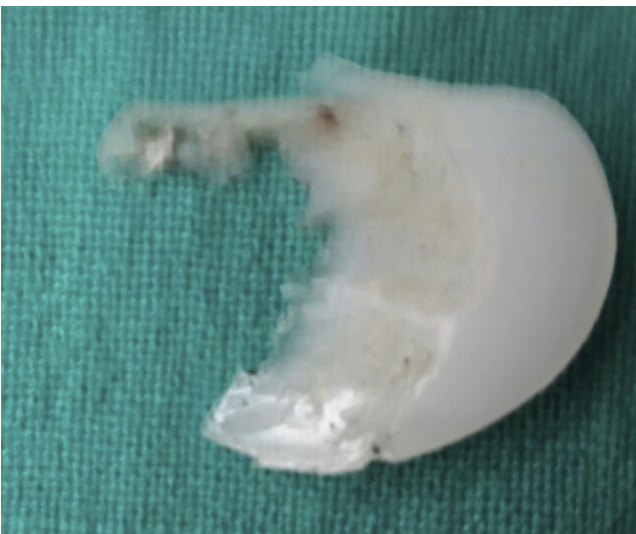
Closer inspection of the prosthesis revealed full thickness erosion of the posterior one-third to one-half of the polyethylene component and the tibial tray (Figs. 5 and 6). The prosthesis retrieved included a cobalt-chrome femoral component, a titanium tibial tray, and a fixed flat 8-mm polyethylene insert (Zimmer unicondylar knee prosthesis; Zimmer Biomet, Warsaw, IN).

**Figure 5.** Polyethylene insert showing full thickness wear over the posterior half.

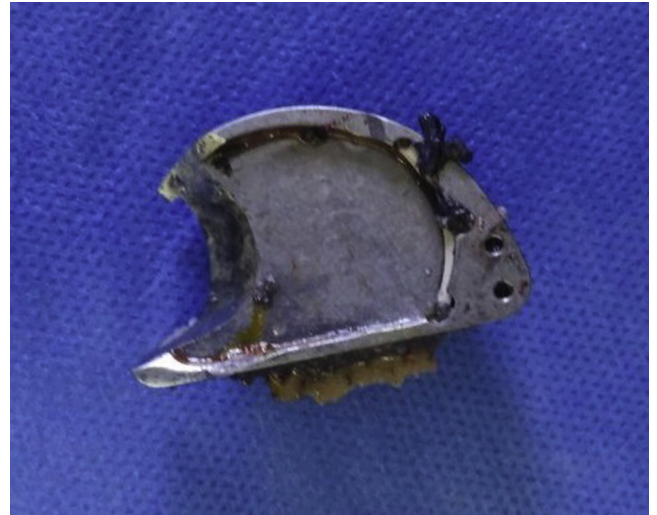
**Figure 6.** Metallic tibial component showing full thickness wear over the posterior one-third.

Abnormal loading of the posterior one-third of the tibial component combined with localized osteolysis leads to progressive subsidence of the tibial tray and gradual increase in the posterior tibial slope and varus alignment of the tibial component. This is proven to lead to an increase in the anterior tibial translation [17]. Suero et al [18] noted that 8° decrease or leveling of the slope reduced the magnitude of tibial translation in ACL deficient UKA knees by approximately 5 mm. It has been recommended to keep the tibial slope below 7°, particularly in ACL deficient knees to reduce the chance of failure of UKA [19].
