Catastrophic ceramic failure in total hip arthroplasty: the role of microseparation

We present a case report of a ceramic liner fracture after total hip arthroplasty; we believe that the fracture occurred because the microseparation between the ceramic bearings was accentuated by an avulsion of the greater trochanter.

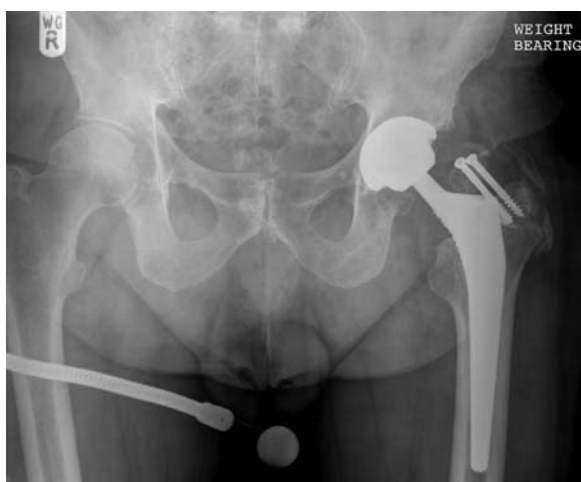
Figure 1
At six weeks the previously fixed greater trochanter was found to be avulsed

In May 2008, a left total hip arthroplasty was undertaken for the treatment of end-stage osteoarthritis in a 77-year-old man with a body mass index of 25 kg/m². A cementless total hip arthroplasty prosthesis was implanted through a transgluteal approach. A combination of a ceramic acetabular liner with a 36 mm ceramic femoral head was chosen. During the procedure, a low femoral neck cut resulted in a fracture of the greater trochanter, which was subsequently fixed with two partially threaded screws. Immediate postoperative radiographs revealed satisfactory orientation of the components and a fixed greater trochanter. The patient made an uneventful recovery and was discharged on the seventh postoperative day with instructions to walk with the use of crutches, partially weight-bearing for six weeks. At six weeks the previously fixed greater trochanter was found to be avulsed (Figure 1).

With regards to the aetiology behind the ceramic liner breakage, we believe that the greater trochanteric avulsion during the primary procedure may have been the initiating factor that eventually led to ceramic failure. Professor Fisher's team¹⁰ studied the phenomenon of microseparation between ceramic bearings *in vitro* and they were able to reproduce clinically relevant wear rates in ceramic-on-ceramic hip prostheses. During their investigation, scanning electron micrographs revealed transgranular fractures of the ceramic. They also suggested that soft tissue tension and muscle forces could influence the degree of microseparation. In our case we believe that the trochanteric avulsion resulted in an accentuation of the physiological microseparation which exists between the bearing surfaces. The formation and subsequent propagation of cracks across the surface of the ceramic liner led to the fracture of the material.

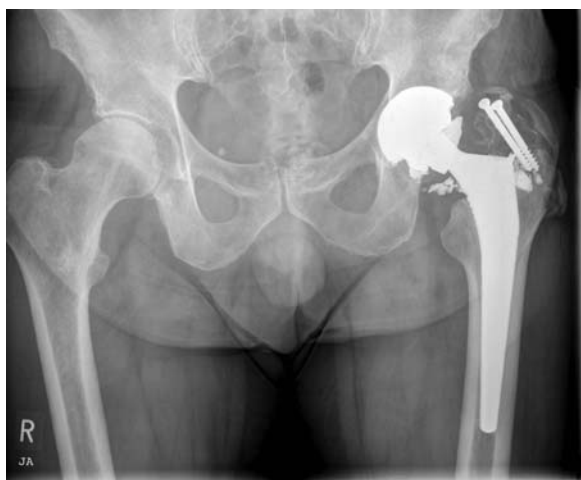
Figure 2
Anteroposterior radiograph of the pelvis showing the acetabular liner fracture, 15 months postoperatively

sudden onset of pain-free squeaking with no history of trauma. Radiographs revealed a fracture of the ceramic acetabular liner (Figure 2) and seven days later revision surgery was undertaken. The fractured liner and the partially threaded screws were removed and thorough debridement of multiple small fragments of ceramic was undertaken. The femoral head exhibited macroscopic signs of wear and was removed as well (Figure 3). Having checked the stability of both prosthetic components, revision consisted of the exchange of the acetabular liner and the femoral head with ceramic implants of the same size as the originals. During the procedure, the greater trochanter was found enveloped in fibrous tissue, partially comminuted. The abductors were found to be atrophic and were reattached with transosseous sutures to the proximal femur. The patient made an uncomplicated recovery and was discharged on the fifth postoperative day. At 24 months following the revision procedure (Figure 4), the patient was pain-free and able to mobilize unaided.

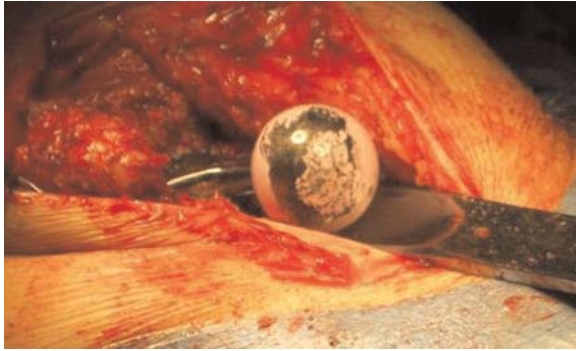
Figure 3
Intraoperative view of the ceramic head exhibiting signs of wear

Visual inspection of the retrieved components revealed evidence of stripe wear on the ceramic

femoral head. The stripe wear was most certainly a result of the direct contact of the femoral head with the acetabular shell; this contact was also the probable cause for the sudden onset of squeaking in the previously 'silent' hip articulation. In terms of the ceramic liner, several medium-sized pieces and multiple smaller fragments were retrieved; further biomechanical assessment of the liner was deemed futile due to the severe damage to its structure.

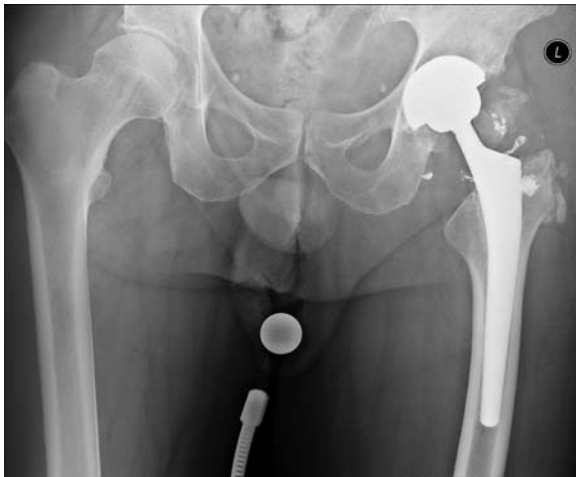
Figure 4
Anteroposterior radiograph of the pelvis, at the last follow-up
