A material stress test study on occurrence of leakage and material failure of peritoneal dialysis (PD) catheters

Matthias Klingele^{1,2✉}, Martin Carstens^{2,3}, Lea Baerens², Matthias W. Laschke⁴, Wolfgang Metzger⁵, Danilo Fliser² & Clemens M. Meier³

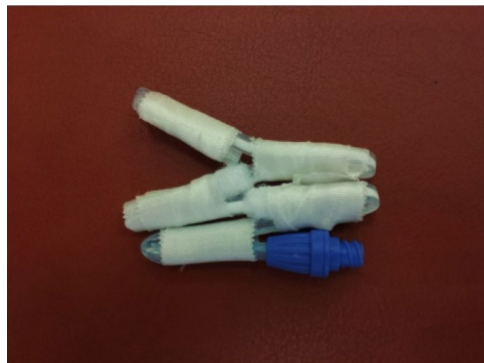
Figure 1. Static physical stress through multiple folding.

Within the laboratory material stress test simulation, the chemical exposure was tested by filling PD catheters with standard dialysate solution (2.3% Fresenius, Fresenius Medical Care, Bad Homburg, Germany) for up to 100 days; renewal of solution every 3–5 days. All applications, e.g. sealing, were either original or of common clinical use. Physical set up when filled was either hanging vertically or laying horizontally. Before and after refill a set of evaluation procedures, e.g. applying different technical methods to measure potential liquid outlet, were performed and documented. Further new and already chemical stress tested PD catheters were then put under static physical stress by multiple folding up (as shown in Fig. 1) and as such stored tightly folded for 11 days.

PD catheters are often folded and fixed on the abdominal skin. Tight clothes even enhance the pressure on folded catheters. This was simulated within our static physical stress test. In this test, the act of folding and fixing the folded catheter was done extremely, trying to provoke potential material failure within a short time period.

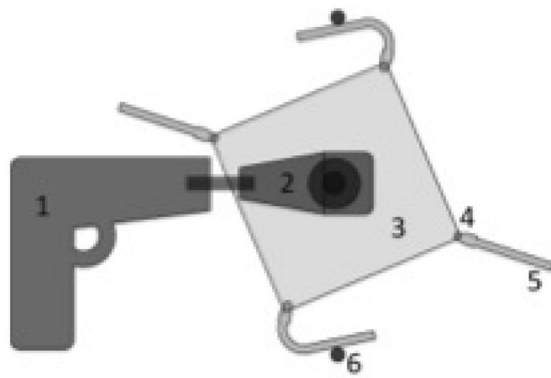
Figure 2. Schematic display of dynamic physical stress test set up. Fixed battery loaded drilling machine (1) drives over an axis and an angle torsional moment (2) a squared birch tree wooden panel. At each square corner 50 mm long PD catheter pieces (5) equipped with Luer-Lock-adapters (4) are attached. Within each full rotation of the wooden panel, each PD catheter piece is twice bend at 100° at the opposite metal sticks (6).

New and already chemical stress tested PD catheters were put under dynamic physical stress by running the PD catheters against a metal piece, making it bend and expand again for 40,000 or even 80,000 times in the exact same spot, as shown in Fig. 2.

Within our dynamic stress test we tried to simulate repeated mechanical folding and defolding of PD-catheters during changes of dialysate. We calculated 5 changes as mean number of dialysate changes per day, resulting in about 2000 foldings and defoldings per year. Since we could not include aging processes of PD-catheters, we doubled the number of dynamic stress events. Thereby we resulted in 40,000 events of folding and defolding to simulate about 10 years of usage. Although technique survival of peritoneal dialysis in a patient does rarely reach 10 years, we wanted to examine material failure for this period. Thereby we can assume, that our results would be of interest for a large majority of PD-patients.

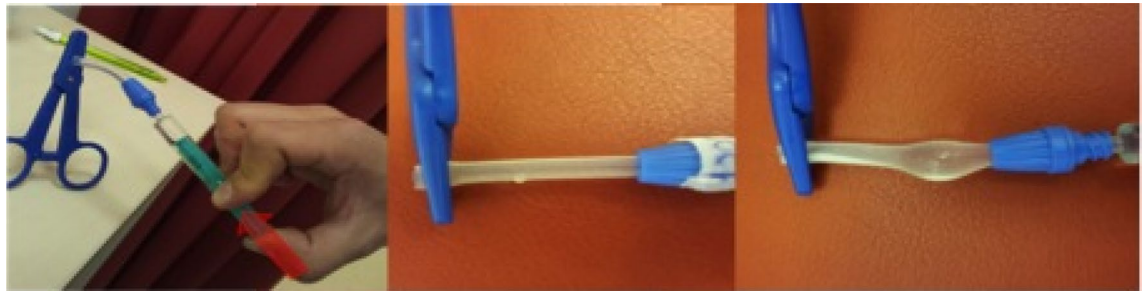
Figure 3. Intraluminal pressure exposure (left) to identify leakages such as e.g. liquid outlets (middle) and/or bulging (right).

- (b) secondly, intraluminal pressure exposure to identify leakages, such as e.g. liquid outlets and/or barrier leakage as shown in Fig. 3
- (c) thirdly, light microscopy (Leica M651, Leica Microsystems, Wetzlar, Germany) with and without Methylene-blue staining (10%, Art.-Nr.: 457250-1, VWR, Darmstadt, Germany);
- (d) finally, scanning electron microscopic assessments

- (b) Secondly, intraluminal pressure exposure to identify leakages, such as e.g. liquid outlets and/or barrier permeability as firstly: no detectable material defects.

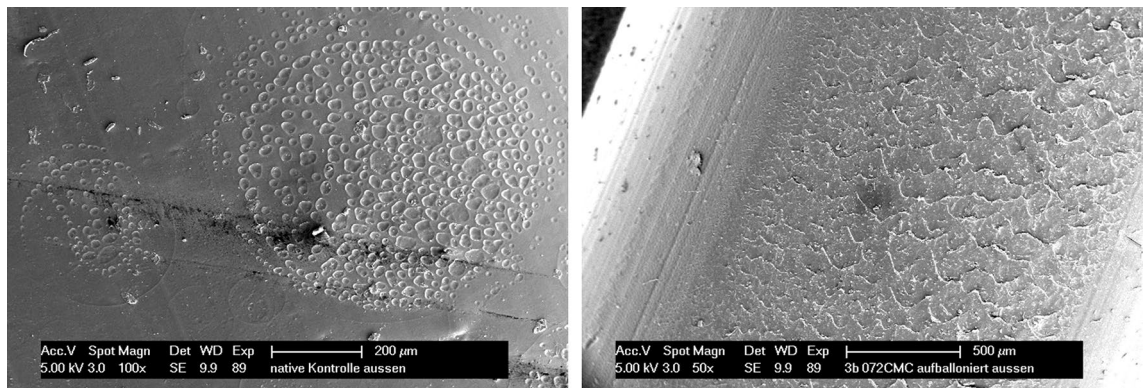
Figure 4. Scanning electron microscopic assessment shows cornfield pattern at the inner surface (left) and scale structure on the outside (right).

- (d) Finally, scanning electron microscopy was performed. Here slightest lesions at the very surface on the in- and outside of the catheter wall could be detected. Overall, on the in- and outside of the catheters some deposits (e.g. glucose and mineral salts) could be identified. Moreover, several catheters showed two different kinds of patterns on the surfaces: cornfield pattern or scale structure as shown in Fig. 4. Both were identified after chemical and or physical stress. In any case, only very small longitudinal cracks on the inner and outer surfaces could be detected. None of all lesions was deep enough to allow liquids or air to pass through, nor had a counter lesion on the opposite side—meaning same spot inverse at the in- or outside.

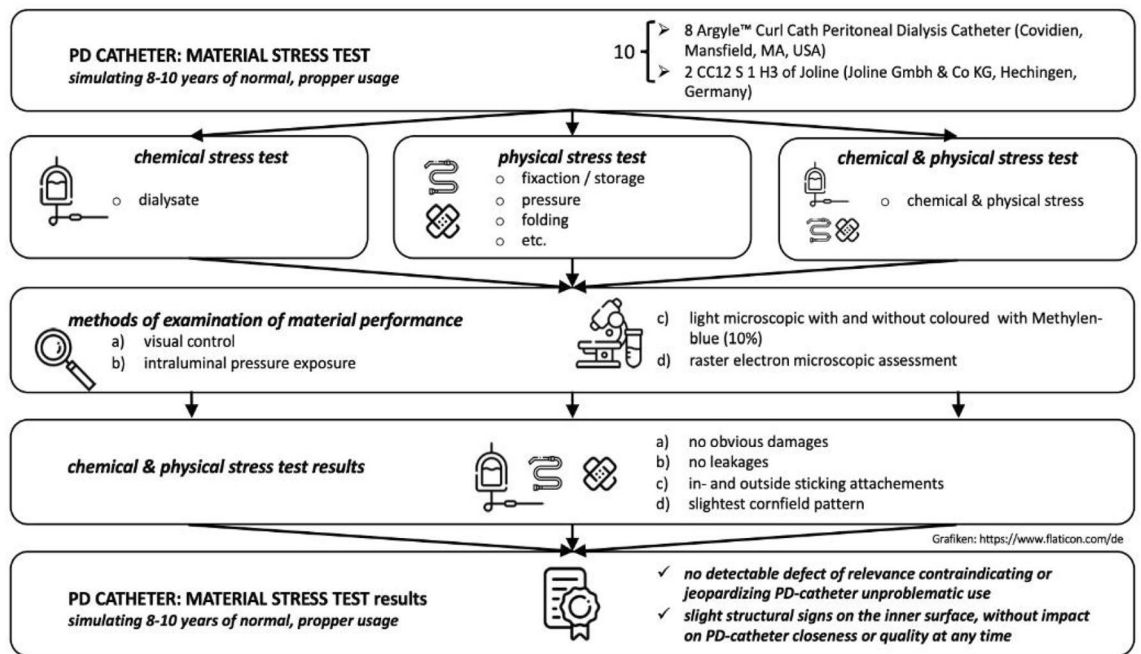
Figure 5. Graphical abstract.

The material stress test study of PD catheters validates the quality of all actually tested batches and pieces. Neither chemical nor physical stress simulation of normal handling of up to 8–10 years led to catheter leakages as shown in Fig. 5. Hence, we have to assume that reported small leakages most likely trace back to handling or application errors, even if unnoticed. However, it is a matter of speculation whether, for example, pointed objects during dressing changes or contact with metal elements led to the leakage. Nevertheless, as most patients denied any handling mistakes in our overall examined peritonitis cases and most small leakages are hardly visible to the naked eye within clinical routine, we started a regular, systematical quality control. Surprisingly, no material malfunction of the PD catheter has been detected since then.
