Dissociation of Polyethylene Liner of the Dual Mobility Acetabular Component after Closed Reduction of Dislocation: A Case Report

Department of Orthopaedic Surgery, Kyung Hee University Hospital at Gangdong,
Kyung Hee University Hospital[†], Seoul, Korea*

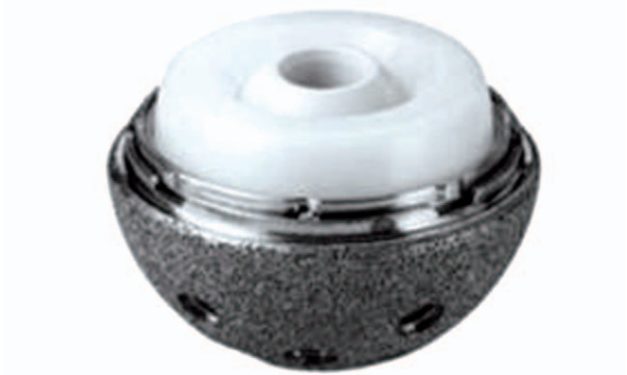
Fig. 1. A dual mobility acetabular hip implant has a bigger hemispherical polyethylene (PE) liner than an acetabular cup, causing its PE liner opening to be smaller than the diameter of a femoral head.

is bigger than an acetabular cup, causing its PE opening to be smaller than the diameter of a femoral head (Fig. 1). Therefore, the PE liner and the femoral head are held by a snap fit. The dual mobility acetabular component reduces the occurrence of dislocation after total hip arthroplasty and has little possibility of a PE liner dissociation^{1,2)}. Therefore, the implant is being used for patients at high risk of dislocation or patients who complain of continued instability. Only three cases of dislocation of hip and dissociation of PE liner after dual mobility acetabular component have been reported. This is the fourth case.

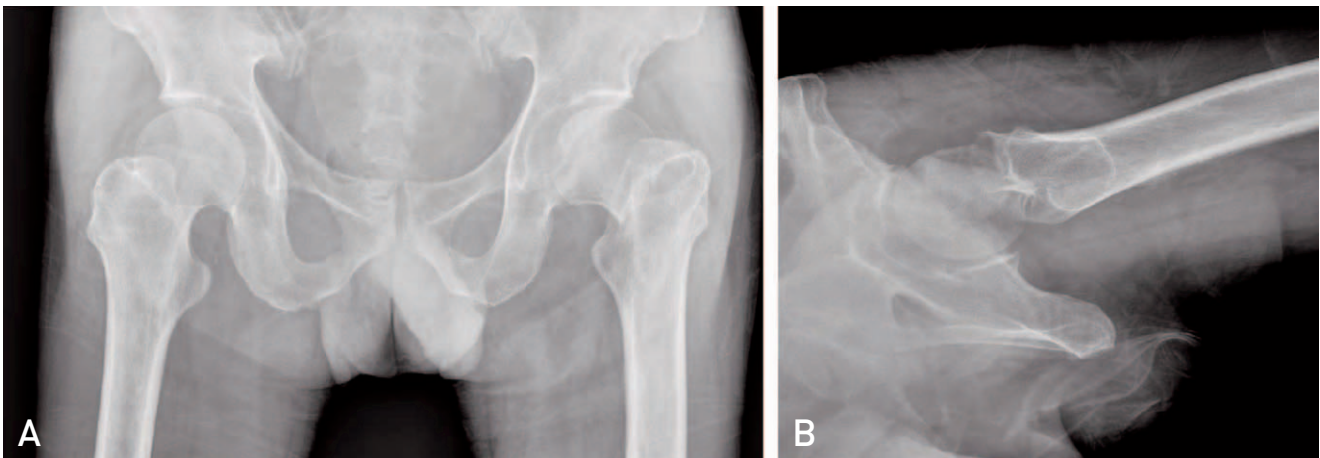
Fig. 2. Anterior-posterior (A) and translateral (B) views of both hip joints shows left femur neck fracture.

A 51-year-old male patient visited the hospital for a left femoral neck fracture that resulted from a fall (Fig. 2). He was receiving neurological treatments for epilepsy, alcohol dependence and behavior disorder, and had suffered

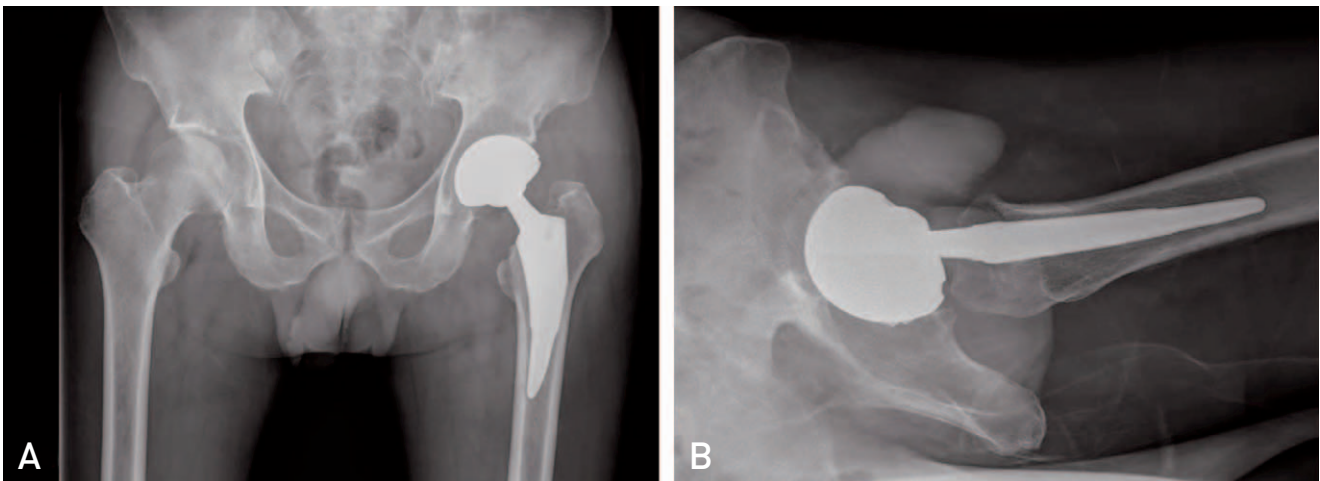
Fig. 3. Total hip arthroplasty was performed using an dual mobility acetabular component.

syncopes for the past one year. A dual mobility acetabular component was used for this patient to reduce the risk of hip dislocation and to improve the range of motion of the hip joint, because he was a young patient and had a vulnerable condition for hip dislocation (Fig. 3). We used cementless acetabular component (Active Articulation™ E1® Hip System; Zimmer Biomet, Warsaw, IN, USA) and cementless femoral stem (Taperloc® Hip System; Zimmer Biomet). A physical examination carried in an operation room revealed normal range of motion; the joints showed no impingement on the neighboring tissues and no instability. No unusual signs were observed in an imaging test as the anteversion and inclination angles of an acetabular cup were 17° and 43°, respectively. The patient visited the hospital 10 weeks after the surgery in a drunken state, complaining of pain of the left hip joint that had occurred after seizure. In the plain radiograph conducted in the

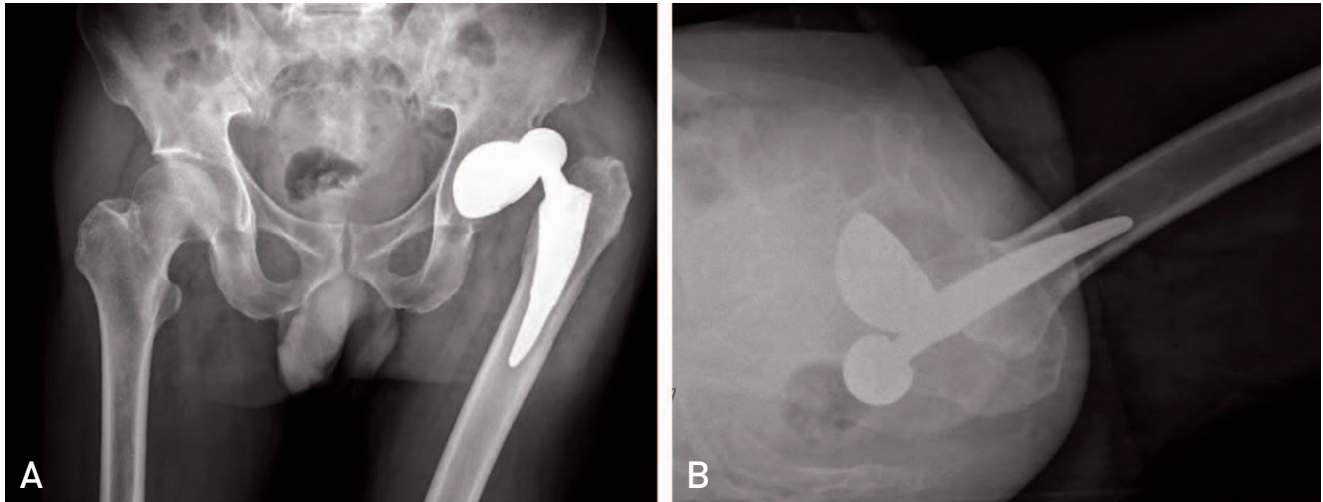
Fig. 4. Ten weeks from the surgery, posterior dislocation of the left hip joint was observed at the emergency department after slip down on anterior-posterior (A) and translateral (B) views of the hip joints.

emergency department, a left hip dislocation was observed and reduced with closed reduction (Fig. 4). However, plain radiograph and computed tomography after reduction showed a dissociation of the PE liner that was not

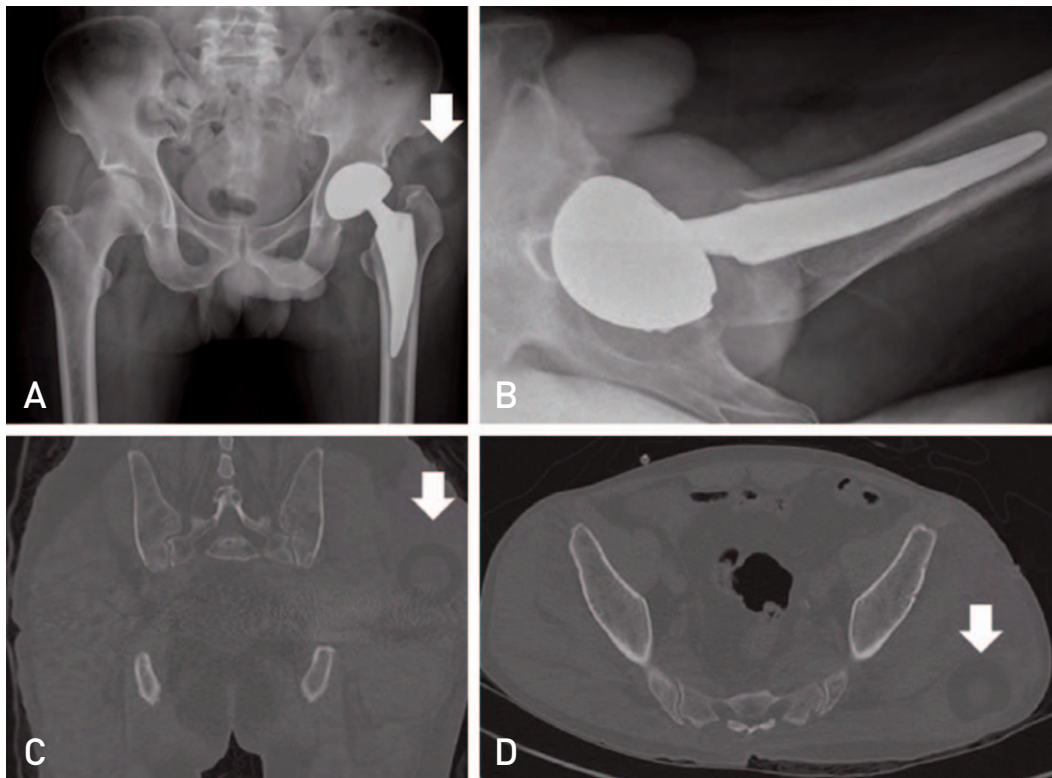
observed before closed reduction and eccentric location of femoral head against acetabular cup (Fig. 5). Therefore, we performed revision of acetabular component. During reoperation, the PE liner was found in the gluteus maximus

Fig. 5. After closed reduction of the dislocated hip joint, an eccentric position of the femoral head and the dissociation of polyethylene (PE) liner was observed in soft tissue (arrow) on anterior-posterior (A) and translateral (B) radiographs. The images of hip computed tomography. On the axial (C) and coronal (D) views, dissociated PE liner (arrows) was evident in the left gluteus maximus muscles.

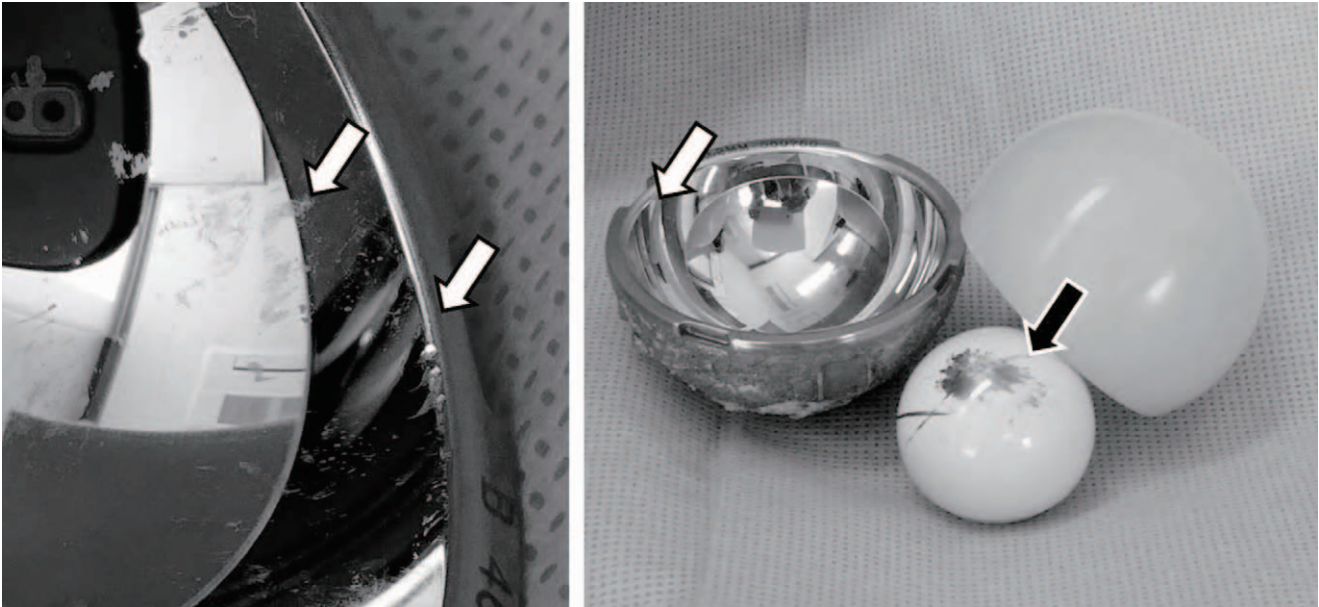
Fig. 6. Injured articular surfaces of acetabular inner surface (white arrows) and femoral head (black arrow) were observed at removed acetabular component and femoral head.

muscles, and the acetabular cup, liner and femoral head were replaced because the acetabular cup and head were injured (Fig. 6). The femoral stem was not replaced since it was stable (Fig. 7). At the moment, he is under observation through the outpatient treatment with no unusual signs apparent.

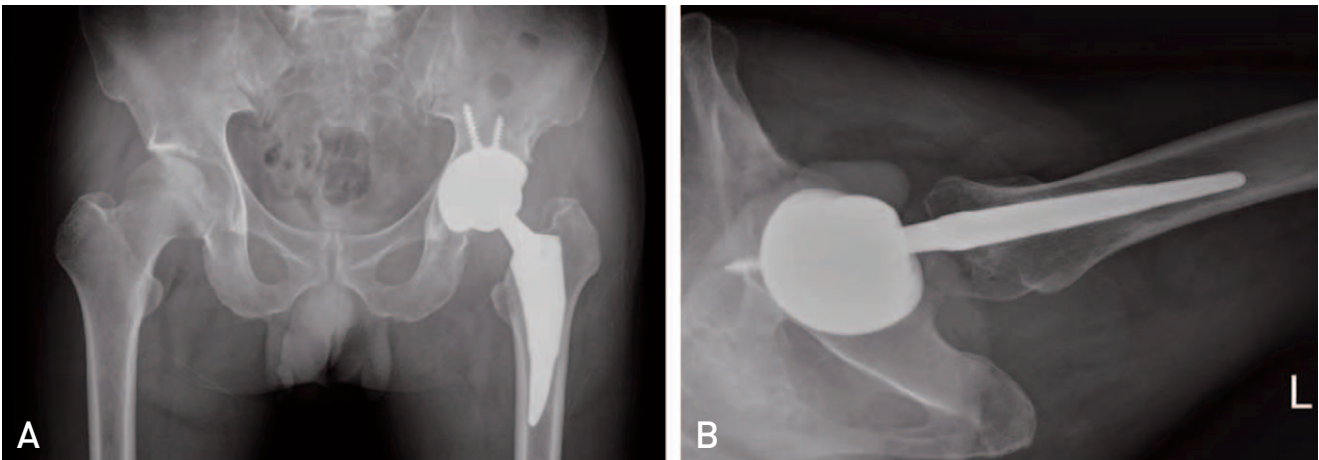
Fig. 7. Anterior-posterior (A) and translateral (B) views of both hip joints after revision total hip arthroplasty.

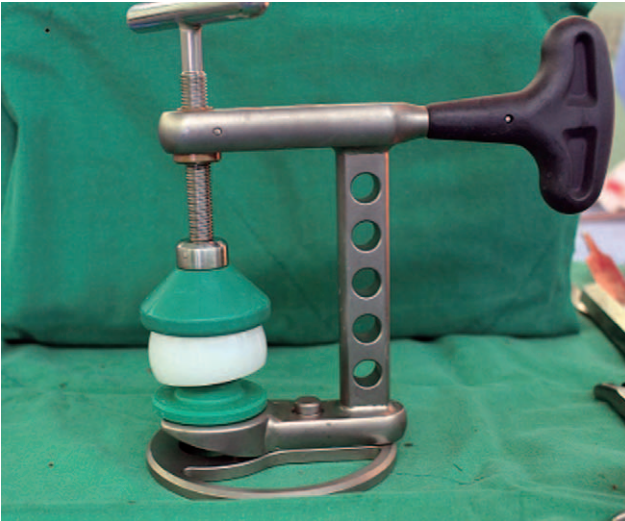
Fig. 8. Insert device for assemble polyethylene liner with femoral head.

can reduce the wear of a liner, prevalence of dislocation and liner dissociation^{1,2,4}. The implants reduce the wear with dual articulation by offering the PE liner mobility in the acetabular cup^{2,5-7}. In addition, it increases jump distance and postoperative stability by having the same effect as using a large femoral head⁷. The hemisphere of a PE liner in such products is bigger than an acetabular cup, causing its PE opening to be smaller than the diameter of a femoral head. Hence, during surgery, insert devices are used to snap fit and assemble the femoral head and PE liner (Fig. 8). It is rare to observe PE liner dissociation in a dual mobility acetabular component.
