Case Report

Diagnostic pitfall in radiological imaging after vacuum-assisted excision of B3 breast lesion: A case report ^{☆,☆☆}

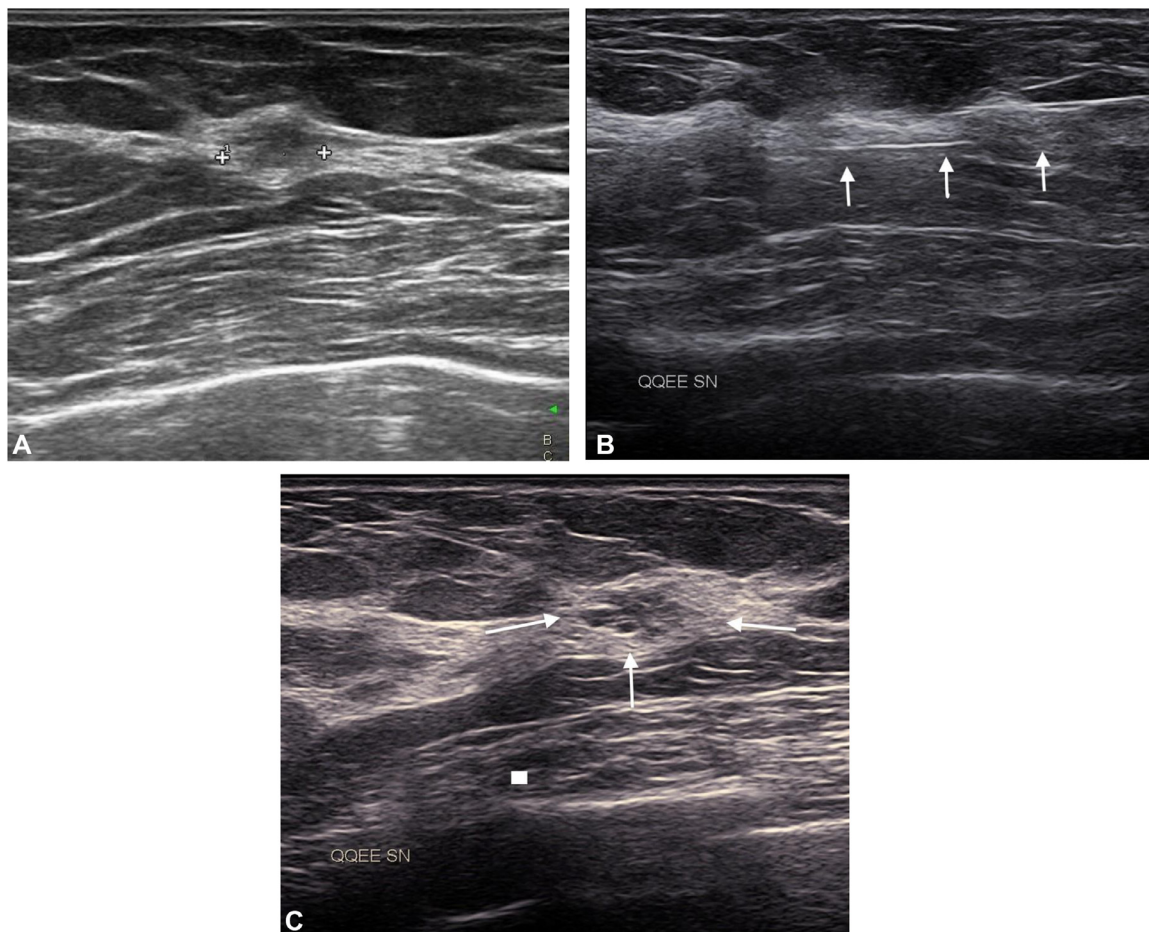
Fig. 1 – US-guided vacuum-assisted biopsy (VAB). (A) Sonogram showing the left breast nodule before the procedure (VAB) (B) Ultrasound during the procedure, showing the positioning of the needle below the lesion (indicated by the arrows) and activation of the vacuum (C) Sonogram obtained after the biopsy demonstrates no evidence of the lesion; the little residual cavity is indicated by the arrows.

A 35-year-old woman, with no symptoms or history of previous pregnancy or breastfeeding but with a positive family history of breast carcinoma (maternal grandmother) and on contraceptive hormone therapy, was found to have an 8 mm hypoechoogenic solid nodular formation with blurred boundaries at the junction of the outer quadrants of the left breast, during an ultrasound screening examination performed at the University Polyclinic of Rome Tor Vergata. In the absence of the previous mammogram, which had been performed earlier that year but was lost by the patient, and given the relatively small size of the lesion, it was decided to perform a vacuum-assisted biopsy (VAB) for proper histological diagnosis (Fig. 1).

In August 2022, an ultrasound-guided biopsy was performed: after intracutaneous injection of a local anesthetic (1–2 mL of 1% lidocaine) and a 3–5 mm skin incision, a 10-gauge

needle was positioned with the aperture of the needle just beneath the ultrasound-visualized lesion. The vacuum biopsy resulted in the excision of several specimens, and a metallic tissue marker clip was placed. The procedure was completed in 20–30 minutes. Compression of the breast was performed for 5–10 minutes following the procedure. Dressing of the incision was made and ice was applied, and the patient was advised to start broad-spectrum prophylactic antibiotic therapy for 5 days according to hospital guidelines.

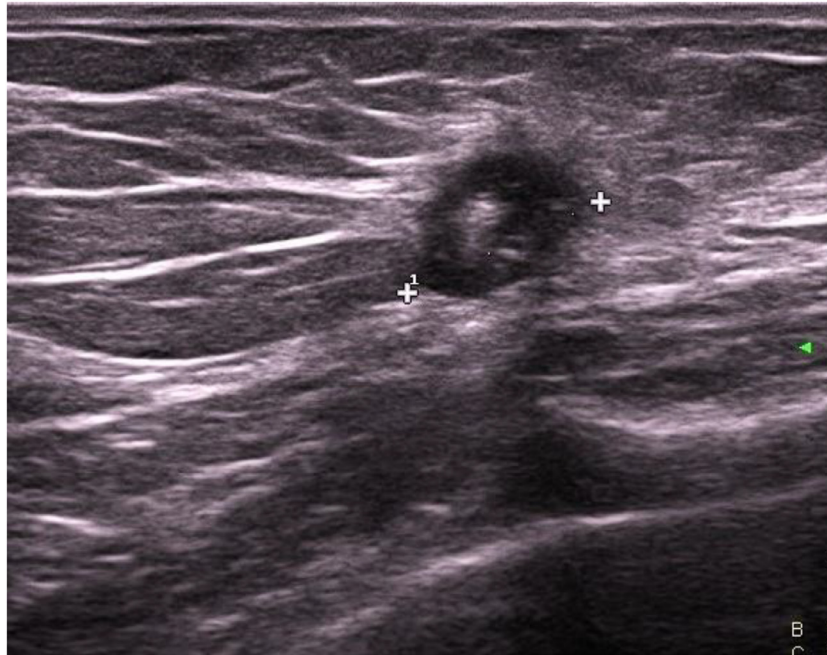
Fig. 2 – Ultrasound follow-up performed 6 month after vacuum-assisted excision (VAE). In the site of the previous procedure, recognizable by the presence of the released clip, an hypo-anechogenic area 1 cm in size, with oval morphology, blurred margins and eco-structural alteration of the adjacent parenchyma is showed.

In March 2023, ultrasound follow-up demonstrated a hypo-anechogenic area 1 cm in size in the left breast at the site where the procedures had been performed. The area had an oval morphology, blurred margins, and central punctiform hyperechogenicity corresponding to the metallic clip placed at the end of the excision, along with fuzzy echostructural alteration of the adjacent parenchyma (Fig. 2). A mammography with tomosynthesis images of the left breast was therefore requested and performed the following month, revealing a nodular opacity with spiculated margins and blurred boundaries, along with adjacent parenchymal distortion at the aforementioned site (Fig. 3).

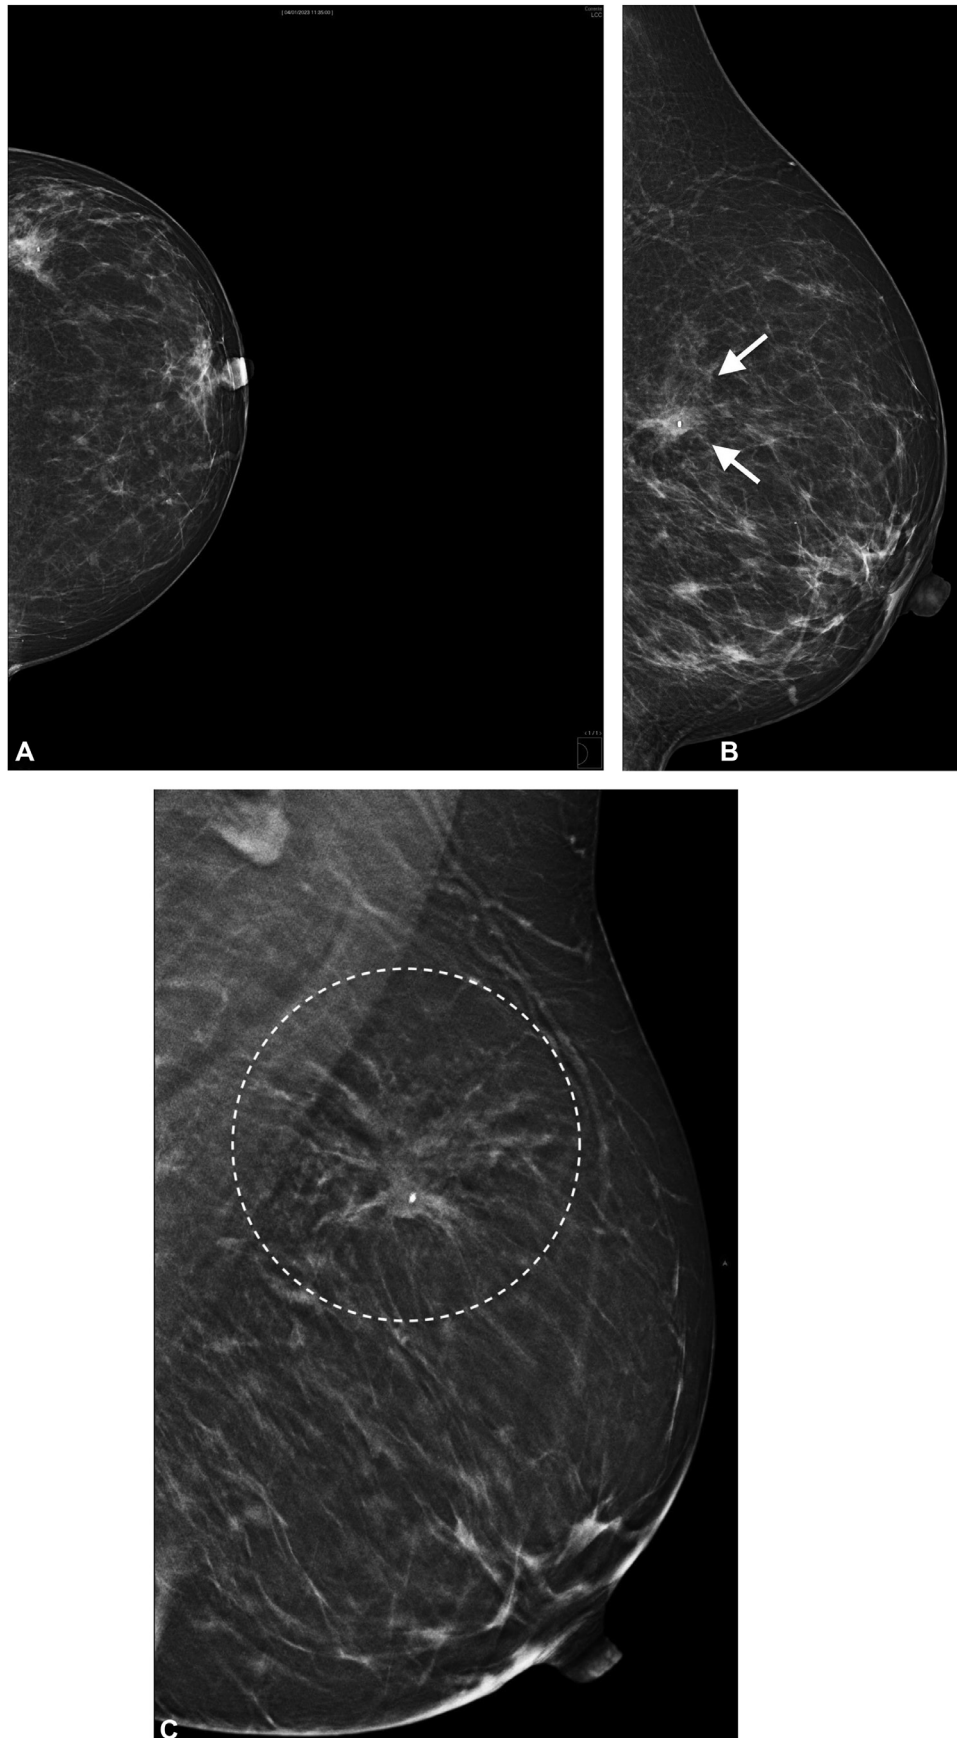
Fig. 3 – Mammographic imaging. Mammography and tomosynthesis projections of the left breast showing a nodular opacity with spiculated margins and blurred boundaries with adjacent parenchymal distortion in the site of previous procedure (indicated by the arrows and surrounded by the dotted line): (A) cranio-caudal mammogram; (B) medio-lateral mammogram; (C) medio-lateral-oblique tomosynthesis projection.

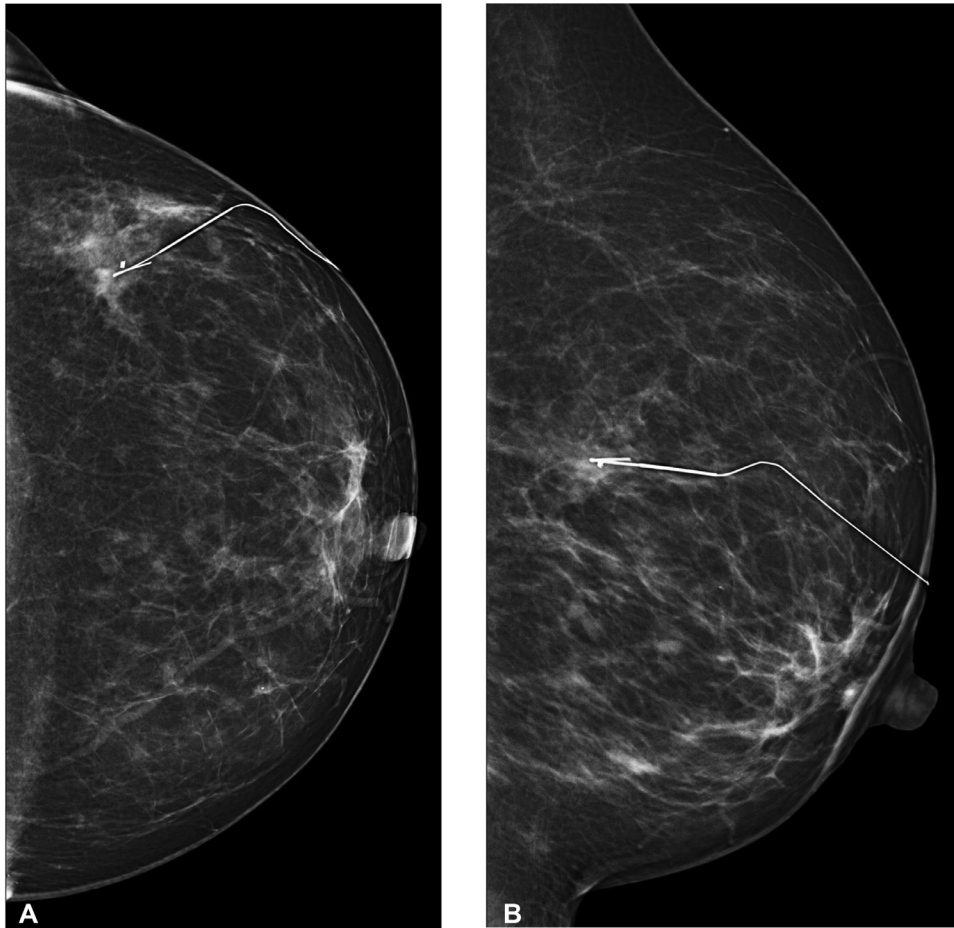
Fig. 4 – Preoperative imaging. Mammographic projections performed after placement a metallic guide wire (A) cranio-caudal mammogram; (B) medio-lateral mammogram.

The patient's case was discussed at the Working Oncological Group (WOG) of our hospital, and it was decided to proceed with surgical intervention. In April 2023, under stereotactic guidance, a metallic guide wire was placed within the area of parenchymal distortion of the left breast. On the same day, the patient underwent breast surgery (Figs. 4 and 5), and histologic examination of the surgical specimen documented the presence of a pseudo-cystic cavity, attributable to the previ-

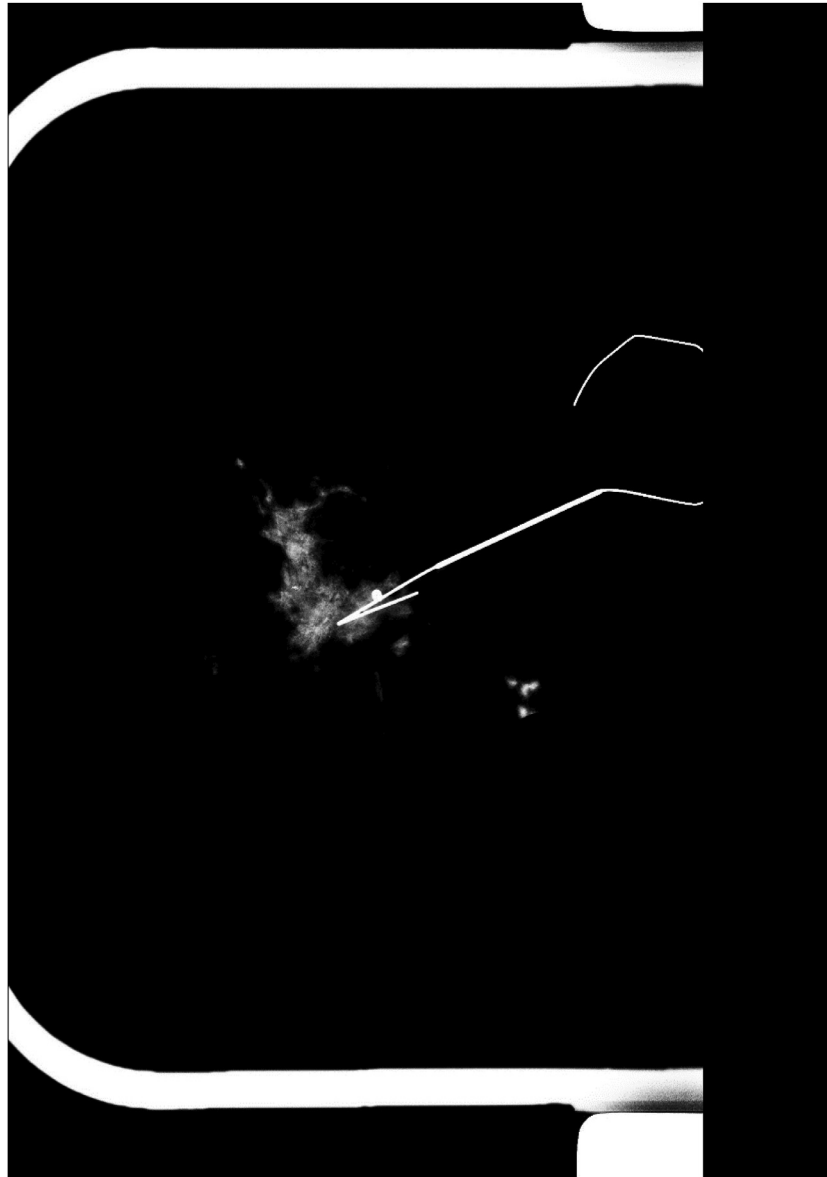
Fig. 5 – Radiographic image of the surgical piece. Metallic clip and metallic repair wire can be seen within the surgical piece excised.
