Data Article

Field reconnaissance data from GEER investigation of the 2018 M_w 7.5 Palu-Donggala earthquake

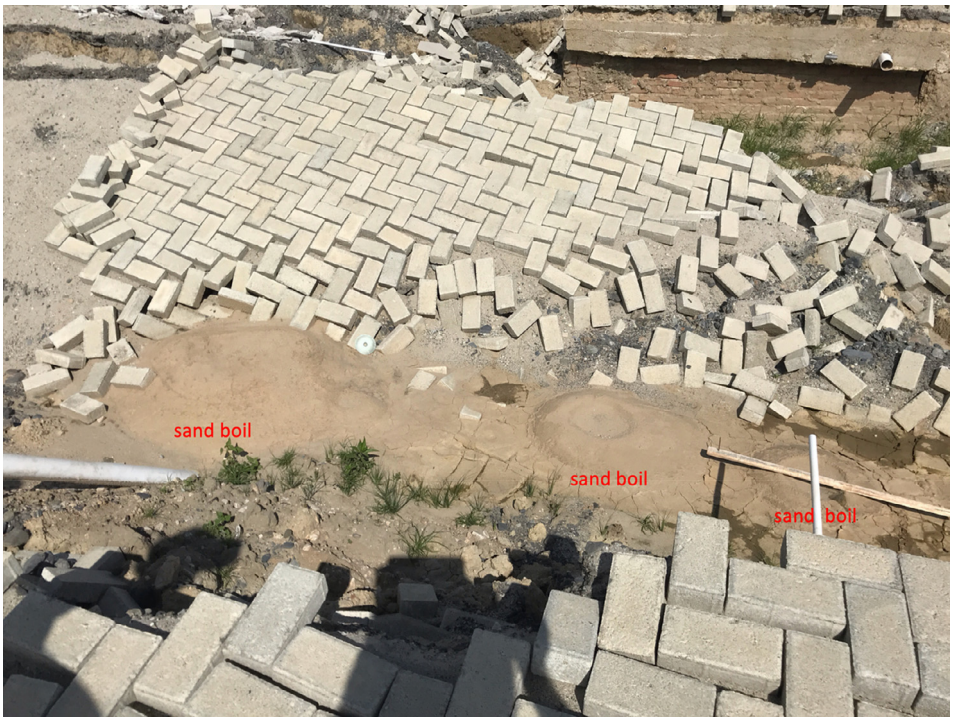
Fig. 2. Example of three cone-shaped sand boils indicating soil liquefaction.

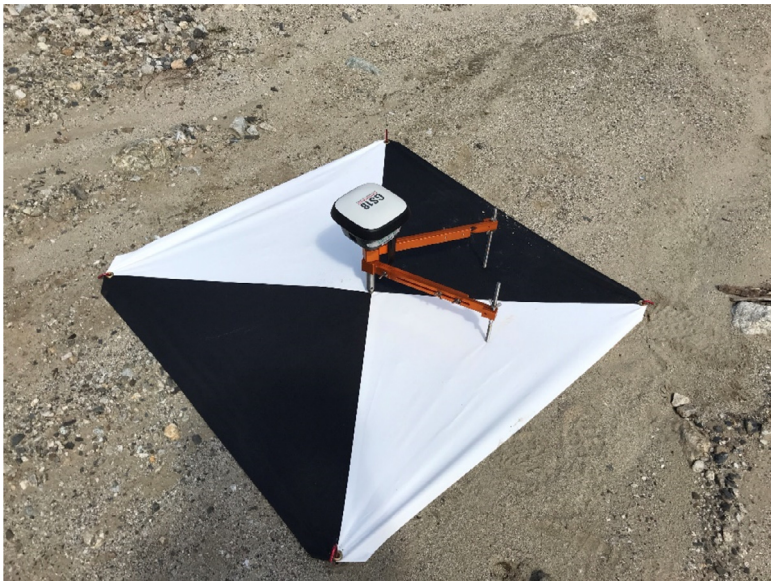
Fig. 3. Photograph of a typical $\sim 1 \text{ m}^2$ ground control points (GCP) target. The vinyl targets were secured to the ground using tent stakes. The photograph also shows the Leica GS-18 GNSS antenna on an orange colored portable "spike mount" used to measure the precise center location of the GCP.

The GEER field investigation took place in Central Sulawesi from 13 to 17 November 2018 (Fig. 1). The reconnaissance was followed by post-processing of the field data, including the development of digital surface models and orthomosaics derived from the UAV images. In addition, other openly available data such as satellite imagery were used to map displacements of structures impacted by the flowslides. The data collected by the GEER team is available on DesignSafe [6], and the findings of related research are presented by Mason et al. [1, 8] and Gallant et al. [2]. The archived data is organized into three general categories. The first category includes geotagged photographs collected by individual team members using handheld cameras, the mobile software application RApp [4], and UAVs. These photographs are organized into folders by the last name of the team member that took the photographs and then by location (e.g., Jono Oge) or category (e.g., sand boils as shown in Fig. 2). The specific location coordinates for each photograph are stored in the metadata (exchangeable image file format, or EXIF) of each image file. The second category of data includes post-processed, UAV-derived products, such as orthomosaic images, point clouds, and digital surface models. Ground control points (GCPs, Fig. 3) were used

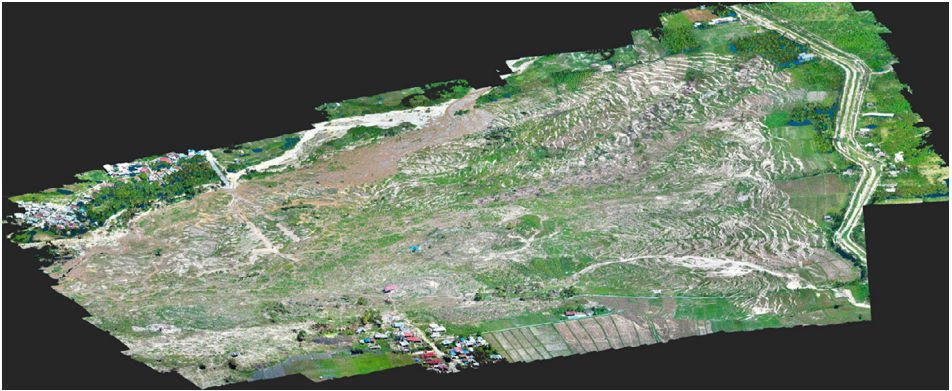
Fig. 4. UAV image-derived point cloud for a portion of the Jono Oge flowslide. The Pix4Dmapper SfM algorithm assigns a realistic color to each point based on color returns in the raw UAV images. The point cloud is displayed in the open-source software CloudCompare.

for surveys at Lolu Village, Jono Oge, and Sibalaya. Three-dimensional point clouds created from the UAV images (e.g., Fig. 4) are archived as standard LAS ("LASer format") files. The orthorectified orthomosaic images and digital surface models (e.g., Fig. 5) are stored as GeoTIFF files for the major flowslides. The final category is geospatial data in geographic information systems (GIS) standard shapefile format. These geospatial data include GPS tracks collected by the team (shown in Fig. 1) and the satellite imagery-derived displacement maps (Fig. 6). GPS tracks were not collected on November 16, but the team followed a similar route to November 15. Examples of structures used for the displacement mapping are shown in Figs. 7-10.

The UAV images were then processed with the precise GCP locations in the structure-from-motion (SfM) photogrammetric software Pix4Dmapper to generate georectified orthomosaic images, point clouds, and digital surface models (DSM). The point clouds in the dataset are not filtered for anthropogenic objects (buildings, infrastructure) or vegetation, and therefore represent ground surfaces (i.e., DSM) rather than ground elevations. Nevertheless, the flowslides stripped much of the vegetation from the sites and buried many buildings, so much of the immediate post-event landscape was, in effect, a “bare earth” landscape. Fig. 4 shows a portion of an example point cloud for a flowslide, while Fig. 5 shows a shaded relief digital surface model.

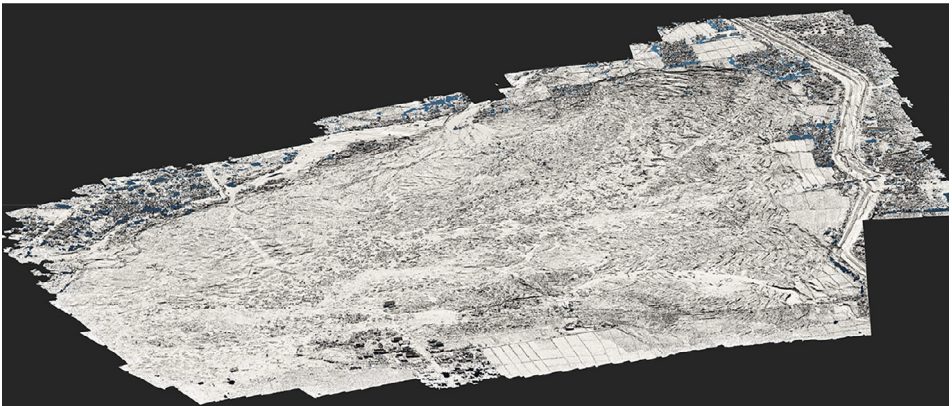
Fig. 5. UAV image-derived digital surface model (DSM) the portion of the Jono Oge flowslide shown in Fig. 4. The shaded relief mapping, which accentuates morphological features, was created in the software CloudCompare. Areas colored blue indicate regions where vegetation concealed the ground surface.

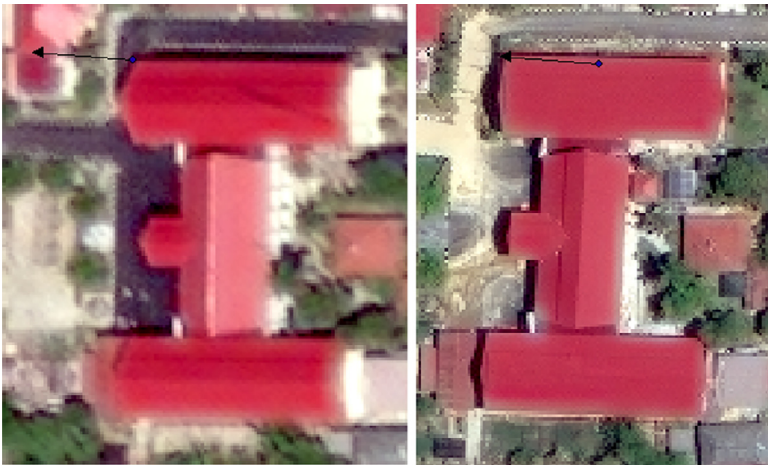
Fig. 7. Ideal building for mapping from (left) before and (right) after the earthquake in ArcMap.

To measure the movement of a building, a vertex or another well-defined point was chosen on both images. The precision of the point chosen was especially important for buildings with small (<25 m) displacements since measurement error could skew the data. Fig. 7 shows a clearly identifiable structure. The pre-earthquake location is marked with a colored dot, and the arrow terminates at the post-earthquake displaced location. The uncertainty of this displacement measurement is low because the building shape is unique, its movement was minimal, and perhaps most importantly, the building was recorded by a high-resolution satellite image both before and after the event. However, it was not always possible to obtain such high-quality displacement measurements, particularly for sparsely populated or rural areas. There are relatively few structures to observe at these locations, and often the satellite images were of lower resolution. Fig. 8 shows an example of imagery where the footprint of a rural structure was not as well defined, but of adequate quality to interpret displacements. For such cases where the building vertices were vague, a corner was assumed by following the more defined sides of the roof to where their intersection would have been depicted if the imagery had better resolution.

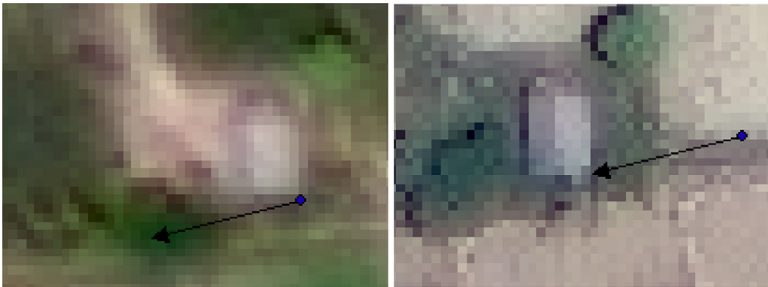
Fig. 8. Suboptimal building for mapping from (left) before and (right) after the earthquake in ArcMap.

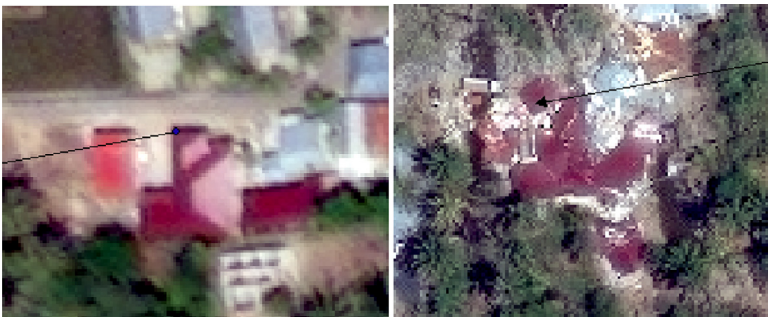
Fig. 9. Unique roof from (left) before and (right) after the earthquake in ArcMap.

There were additional difficulties with the areas that experienced large (>25 m) displacements. Identifying buildings is more challenging, as they did not merely slide in a uniform, coherent manner but were often rotated in the flowslide along a nonlinear path. To identify buildings in these areas, we focused on structures with unique roof lines and colors (Fig. 9). Buildings that could not be confidently identified from the before and after images were excluded. Within the footprint of the flowslides, the buildings were often too heavily damaged to be clearly identified in the post-event imagery. In these cases, the reconnaissance photographs and UAV imagery were used to supplement the satellite images. For example, the reconnaissance team photographed the damaged remains of the Patra Poultry Shop at the Jono Oge flowslide,

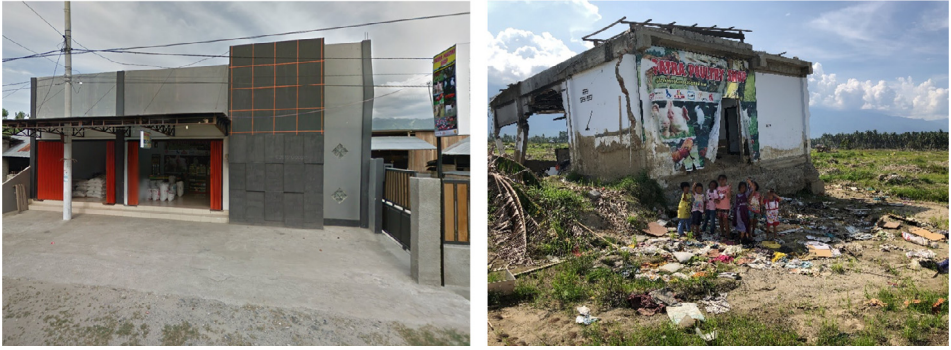
Fig. 10. Patra Poultry Shop in Jono Oge from (left) before the earthquake in Google Streetview and (right) after the earthquake as observed by the reconnaissance team. The children's faces in the photograph taken by the reconnaissance team are blurred to protect their privacy.

which provided the post-earthquake location (Fig. 10). Google Maps and Streetview was then used to locate the market's pre-earthquake position (Fig. 10), which was 1.2 km away from the final location. This finding allowed other structures, including a heavily damaged church, to be identified in the post-earthquake imagery.
