# Evaluating Non-ablative Erbium Yttrium Aluminium Garnet (YAG) Laser Treatment for Polypropylene Mesh-Induced Vaginal Erosion: A Case Series

Nobuo Okui<sup>1</sup>, Yuko Kouno<sup>2</sup>, Kaori Nakano<sup>2</sup>, Machiko A. Okui<sup>5</sup>

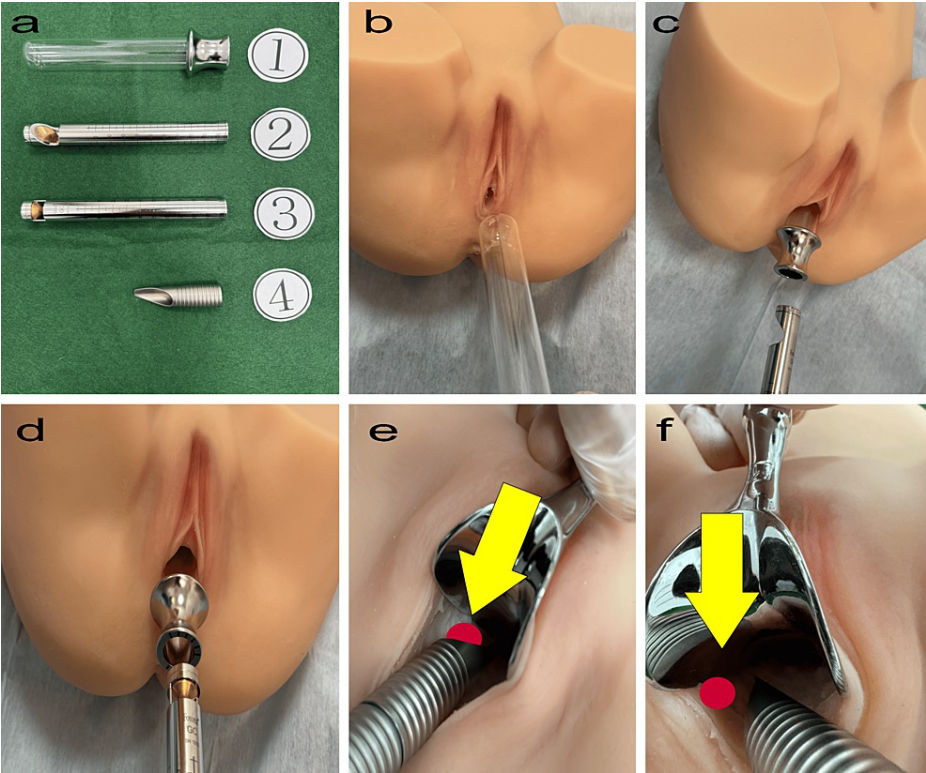
**FIGURE 1: VEL treatment procedure.**

Figure 1 illustrates the laser procedure, with photographs highlighting erosion on the posterior vaginal wall. The lesion, measuring 1.5 cm in size, is marked with a red circle in the images to clearly indicate its location and extent. Patients received local anesthesia with 8% xylocaine spray (Sandoz KK, Tokyo, Japan) for 15 minutes, followed by laser irradiation using RenovaLase (SP Dynamis Fotona d.o.o., Ljubljana, Slovenia). Various handpieces connected to the SP Dynamis laser were utilized. The VEL steps involved inserting a glass speculum into the vagina, using the PS03 handpiece with specific settings to irradiate the eroded areas, comprehensive vaginal irradiation with the R11 handpiece, and finally, targeted treatment of erosions with the PS03 handpiece.

a. SP Dynamis, Copyright © 2013. Courtesy of Fotona d.o.o. (Ljubljana, Slovenia). This image in Figure 1a is provided by Fotona d.o.o. free of charge: 1, Special glass speculum for laser treatment; 2, PS03-GA angular adapter laser probe for the anterior vaginal wall; 3, R11-GC circular adapter laser probe for treating the entire circumference of the vagina; 4, PS03 adapter probe for direct erosion irradiation.

b. Insertion of a glass speculum.

c. Laser irradiation of the posterior vaginal wall using the PS03-GA.

d. Whole-vaginal laser irradiation with the R11-GC.

e. Targeted irradiation of erosions (indicated by the yellow arrow and red circle) using the PS03.

f. An additional aspect of the procedure, as shown in e.

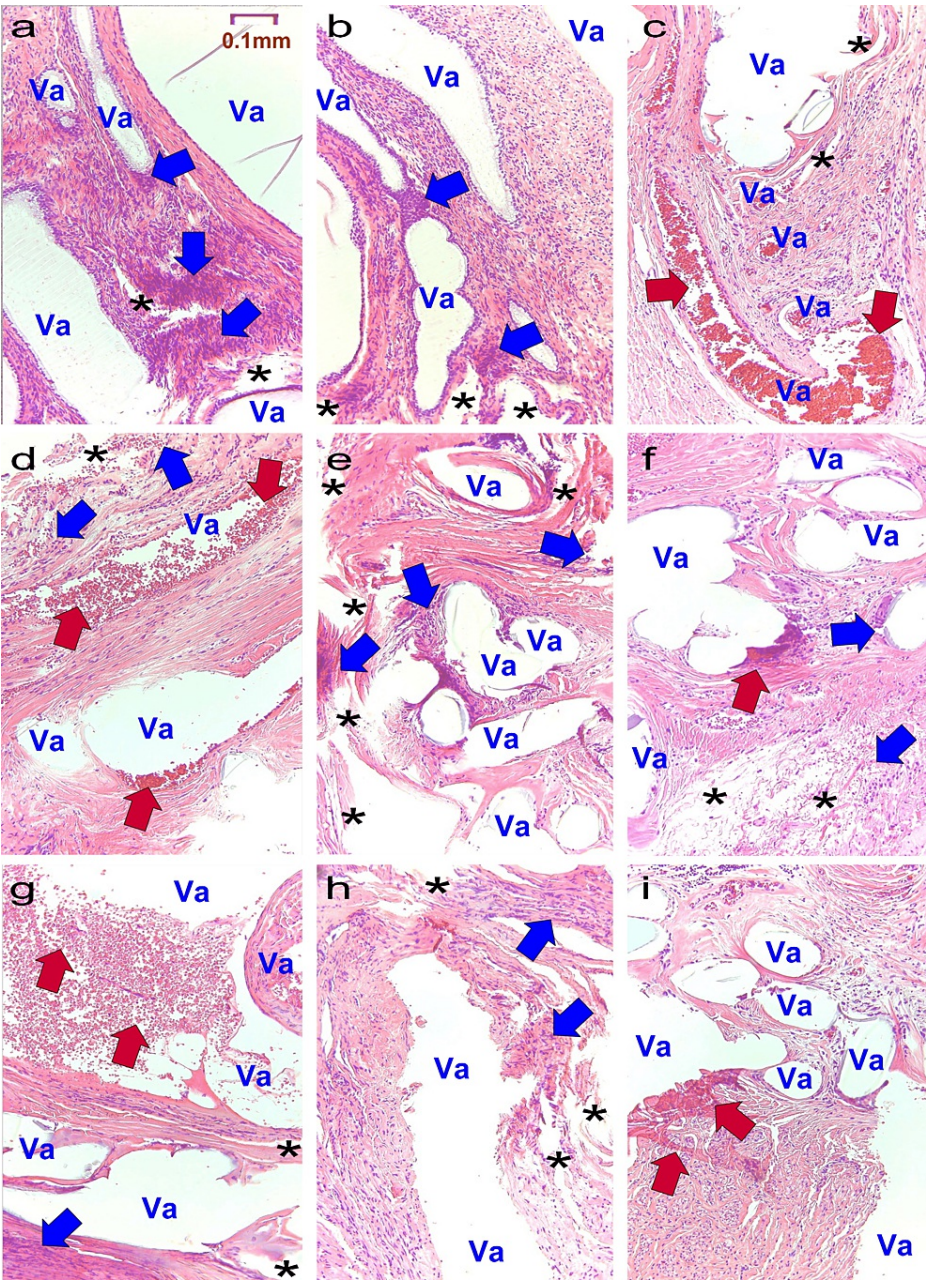
**FIGURE 2: Pre-treatment biopsy tissue.**

Figure 2 displays the biopsy tissues before treatment in all cases.

a: Case a; b: Case b; c: Case c; d: Case d; e: Case e; f: Case f; g: Case g; h: Case h; i: Case i.

Va: Vacuoles formed when mesh fibers dislodged during the preparation of pathological specimens.  
Blue arrows: Foreign-body giant cells. Red arrows: Sites of bleeding.  
\*: Cracks in the surrounding tissue caused by the fraying of polypropylene mesh fibers due to aging.  
All images were stained with H&E and captured at an optical magnification of 40x using an Olympus System Microscope BX43 and objective lens LPLN10X (Olympus Corporation, Tokyo, Japan).

In case a, the site of mesh insertion formed vacuoles due to polypropylene mesh fibers falling out during the preparation of the microscopic specimen (Va). The fibers are frayed due to aging, causing destruction of the surrounding tissue and resulting in large vacuoles. Additionally, foreign-body giant cells form aggregates and abscesses (blue arrow). Healthy tissue is affected by fine damage from fibers, leading to cracks (\*).

In case b, multiple deformed vacuoles were observed, similar to case a, along with enlarged cracks in the tissue (\*).

In case c, adjacent to the enlarged vacuoles (Va), a large hematoma was observed (red arrow), with fine cracks (\*).

In case d, the vacuoles were deformed (Va), accompanied by a hematoma (red arrow).

In case e, it is presumed that the fiber size was relatively maintained, with vacuoles approximately the same size as the fibers being prominent (Va). However, some vacuoles ruptured, starting abscess formation (blue arrow).

In case f, due to varying conditions of the fibers, the vacuole sizes are inconsistent (Va), with minor bleeding present (red arrow).

In case g, the vacuoles could not maintain their shape (Va) and formed a large hematoma (red arrow).

In case h, vacuoles collapsed and merged with adjacent vacuoles (Va), with cracks observed throughout the tissue.

In case i, the vacuoles have healed or changed due to the disruption of fibers (Va), with bleeding observed (red arrow).

Third, pretreatment pathology is considered. Pathological examination of the erosive area at T0 showed characteristic vacuole formation. Wang H et al. elucidated that polypropylene mesh, frayed and peeled due to aging, elicits a significant inflammatory response in the surrounding tissue [13]. They reported an increase in the number of M2 subtype macrophages and T lymphocytes in severely degraded mesh, with a trend of increasing along with mesh degradation [13]. Taylor D et al.'s study characterized soft tissue erosion by surgical mesh in vitro, focusing on a significant postoperative complication known as "mesh erosion," which occurs when mesh materials wear down adjacent soft tissues through friction, reporting erosion rates consistent with clinical experience [5]. Our study found that the longer the mesh was inserted, the more the fibers degraded, showing abrasion and cracks around them. In addition, vacuoles along the mesh shape merged and enlarged, with some forming abscesses and hematomas.

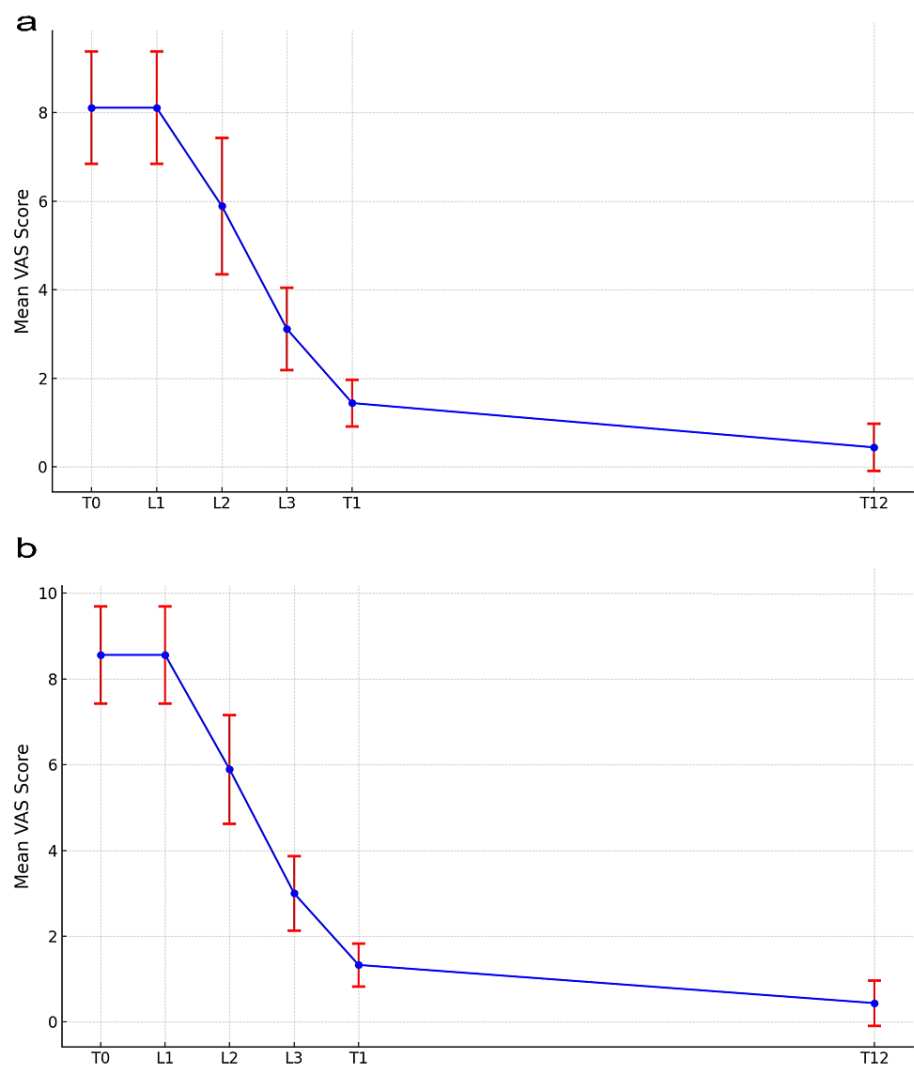
**FIGURE 3: Temporal changes in bleeding and QoL.**

Figure 3a depicts the bleeding from erosions assessed using VAS. The average VAS score at T0 was  $8.11 \pm 1.27$ , with L1 showing no change from T0. The average VAS at L2 was  $5.89 \pm 1.54$ ; at L3, it was  $3.11 \pm 0.93$ ; at T1, it was  $1.44 \pm 0.53$ ; and at T12, it was  $0.44 \pm 0.53$ . The change from T0 to T12 was statistically significant ( $p < 0.001$ ).

a: VAS evaluation of bleeding. Vertical axis: VAS score; horizontal axis: time.

b: VAS evaluation of QoL. Vertical axis: VAS score; horizontal axis: time.

T0: At initial consultation; L1: After the first laser treatment; L2: After the second laser treatment; L3: After the third laser treatment; T1: One month after L3; T12: 12 months after L3.

Figure 3b illustrates the evaluation of QoL using the VAS. The average VAS score at T0 was  $8.56 \pm 1.13$ . At L1, the score remained similar to T0. By L2, the average VAS decreased to  $5.89 \pm 1.27$ , indicating that the treatment significantly reduced bleeding over a short period. The average VAS score further decreased to  $3.00 \pm 0.87$  at L3, and by T1, the score was reduced to an average of  $1.33 \pm 0.50$ , significantly improving the patient's QoL. At the T12 follow-up, the VAS score decreased to an average of  $0.44 \pm 0.53$ , revealing the long-term effects of the treatment. The change from T0 to T12 was statistically significant ( $p < 0.001$ ).

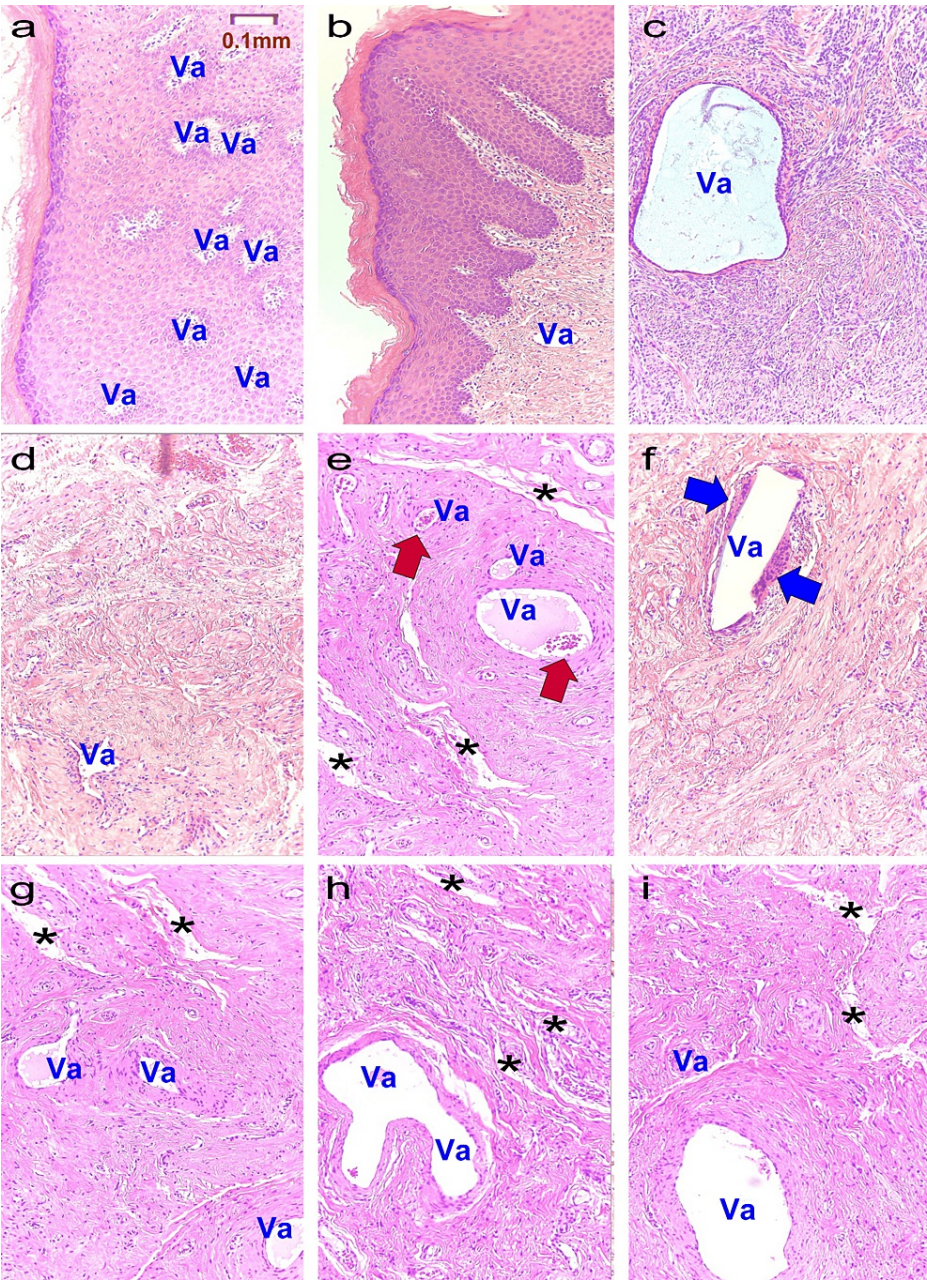
**FIGURE 4: Post-treatment pathological analysis.**

Figure 4 presents histological images of the lesion sites at T12. In all cases, cell proliferation has filled the previously fiber-induced tissue deficits, with fibers remaining and forming minimal-sized vacuoles (Va). In case a, numerous small vacuoles are observed. In case b, significant epithelial regeneration is noted, with fibers being moved deeper into the tissue. In case c, enlarged vacuoles are visible due to the disintegration of fibers, surrounded by cells. Case d exhibits only one vacuole. Meanwhile, cases e and f show minimal rebleeding. In cases e, g, and h, it is apparent that cells, once densely regenerated, are now being split by parts of frayed fibers (\*). In cases, e, f, h, and i, similar to case c, large vacuoles are present due to deformed fibers but are surrounded by cells.

a: Case a; b: Case b; c: Case c; d: Case d; e: Case e; f: Case f; g: Case g; h: Case h; i: Case i.  
Va: Vacuole formed when the mesh fell off during pathological specimen preparation. Blue arrows: Foreign-body giant cells. Red arrows: Sites of bleeding. \*: Cracks in the surrounding tissue caused by the fraying of polypropylene mesh fibers due to aging.

Fourth, the post-VEL pathological findings are discussed. Gaspar A et al. reported changes in the vaginal mucosa after VEL [14]. Post-VEL treatment, the thickness of the vaginal mucosa increased from 45  $\mu\text{m}$  (10–106  $\mu\text{m}$ ) to 153  $\mu\text{m}$  (97–244  $\mu\text{m}$ ), with significant cell proliferation observed [14]. Previous research has reported that even in cases with severe vaginal pain, the average thickness of the vaginal wall before treatment was 57.3 $\pm$ 14.2  $\mu\text{m}$ , whereas post-treatment it was 133.3 $\pm$ 24.5  $\mu\text{m}$  [8]. Our study is distinctive in the pathology of cell proliferation surrounding the vacuoles, as reported by Wang H et al. and Taylor D et al., with an overall increase in cell numbers. However, some patients showed rebleeding on pathological examination, suggesting the need for additional VEL treatments every one to two years.
