Zotarolimus-eluting stent fracture at initial implantation diagnosed with StentBoost

SAGE Open Medical Case Reports
Volume 4: 1–4
© The Author(s) 2016
Reprints and permissions:
sagepub.co.uk/journalsPermissions.nav
DOI: 10.1177/2050313X16645754
sco.sagepub.com

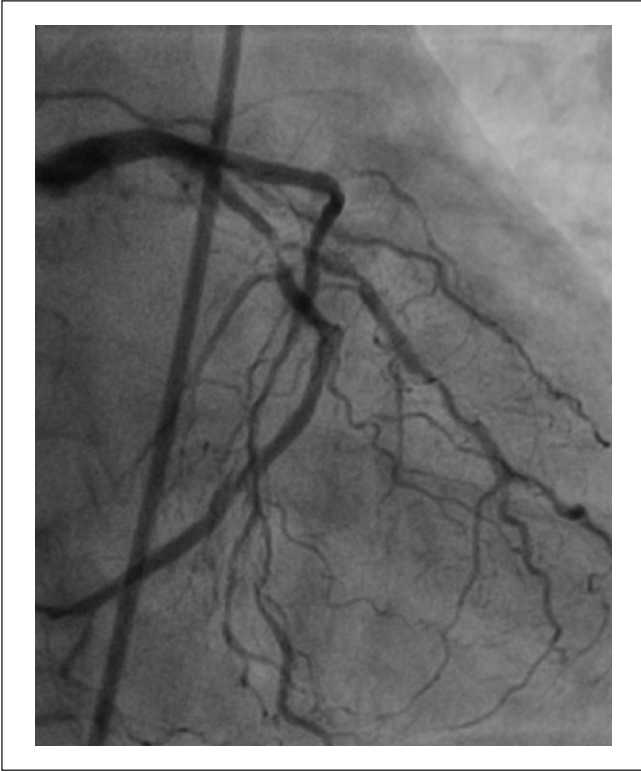
Figure 1. Coronary angiography revealed a Medina 1-1-1 obtuse marginal branch of circumflex coronary artery (CX-OM) bifurcation lesion.

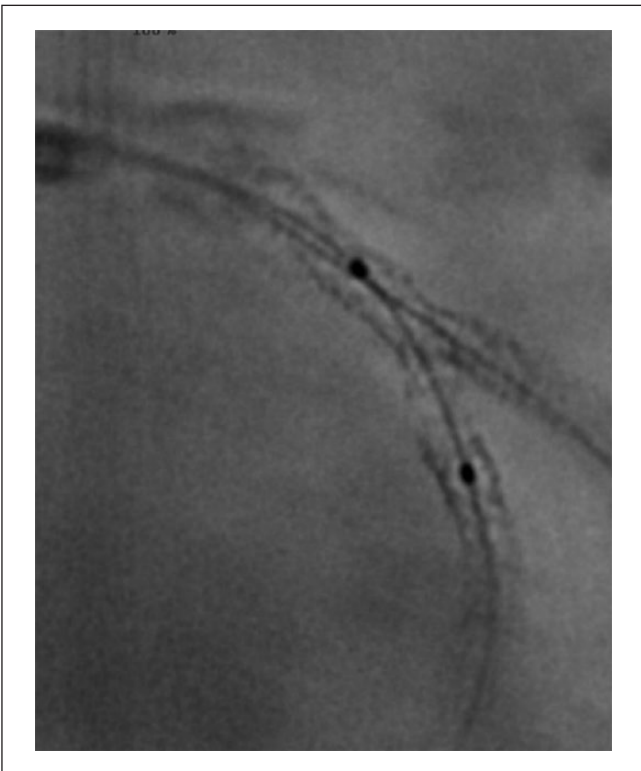
Figure 3. StentBoost shows type V stent fracture (SF).

As demonstrated in our case, image enhancement can be very useful in differential diagnosis of in stent haziness. At first sight, thrombus formation and plaque prolapsus were considered as possible underlying mechanisms, but image enhancement with StentBoost showed a type V SF (Figure 2). The haziness was probably caused by plaque prolapsus/shift at fracture, disruption sites. In our case, aggressive postdilatation with NC balloon after stent implantation or the thin strut structure of the stent may be the cause of the fracture. In the era of newer generation stents with thinner struts, image enhancement should be used routinely to assess stent expansion and possible complications like fracture or longitudinal compression especially when performing complex interventions with multiple stenting.

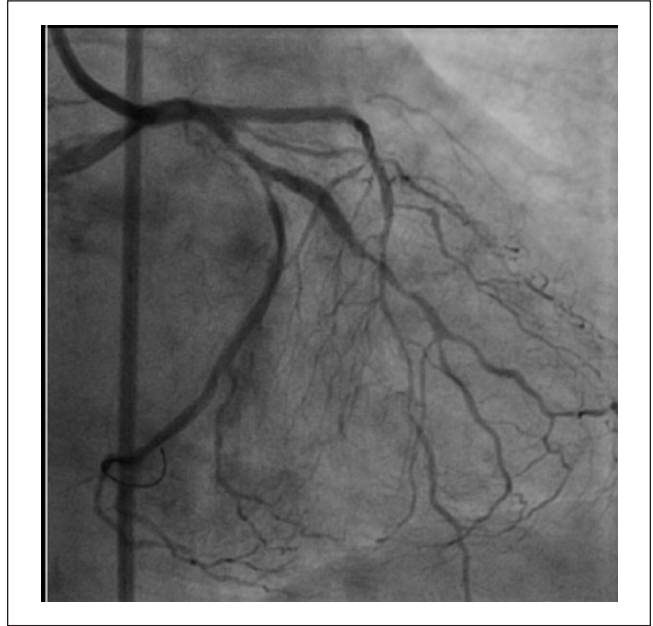
Figure 2. The arrows showing localized haziness appeared in the main branch stent both in the proximal part and distal to the OM take off.

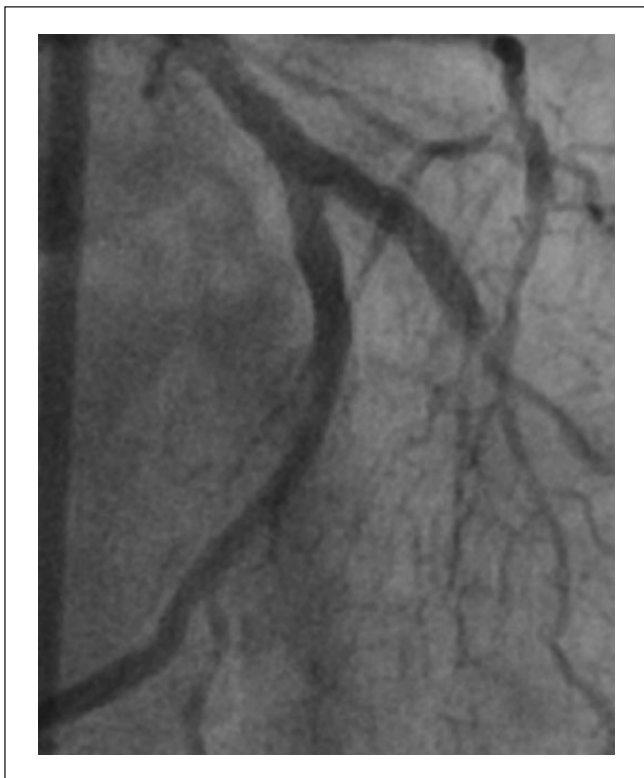
Figure 4. Endeavor Resolute stent was implanted at 14atm. The final result was good.

18 atm. Thereafter, while parking a balloon in the main branch, a 2.5×18 -mm stent (Endeavor Resolute; Medtronic) was deployed in the side branch at 12 atm and postdilated with a 2.5×12 -mm noncompliant (NC) balloon (Simpass; Simeks) at 20 atm. Subsequently deploying the main branch balloon, a mini crush was performed and another 2.5×30 -mm stent (Endeavor Resolute; Medtronic) was implanted at 20 atm into the Cx body. The OM was rewired and final kissing was performed with NC balloons. Thereafter, localized haziness suggesting thrombosis at first sight appeared in the main-branch stent, both in the proximal part and distal to the OM take off (Figure 2). The patient had no symptom and was hemodynamically stable. StentBoost showed stent fracture and disruption (Figure 3). Another Endeavor Resolute stent was implanted at 14 atm to cover the fracture sites. The final result was satisfactory (Figure 4).
