Early Disassembly of Femoral Head and Neck Components After Total Hip Arthroplasty Revision

Categories: Orthopedics

Keywords: femoral head-neck dissociation, modular, revision hip arthroplasty, manufacturing error

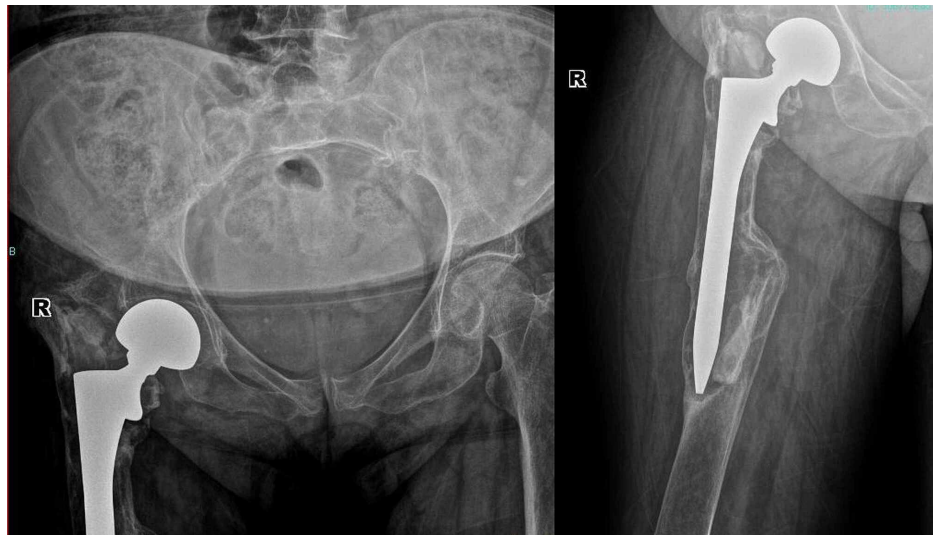
A 76-year-old female patient who underwent bipolar hemiarthroplasty due to right femoral neck fracture six years ago, presented with increasing pain in her right hip. Her complaints had started approximately three years ago. Implant loosening and malposition were detected in the right hip prosthesis; therefore, revision surgery was indicated (Figure 1).

FIGURE 1: The preoperative radiographs of the patient with loosening of the right hip prosthesis.

The patient underwent hip arthroplasty revision surgery with a posterior approach (Figure 2).

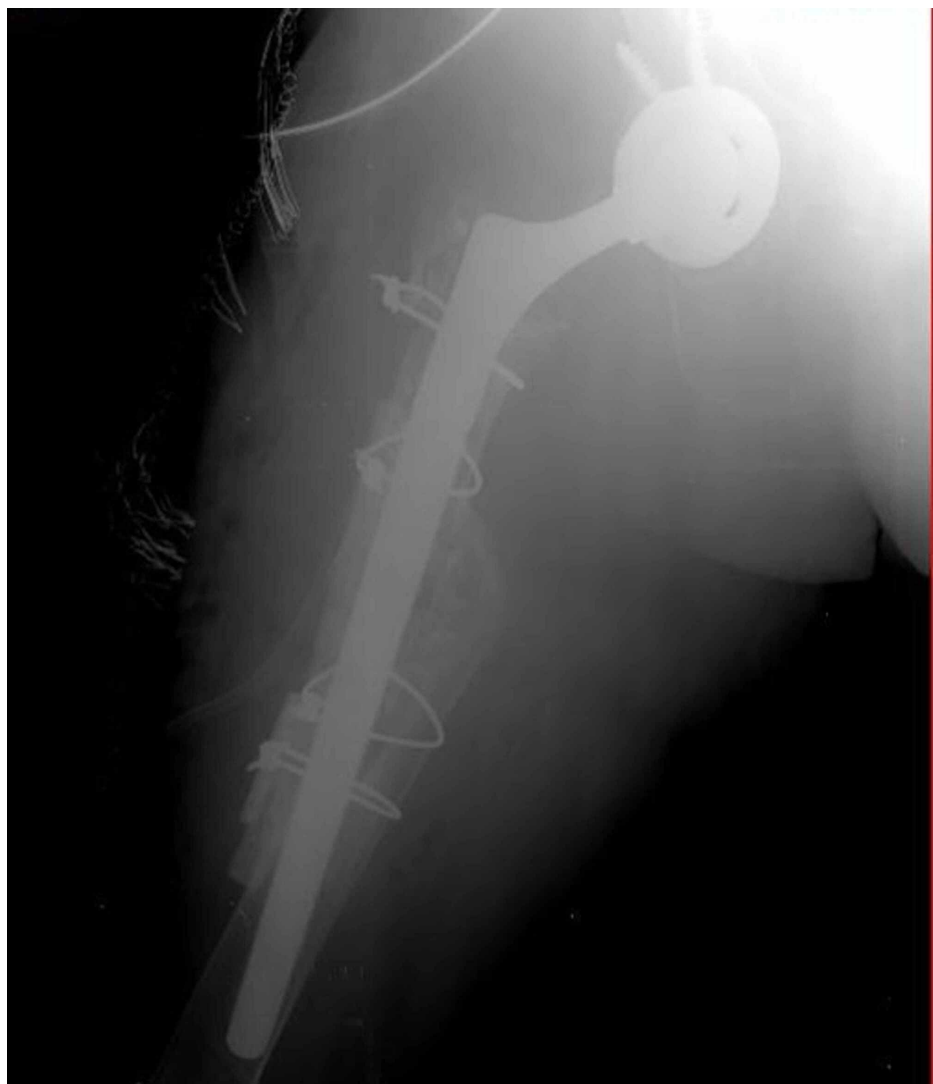
FIGURE 2: Early postoperative radiography of the patient who

underwent revision total hip replacement.

Acetabular cup no. 48, CoCr femoral head no. 32 (+4 mm) and lateralized offset neck (+4 mm) (Lima Corporate, Italy) were used. The femoral head was impacted on the neck with an appropriate force and the hip was reduced.

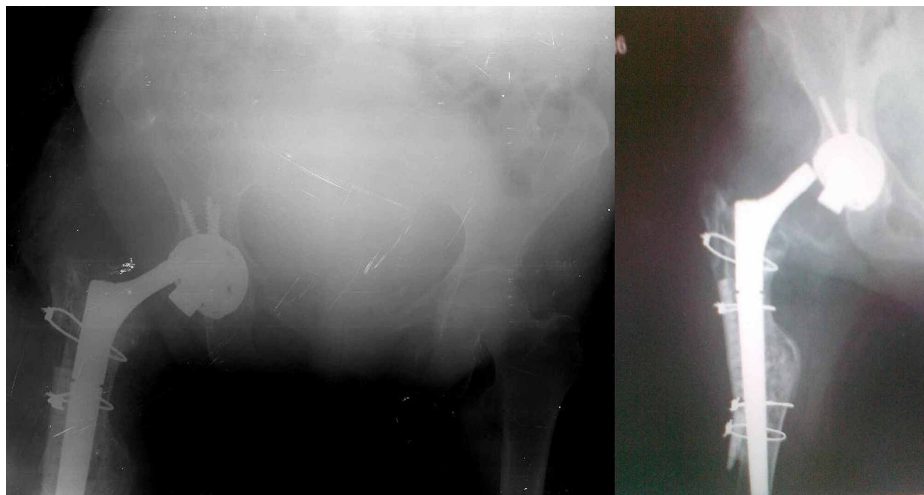
Weight-bearing was allowed at the end of sixth week. At third-month follow-up, the patient was able to mobilize pain-free. However, a few days after her third-month follow-up, she was admitted to the outpatient clinic with complaints of severe pain and limitation of motion in the right hip without any history of obvious trauma. The patient reported that the pain and limitation emerged following a sound she heard while getting up from her seat. Disassociation of femoral head and neck components and accompanying hip dislocation was detected in the right hip (Figure 3).

FIGURE 3: The direct radiographs of the patient three months after the surgery showing disassociation of the femoral head and neck components of the hip prosthesis.

The femoral head was in the acetabular cup. There were no signs of osteolysis or loosening of the components on the radiographs.

A same-sized femoral head, liner, and proximal modular part of femoral stem replacement were performed via the same anatomic approach (Figure 4).

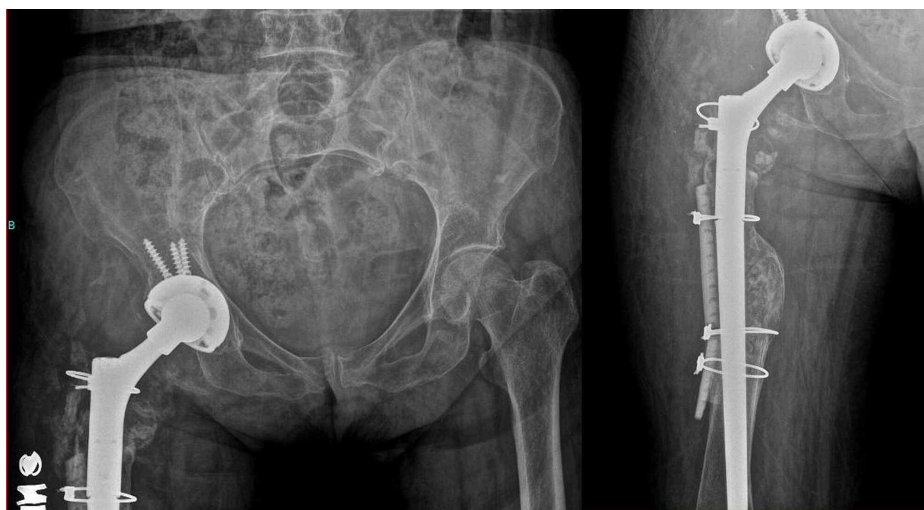
FIGURE 4: Postoperative one-year radiographs of the patient showing replaced femoral head, liner, and proximal modular part of femoral stem

after revision due to the disassociation of the femoral head and neck components.

Both distal part of the femoral stem and acetabular shell were in a good position as observed intraoperatively, thus were not revised. No apparent corrosion was detected on the removed components. There were no signs of metallosis in the surrounding tissues, nor any sign of an impingement that could potentially affect femoral head or neck. The retrieved parts of the prosthesis revealed that the head-neck interface was not matching appropriately although no visible damage was detected on the implants and the taper sizes (12/14) were appropriate for both neck and head components. The disassociation was attributed to a possible manufacturing error of either head or neck component. The hip joint was stable after revision. No problems were encountered during the patient's three years of follow-up.
