# Removal of a separated endodontic instrument by using the modified hollow tube–based extractor system: A case report

SAGE Open Medical Case Reports  
Volume 8: 1–4  
© The Author(s) 2020  
Article reuse guidelines:  
sagepub.com/journals-permissions  
DOI: 10.1177/2050313X20907822  
journals.sagepub.com/home/sco

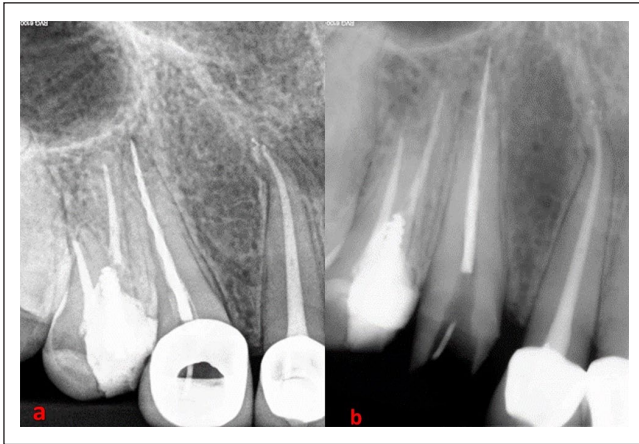
**Figure 1.** Diagnostic radiography (a) before and (b) after removal of the metal ceramic crown.

revealed another small separated instrument in the pulp chamber (Figure 1(b)); the access cavity was reevaluated, but there was no need to modify it. Several attempts were made to extract the separated instrument (F3) by using the ultrasonic tip ET25 (SATELEC, A company of the ACTEON Group, France) under magnification with a Leica M320 dental microscope (Leica Microsystems, Wetzlar, Germany); however, the F3 instrument remained firmly fixed and could not be removed. Therefore, the use of another technique was attempted. A tool modified from a hollow tube-based extractor system was used with an etching needle and a K file size 40 (Dentsply Maillefer, Ballaigues, Switzerland) as the extraction device (Figure 2(a)). The etching needle was inserted into the canal and interlocked with the separated instrument, and then, a K file size 40 was inserted into the needle lumen, which shackled the separated instrument (Figure 2(b)). After three attempts to withdraw the separated instrument, the instrument was removed from the canal (Figure 3(a)). The length of the fragment was approximately 16 mm (Figure 3(b)), and then, the small separated instrument in the pulp chamber was removed by using an ultrasonic tip. Cleaning and shaping of the canal were completed by using a new F3 instrument from the ProTaper universal

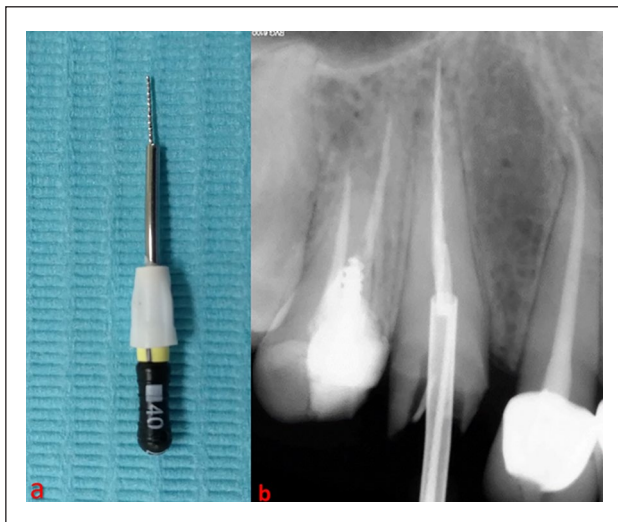
**Figure 2.** (a) Etching needle with a K file as an extraction device and (b) etching needle engaged around the separated instrument and interlocked with the K file.

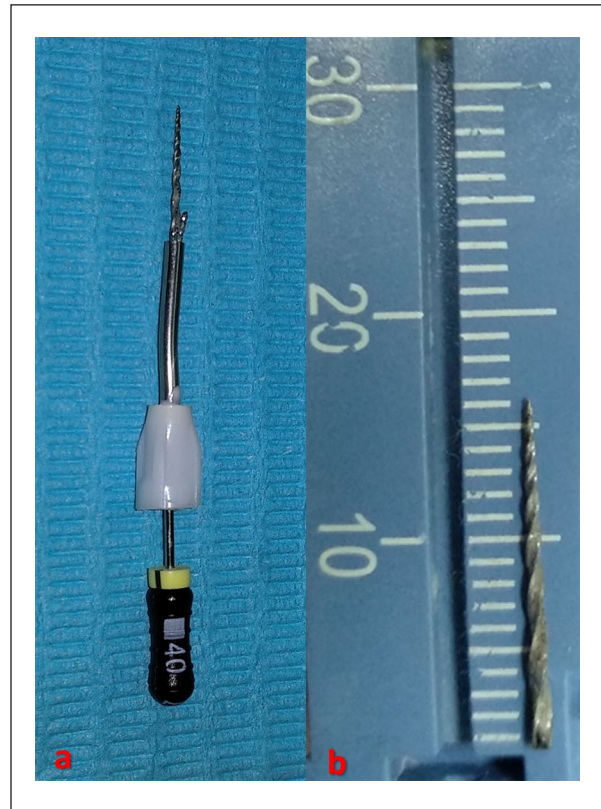
**Figure 3.** Separated instrument after it was removed from the canal. (a) the removed separated instrument by hollow tube-based extractor and (b) the length of the fragment was approximately 16 mm.

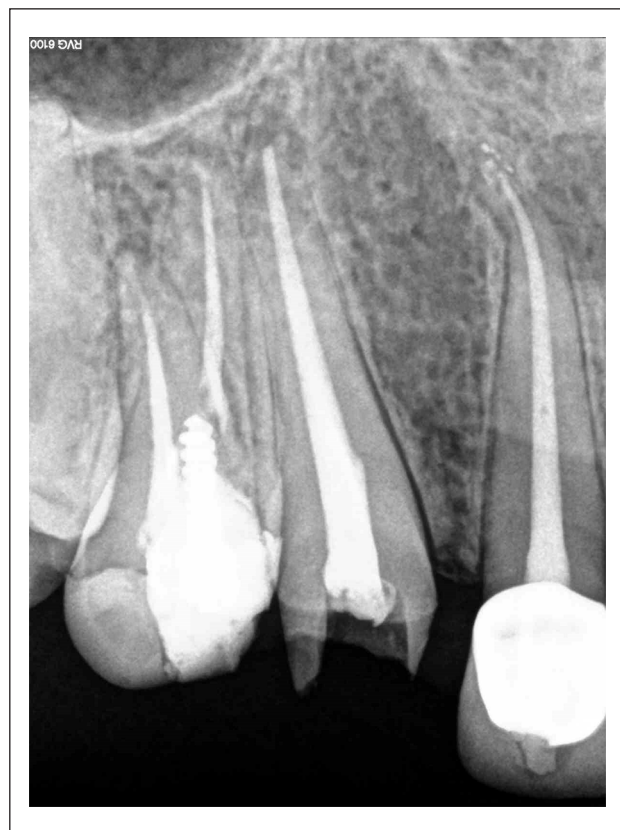
**Figure 4.** Final root canal obturation.

NiTi system, and the canal was filled by using the Calamus dual 3D obturation system (DENTSPLY International, Inc., Tulsa) (Figure 4), and the patient was referred to the prosthodontic department for final restoration.
