# Polymer Emboli Complicating Transcatheter Aortic Valve Implantation

## A Case Report

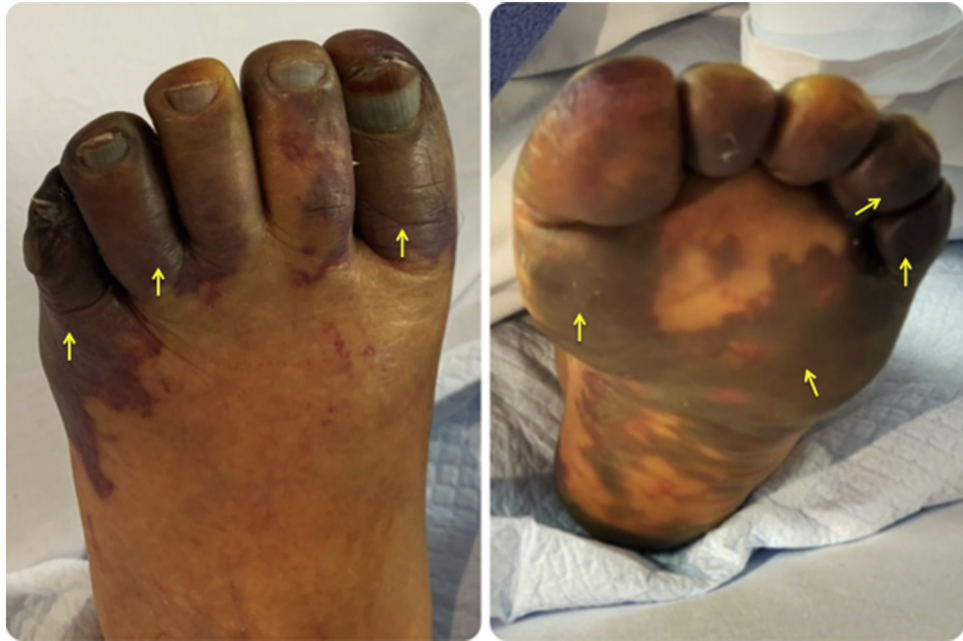
**FIGURE 4** Ischemic Left Foot

Dorsal and plantar aspects of the patient's left foot on day 3 after transcatheter aortic valve implantation demonstrates gangrene involving the entire plantar aspect and proximal and distal regions of digits 1 to 5, with scattered petechiae seen on the dorsal aspect.

On day 3 post procedure, the patient developed severe abdominal pain, acute kidney injury, and blue discoloration of the left foot (Figure 4). Computed tomography abdominal scan with oral and intravenous contrast showed complete thrombosis of the distal third of the superior mesenteric artery, with extensive pneumatosis intestinalis and gas in the mesenteric branches of the superior mesenteric vein and splenic vein; complete thrombosis of the distal half of the right renal artery, with no enhancement of almost the entire right kidney; and extensive calcification of the aorta and bilateral iliac arteries (Figure 5). She underwent emergency exploratory laparotomy, in which the entire gangrenous bowel was resected (Figure 6). After 48 hours, she underwent follow-up exploratory laparotomy where a side-to-side colo-jejunal anastomosis was performed. Biopsies of the gut and the gangrenous left foot were consistent with typical findings of hydrophilic polymer emboli (HPE) (Figure 7).

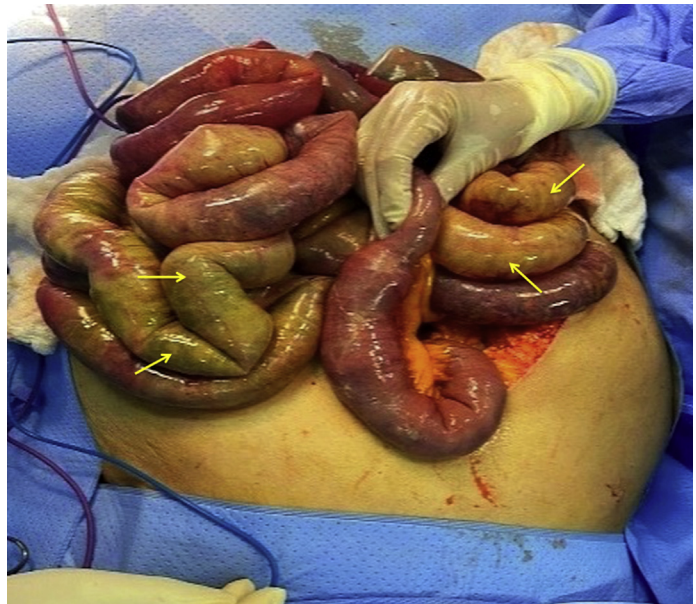
**FIGURE 6** Mesenteric Ischemia

Emergency exploratory laparotomy shows patchy segments of acute gangrene involving the small bowel.
