Removal of Aquafilling Using Body-jet: A Waterjet-assisted Lipsuction Device

Shunichi Nomoto, MD, PhD; Rei Ogawa, MD, PhD, FACS

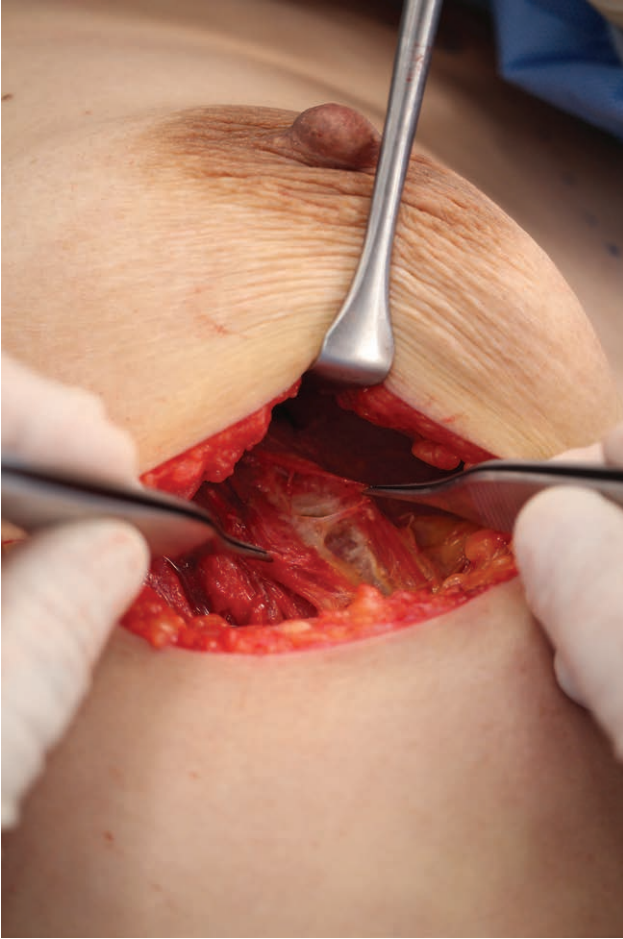
Fig. 1. Photograph showing infiltration of Aquafilling into the fibers of the pectoralis major muscle.

and has become a gel-like substance that has a thick and viscous consistency. In addition, some of the worst cases exhibit filler infiltration of the submammary fascia and pectoralis major (Fig. 1) and/or migration of the filler to the axilla, back, or abdominal wall. These cases are caused by roughly performed injections that were not guided by imaging. Such poor techniques can injure the local tissue and disrupt the normal encapsulation process, thereby inducing infiltration and migration, respectively. These changes associate with serious complications, including biofilm growth on the residual material and inflammatory responses to these microorganisms and the capsule components. Another common problem that we encountered when performing salvage surgery after keyhole surgery in other institutions was the presence of large amounts of the saline wash, which could not be removed through a small incision; in such cases, we had to use a large incision line to remove most of the saline.
